# The History and Remains of the Wheal Victoria Copper Mine at Golitha Falls

By Clive ffitch, Redgate Smithy, Redgate, Cornwall

Dated 5 May 2020; for online photographs and content of this research, please refer to:  
<http://www.photofilecornwall.co.uk/cornwall-mineheritage/wheal-victoria-copper-mine.htm>

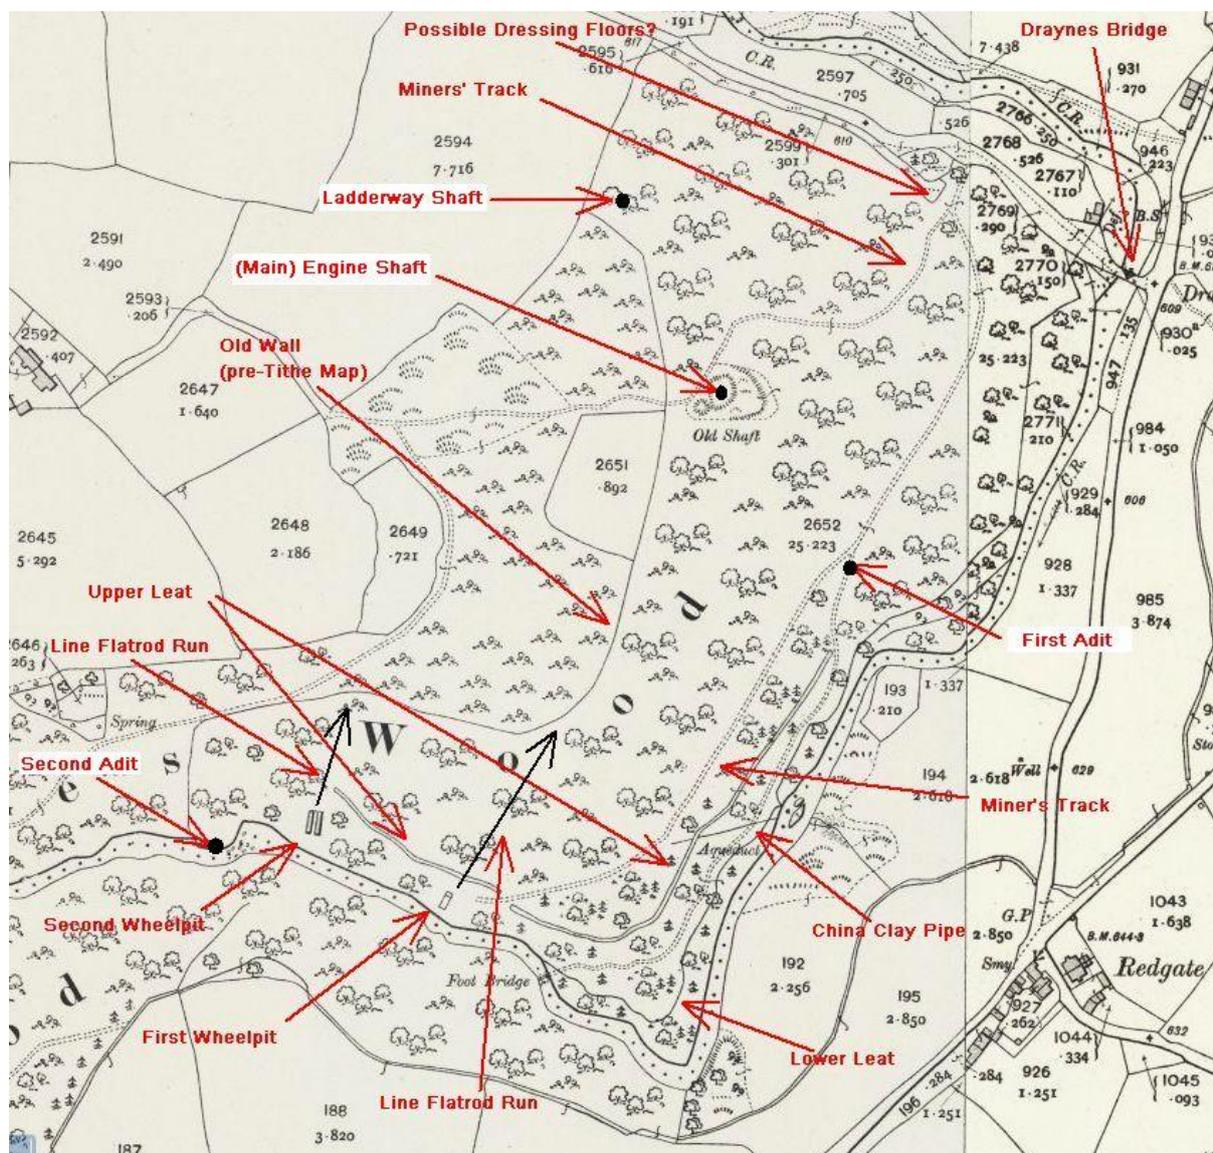
**A map of the main extant features of Wheal Victoria,  
as marked on the 1892 to 1914 OS Map (post 1908 in this case)**

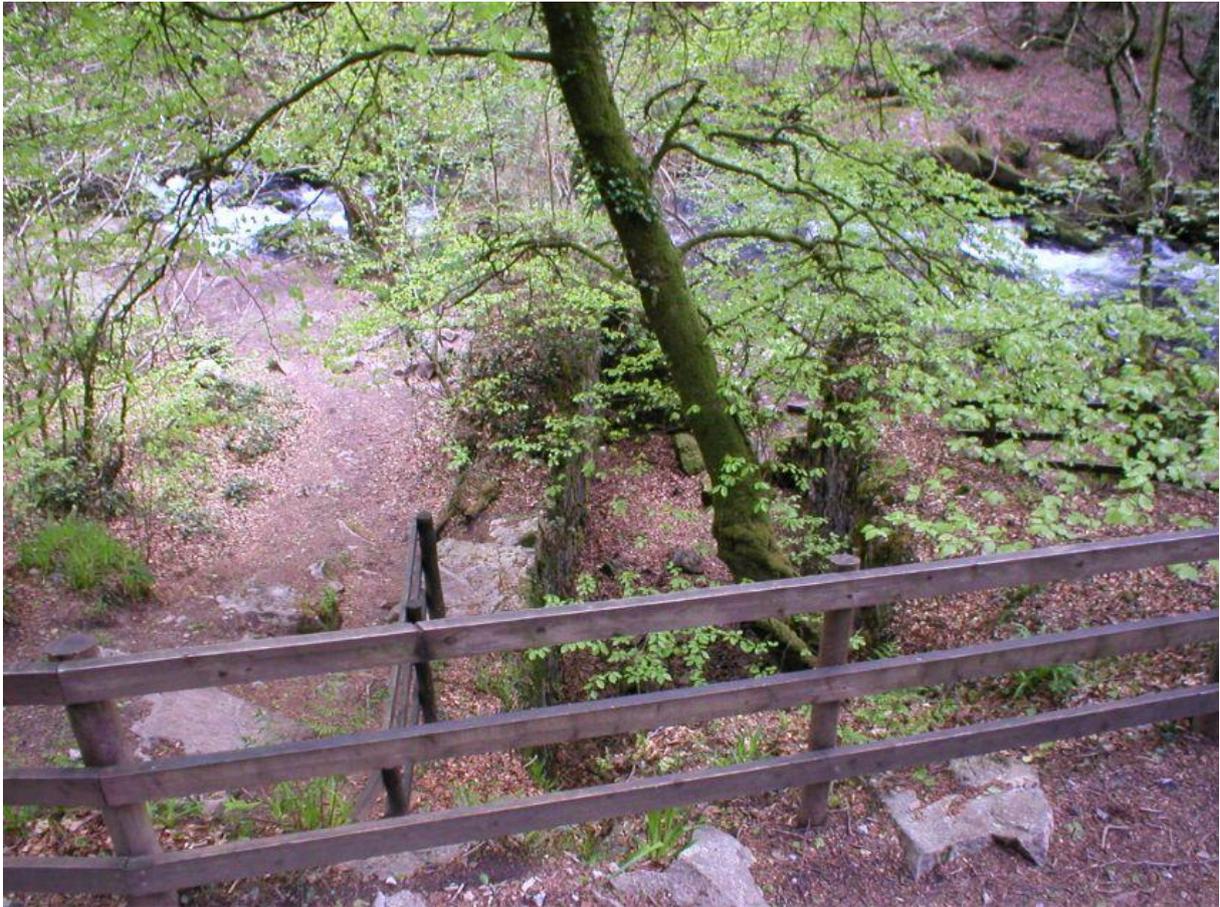
*The First Wheel-pit as it was in 2004 with a large tree still growing out of the inside wall!*

Following the old Miners' Track along the side of the river and past the upper falls, you will come to the First Wheel-pit. A closer inspection will reveal where the wheel axles would have been supported. The large tree growing out of it in the first photo has fortunately since been removed!

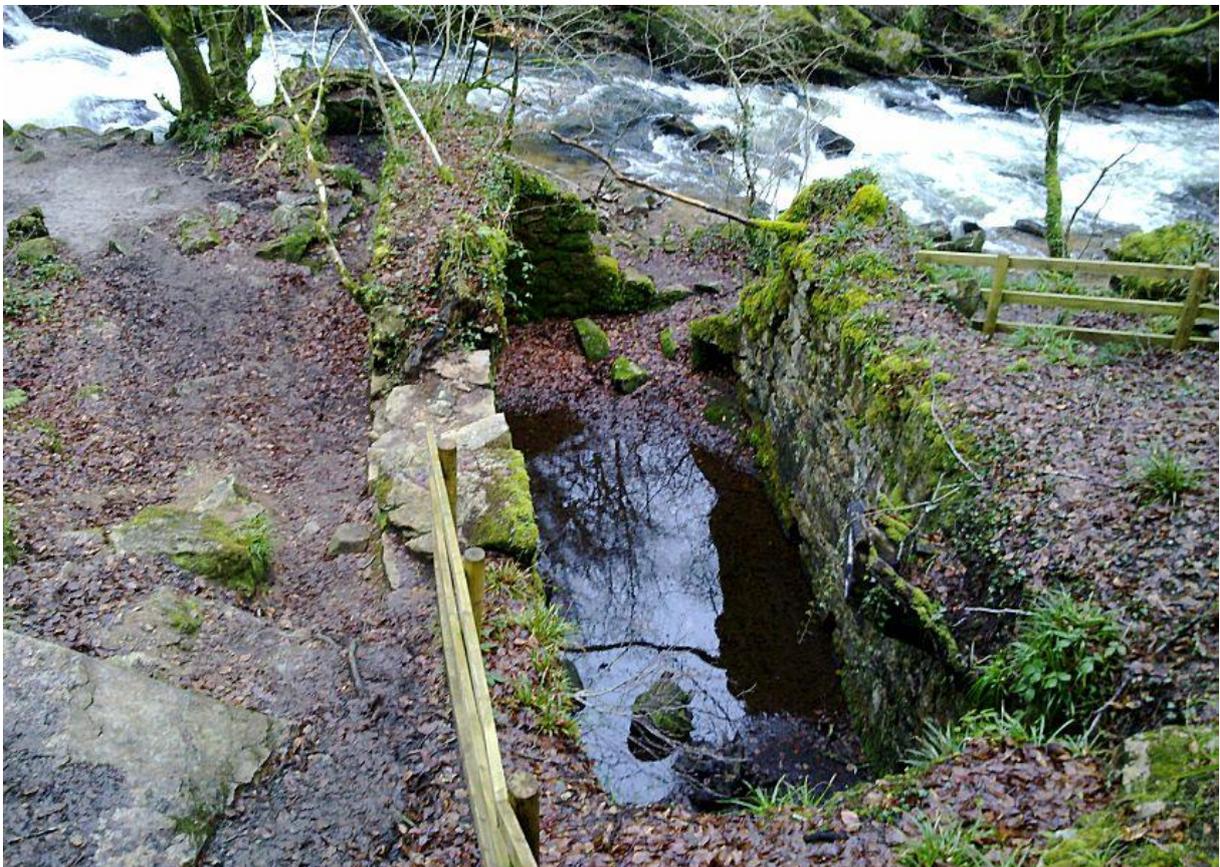
*The First Wheel-pit with tree now removed, and a lot safer for preserving the structure*

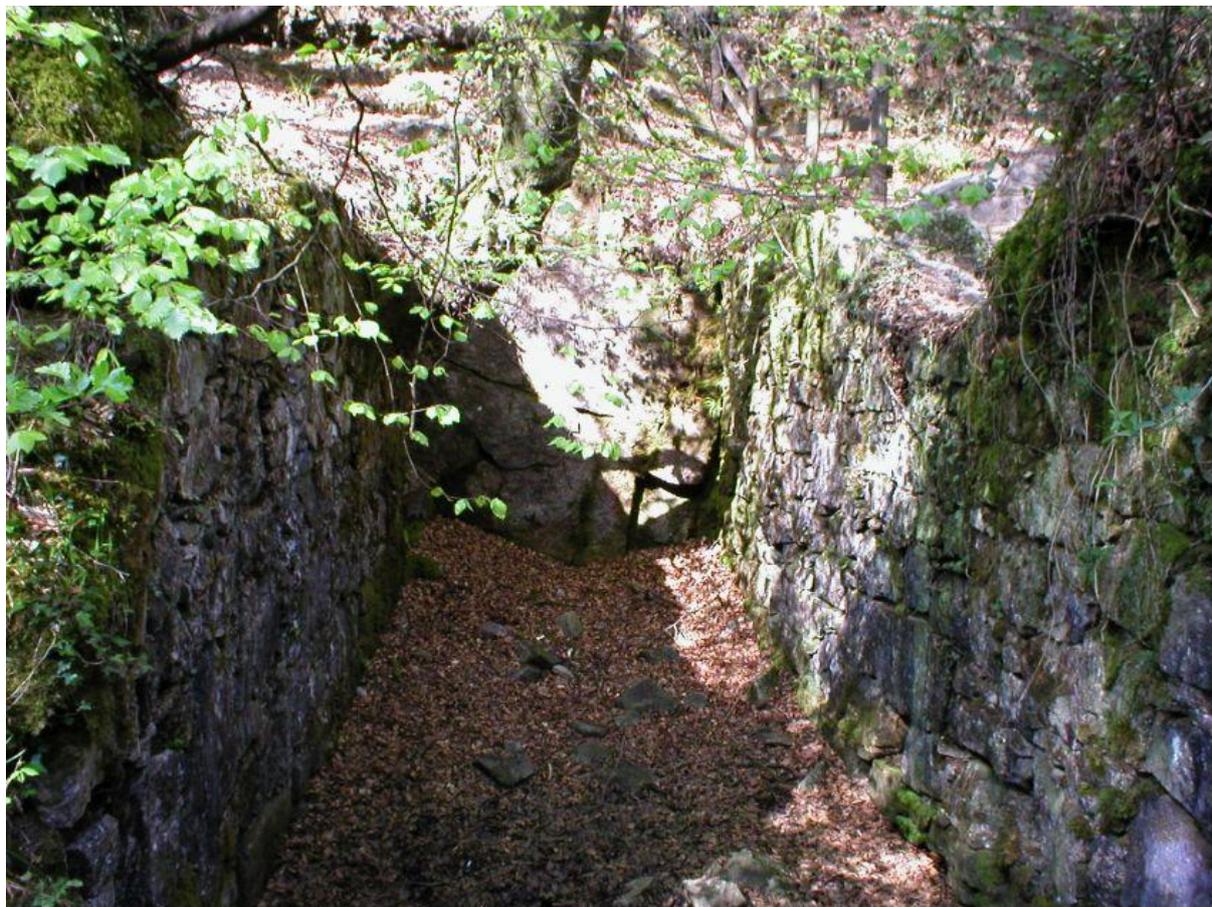
***Looking inside the First Wheel-pit; this wheel-pit has not stood up to the test of time quite as well as the second wheel-pit***

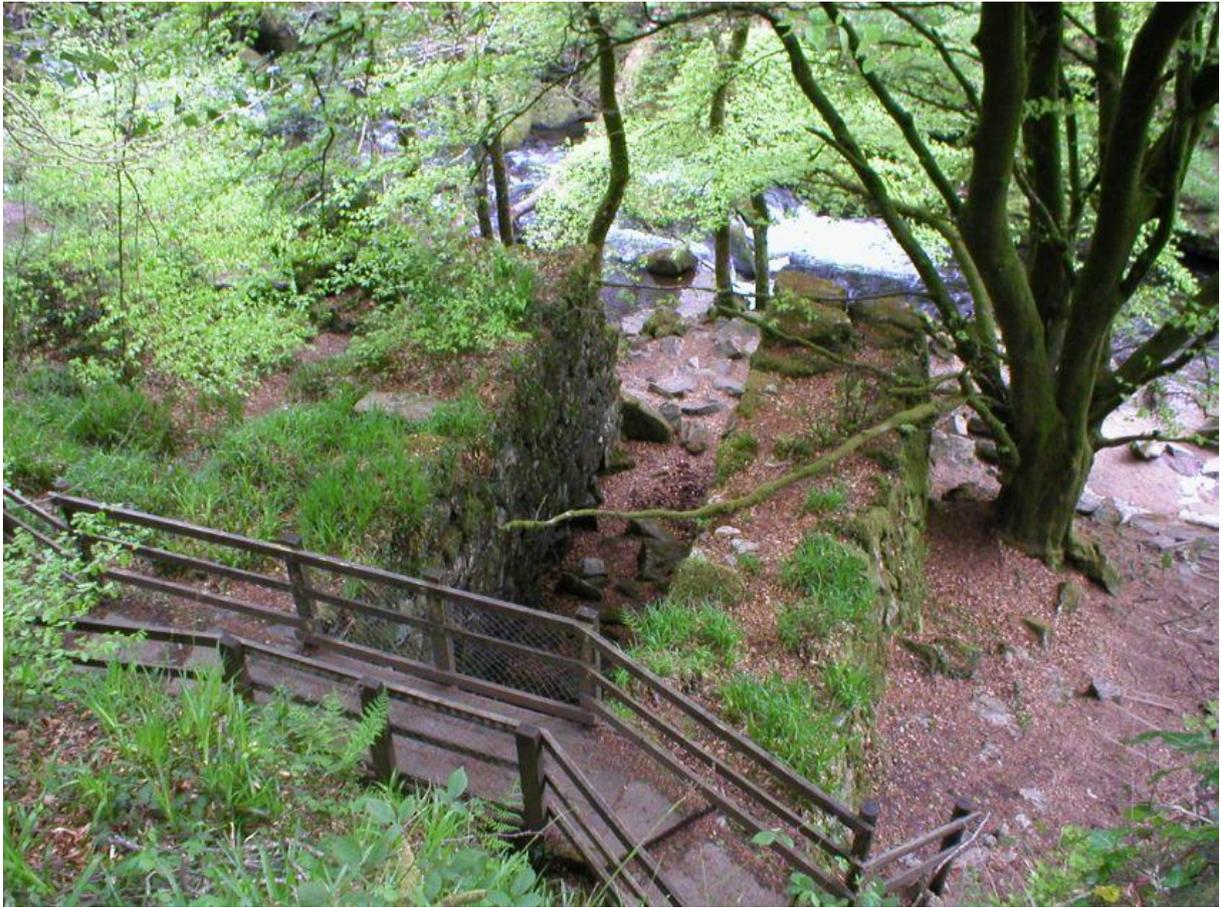
*The Second Wheel-pit*

The Second Wheel-pit can be found a little further along the side of the falls, and will be seen to be in a slightly improved state of repair to the first, and perhaps a little less encumbered by trees. The reason for this wheel-pit is far less clear, though its purpose must have been significant.

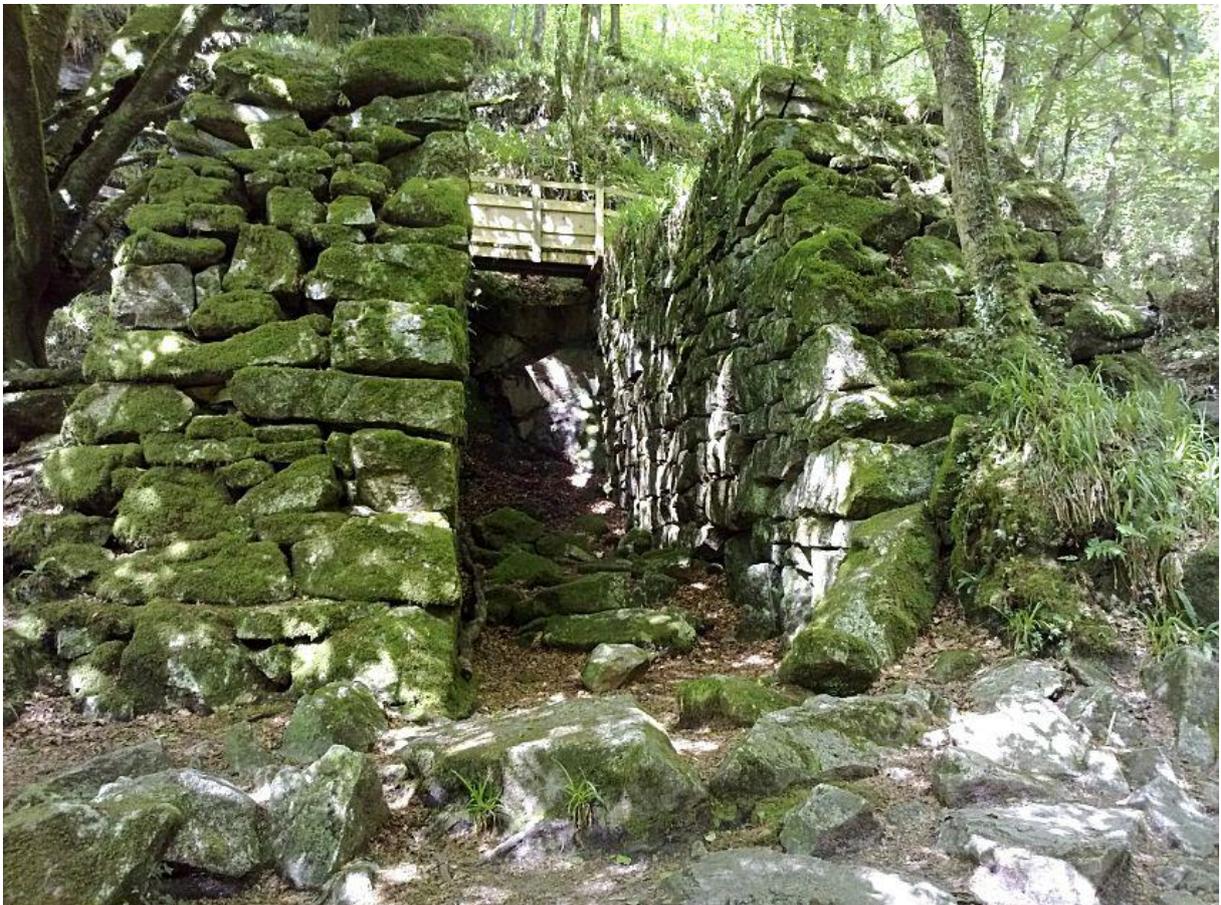
*Looking into the Second Wheel-pit*

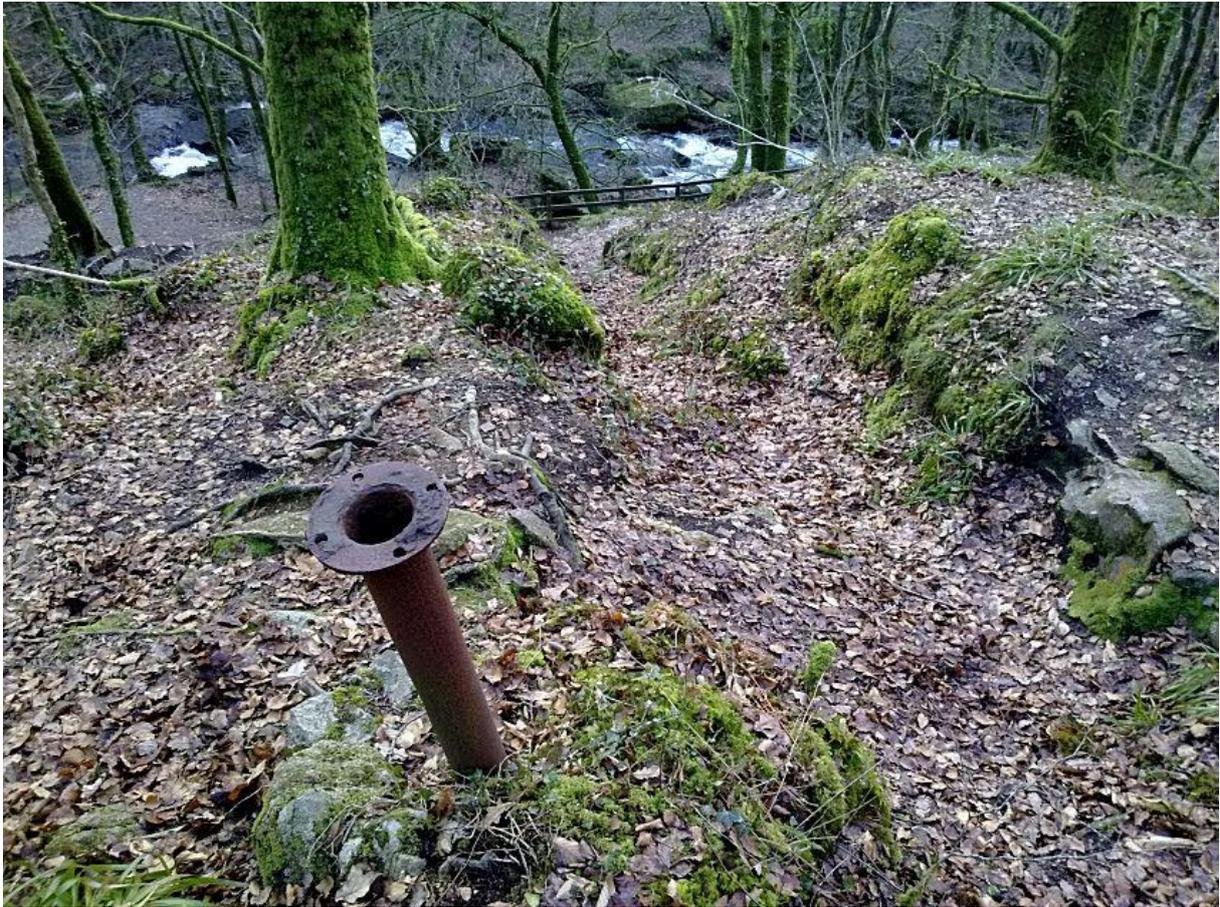
***Looking down the Flat-rod Run towards the First Wheel-pit***

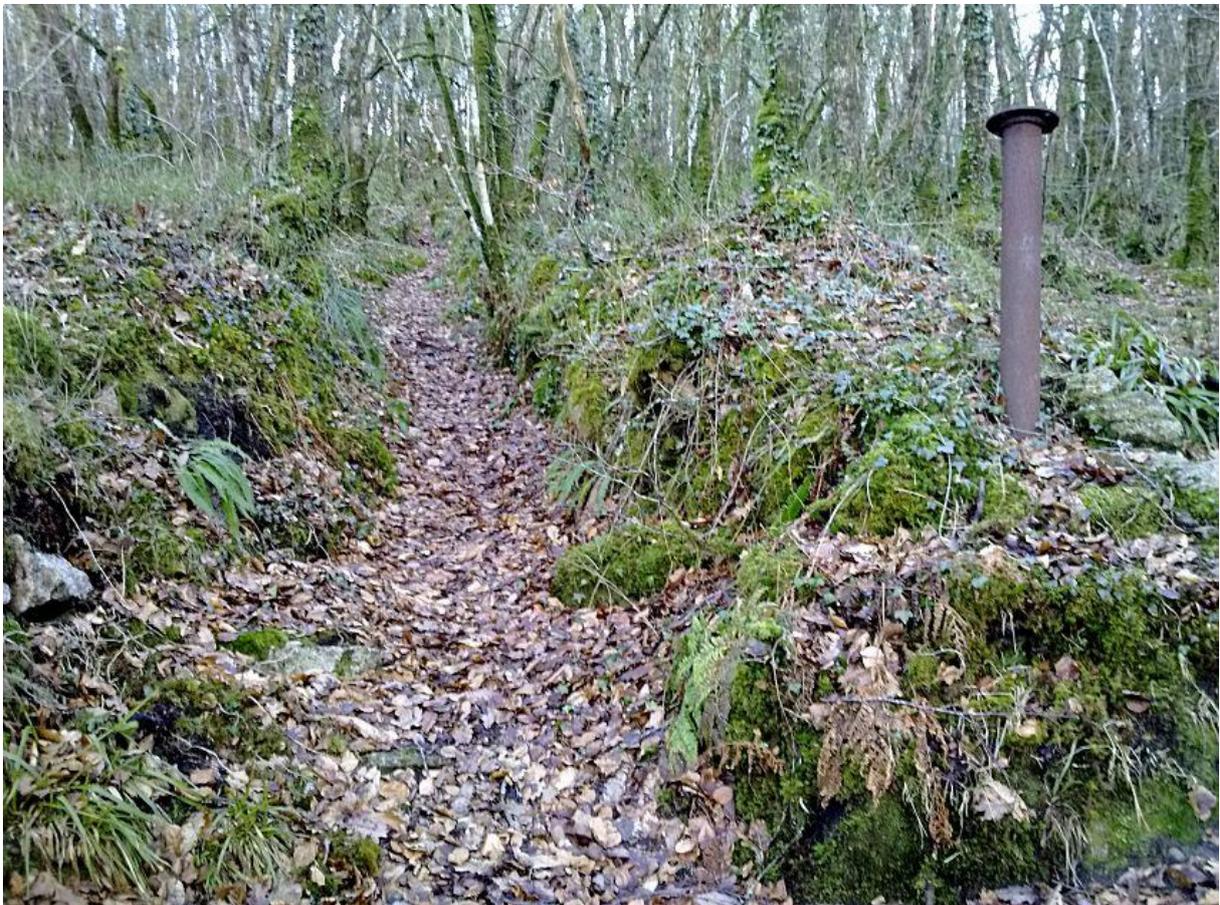
***Looking up the Flat-rod Run from the First Wheel-pit  
(past the China Clay uncapped vent / survey access pipe)***

Part-way up the First Wheel-pit Flat-rod Run, there is an embedded uncapped "pipe" sticking up out of the ground on the right hand side (looking up). This is nothing to do with the mine, but is a vent / survey access pipe for the China Clay Pipeline, which was constructed long after the Wheal Victoria Mine ceased working. For further information on this, see [Appendix 2](#).

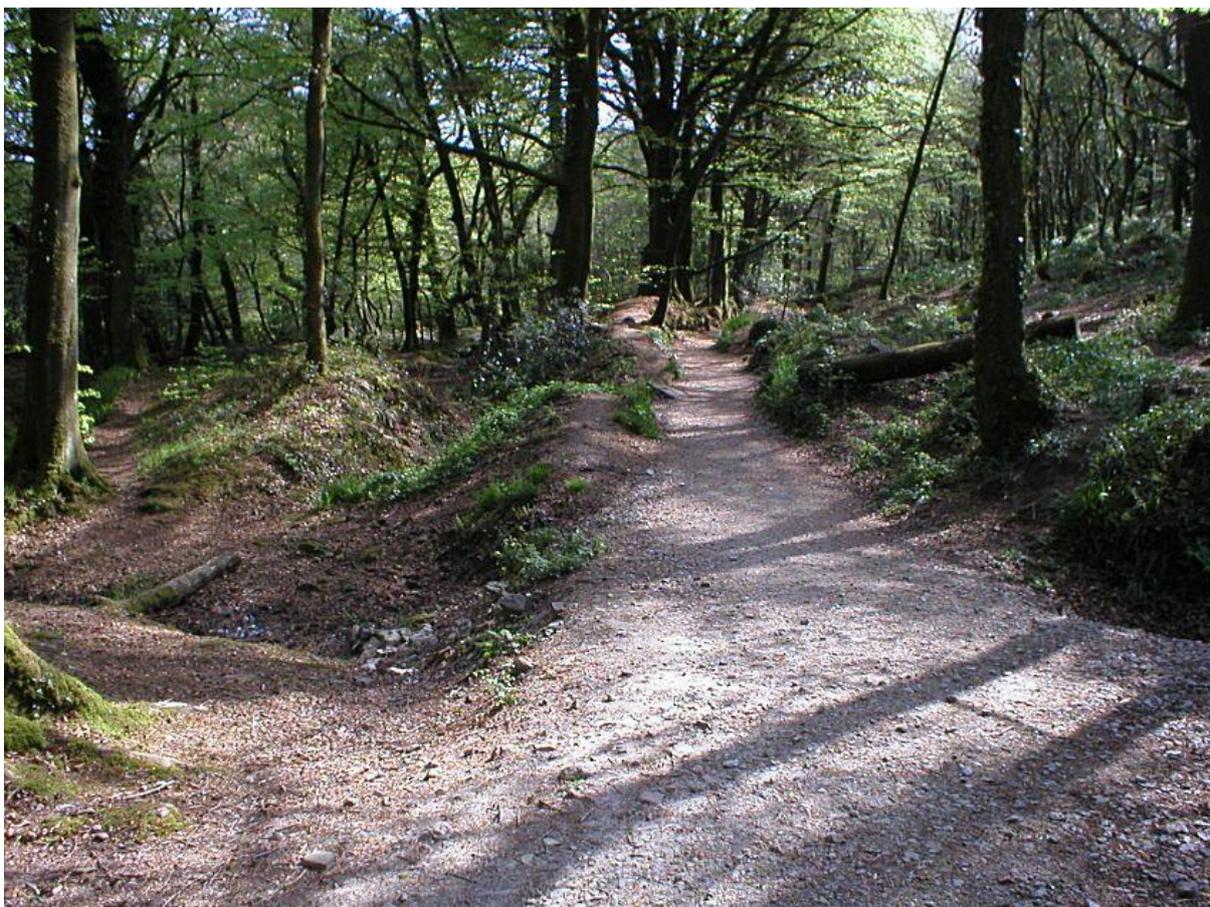
***The Upper Leat, not on the left, but what is now the path on the right, tracing its course towards supplying the wheel-pits***

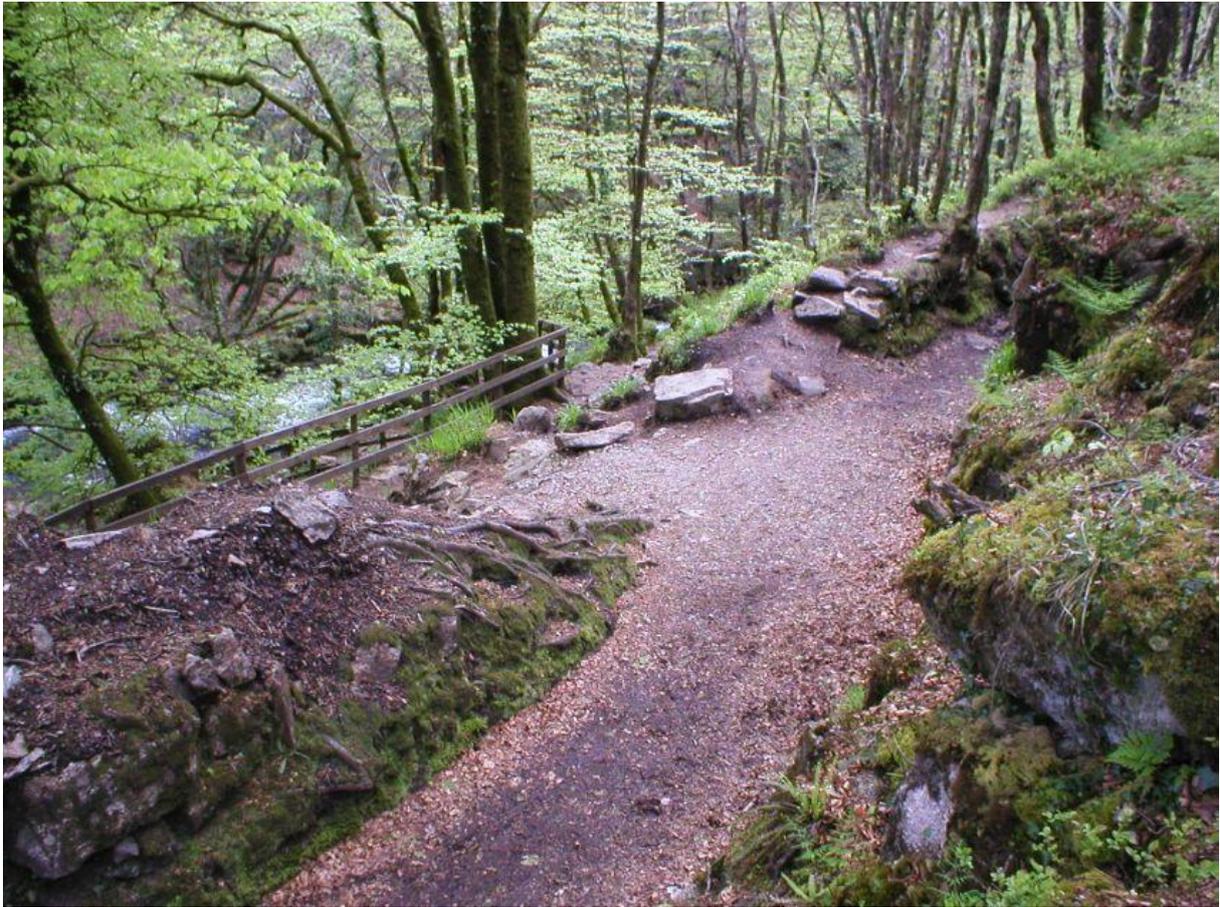
*The Upper Leat as it passes the first wheel-pit,  
and crosses the line of the flat-rod run that would have passed over it*

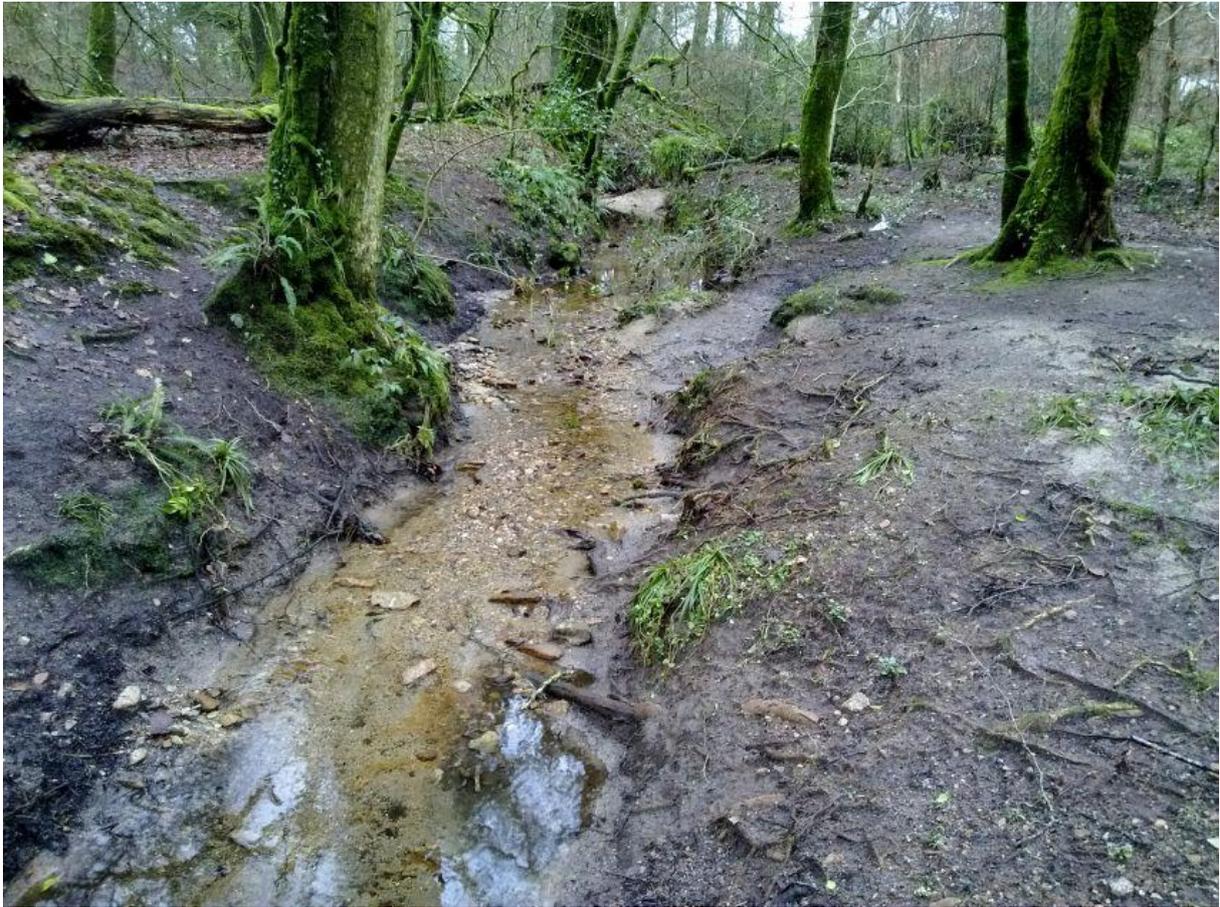
*The Lower Leat after being scoured by floods in late 2012*

The Lower Leat appears to lack real purpose. It feeds back into the river above the wheel-pits, and was not used, it seems, to provide any motive power for the mine. It is possible that it was an "overflow" leat for the upper leat when it was previously connected in some way, to take excess water away from the water-wheels feed, in times of heavy rain and high flow rates entering it from the river.

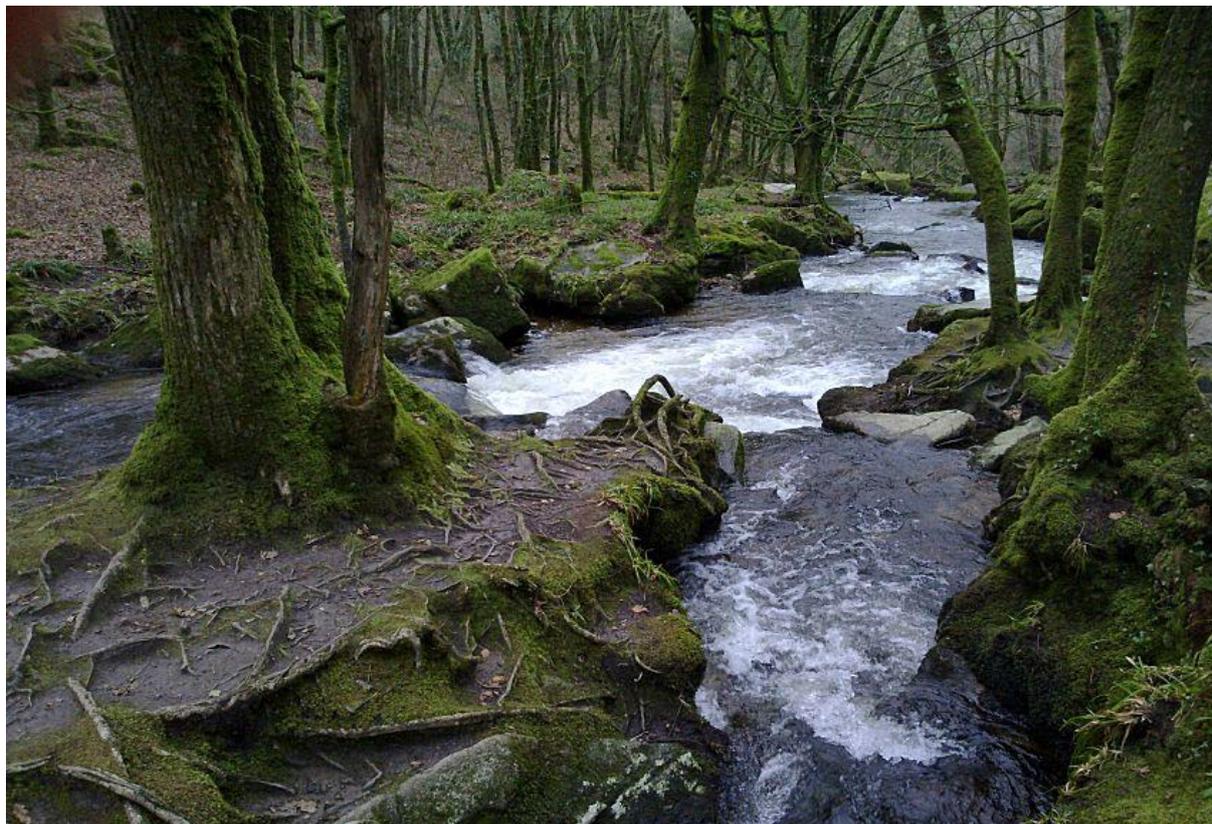
*The Lower Leat re-enters the river some way above the Wheel-pits*

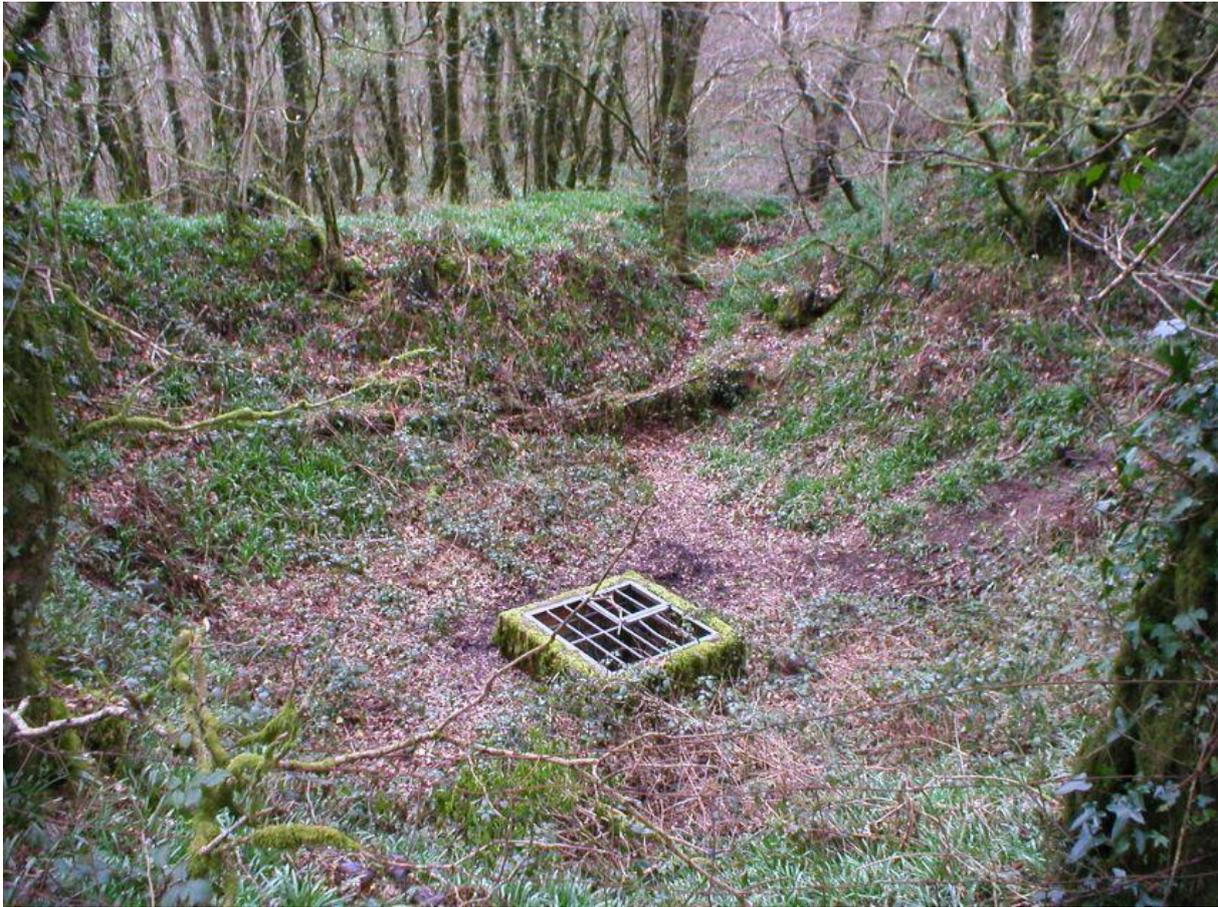
***The Main Engine Shaft looking towards the cutaway in the side of the hollow (in 2006). This hollow allowed access for the Flat-rod Run coming up from the First Wheel-pit***

The evidence that effectively proves the case however, is more recent research with LIDAR mapping (Light Detection And Ranging, sometimes referred to as Laser Imaging Detection And Ranging). This is essentially 3D mapping of the landscape and underlying terrain, that effectively "sees through" vegetation and structures, to reveal the natural and archaeological features of the ground surface. The technique is very revealing. Using LIDAR mapping that is now freely available online, it can now be shown that the First Wheel-pit was almost certainly linked to the Main Engine Shaft.

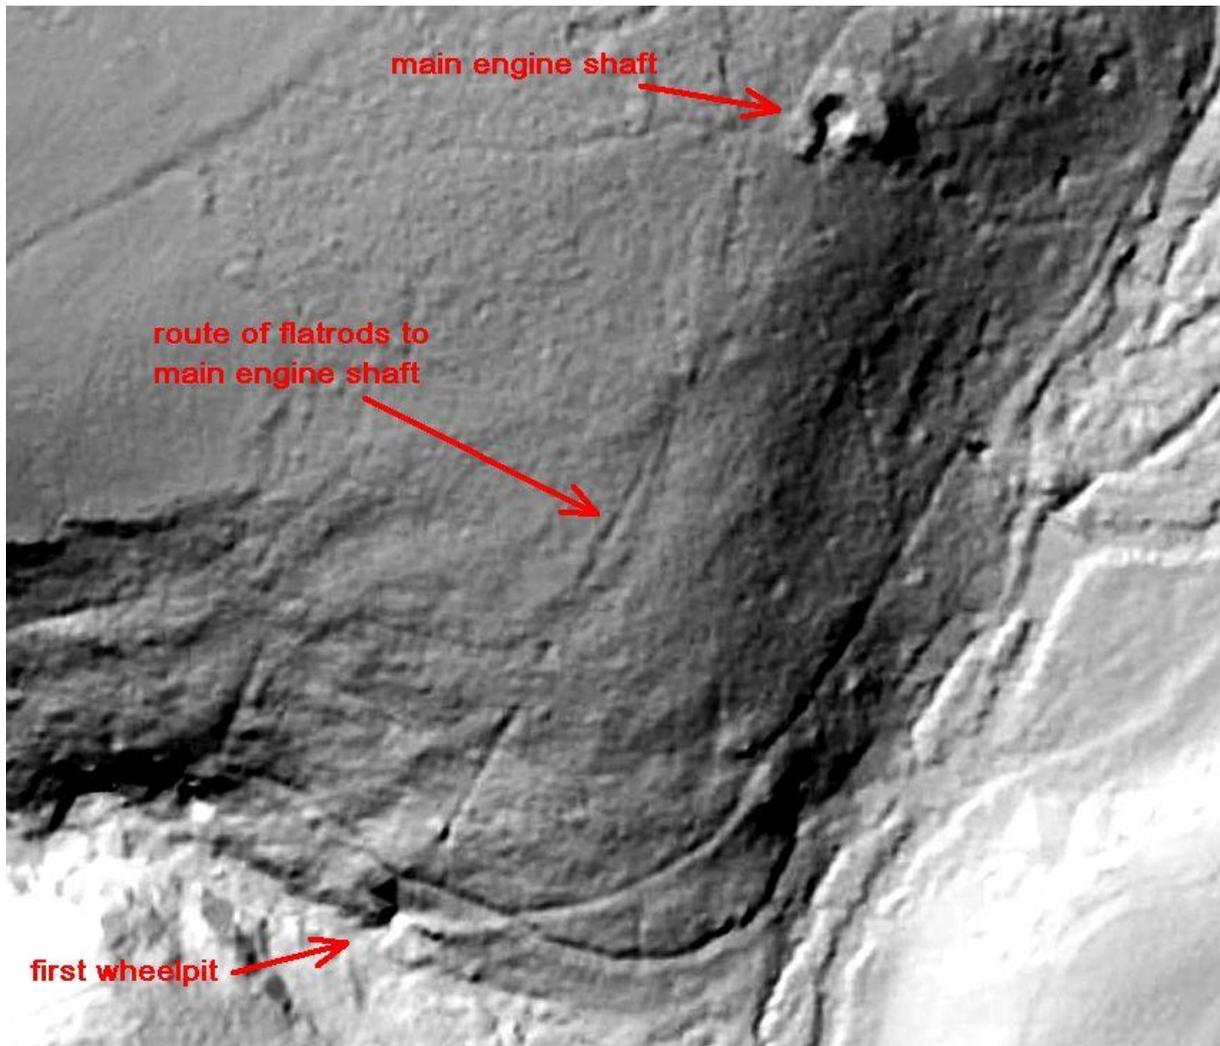
***This LIDAR map shows more clearly the alignment of the Flat-rod Run***

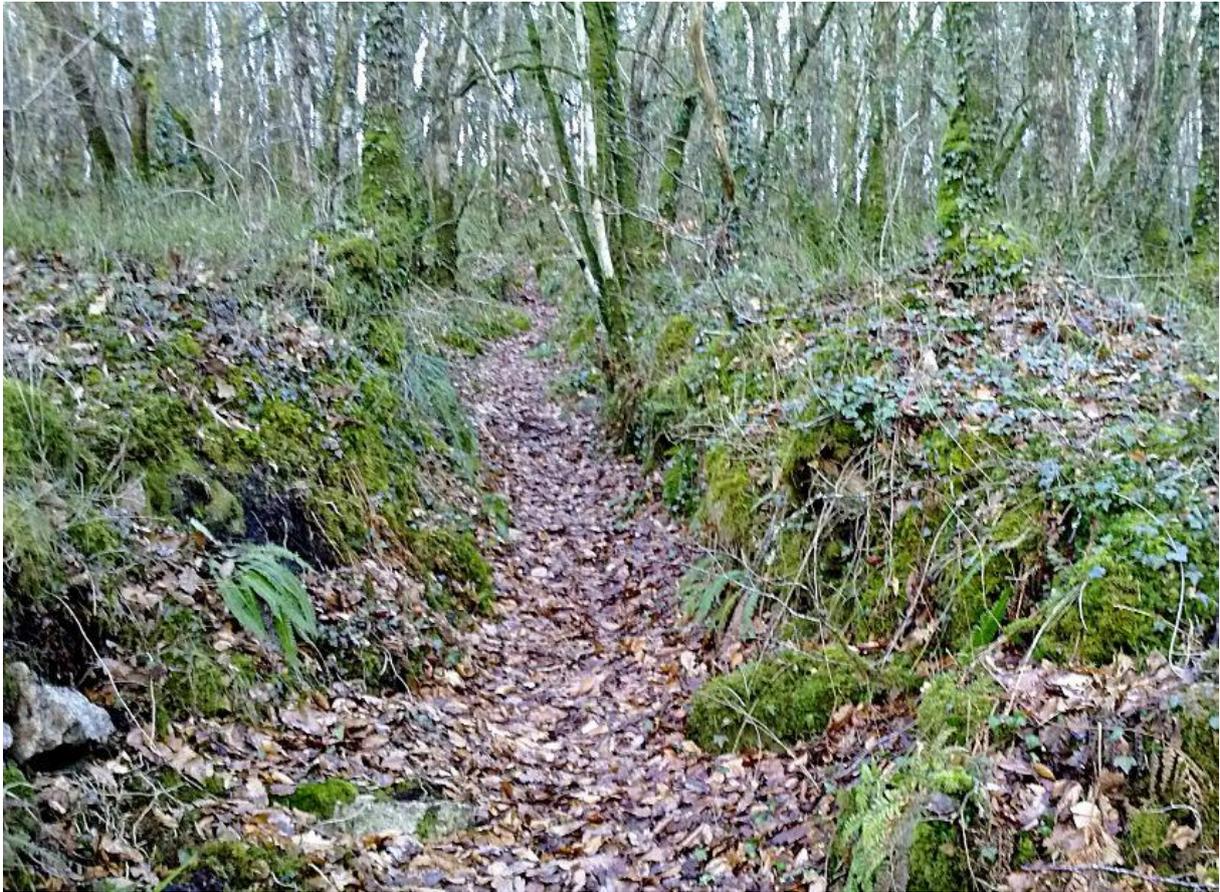
***Remains of the Flat-rod Run going up from the First Wheel-pit, towards the top of the hill***

The LIDAR map above shows more clearly, with annotation, the direct alignment of the First Wheel-pit and the opening to the Engine Shaft up on the hill. The flat-rod run can also be clearly discerned leaving the wheel-pit and progressing in direct line up the hill, and beyond the old wall in the woods. The flat-rods cross the line of the wall in two places, and the evident line becomes less clear in the upper section, but the destination, with the length of flat-rods, becomes inescapable.

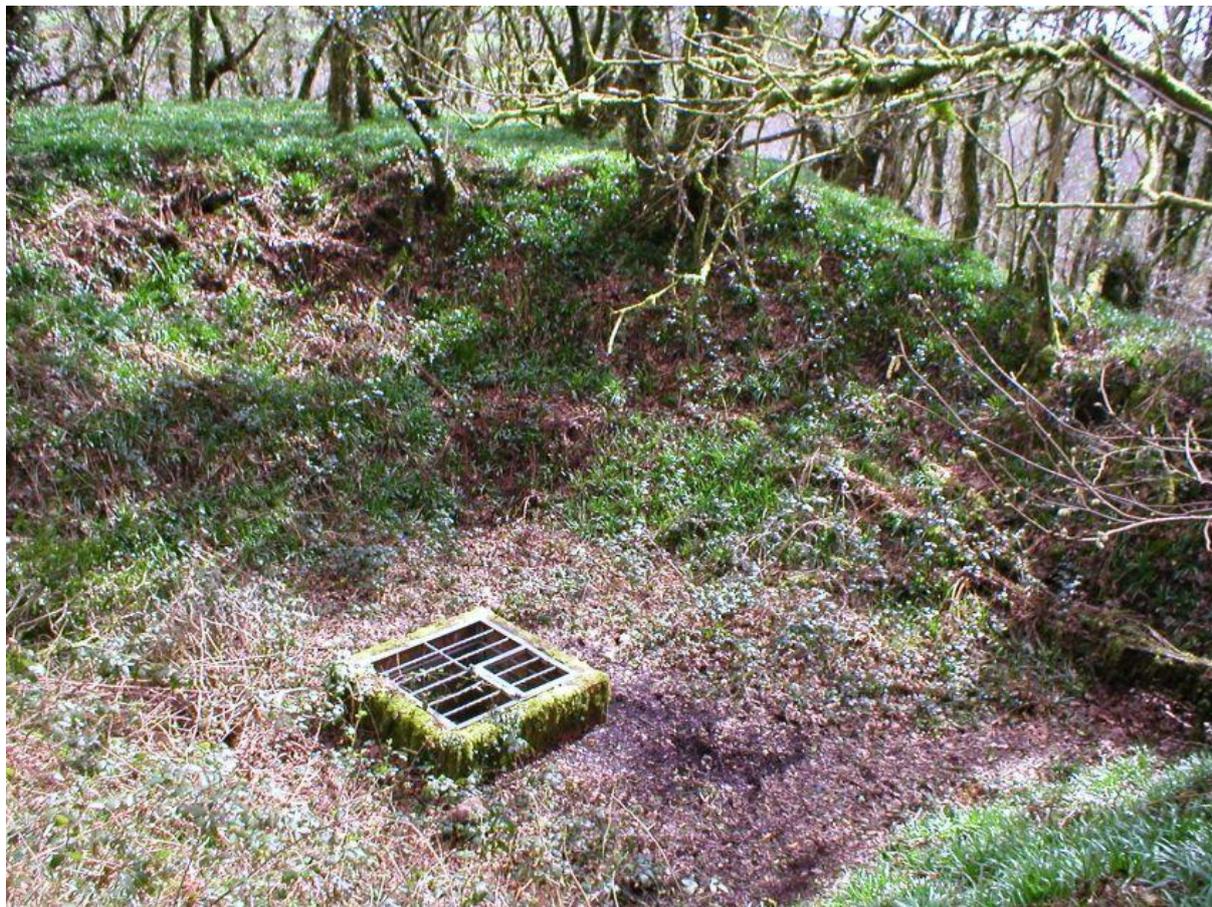
***The Engine Shaft in 2006 showing the spoil ground behind***

The shaft top is in a gentle hollow by the side of the track, and unusually, it is not capped with concrete, or "choked" (run-in). A grill covers it, and it is possible to peer down into its murky depths. At the top of the hollow is a large flat area overlooking the valley, and across to Redgate, that would have been the top and edge of the mine "dumps", or spoil heaps. This would have been where the waste material was literally dumped at the surface, close to where it was brought up, that had been extracted from both the shaft (when it was sunk), and the mine "levels" (where the "lodes", or veins of ore were worked).

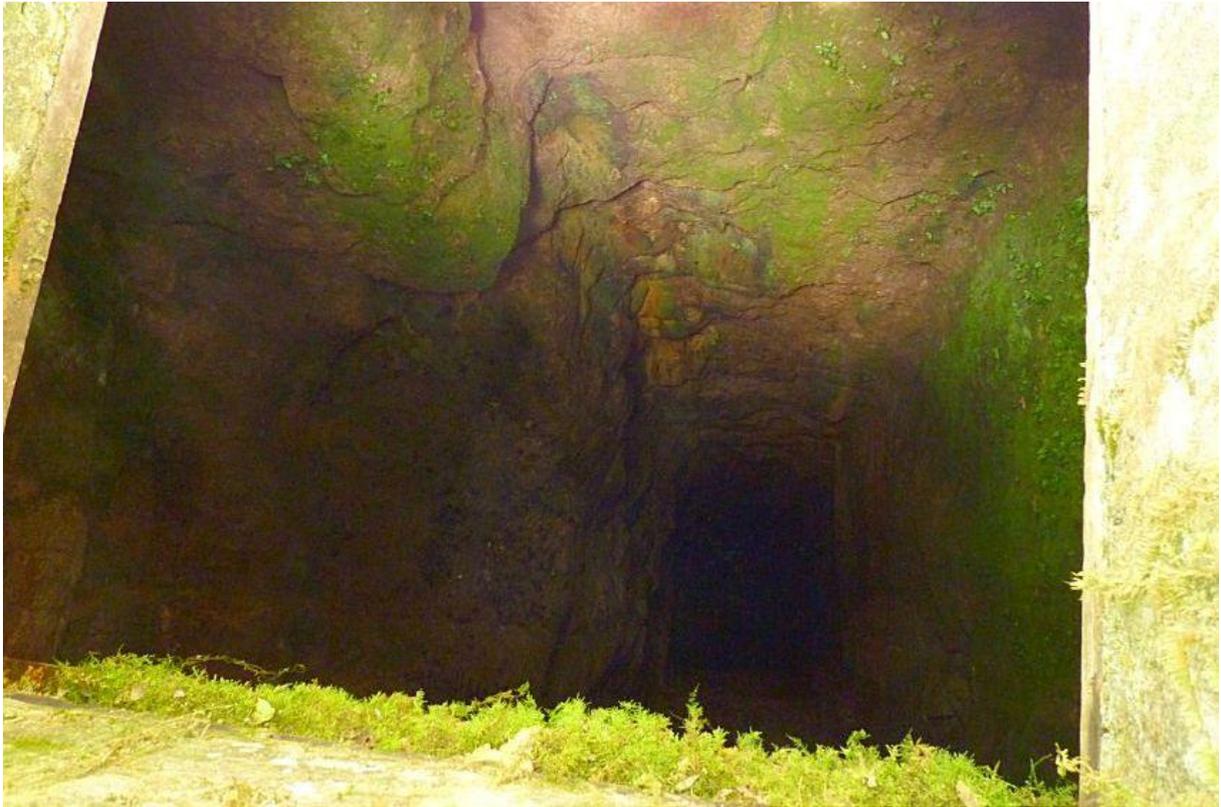
*Looking down the Wheal Victoria Engine Shaft*

Given that the shaft was sunk to 57 fathoms (342 feet), there appears to be a good level of rubbish and likely flood water at the visible "bottom", so a good deal of rubbish and possible spoil has gone down here, as well as being flooded from being sunk below the level of the river and water table.

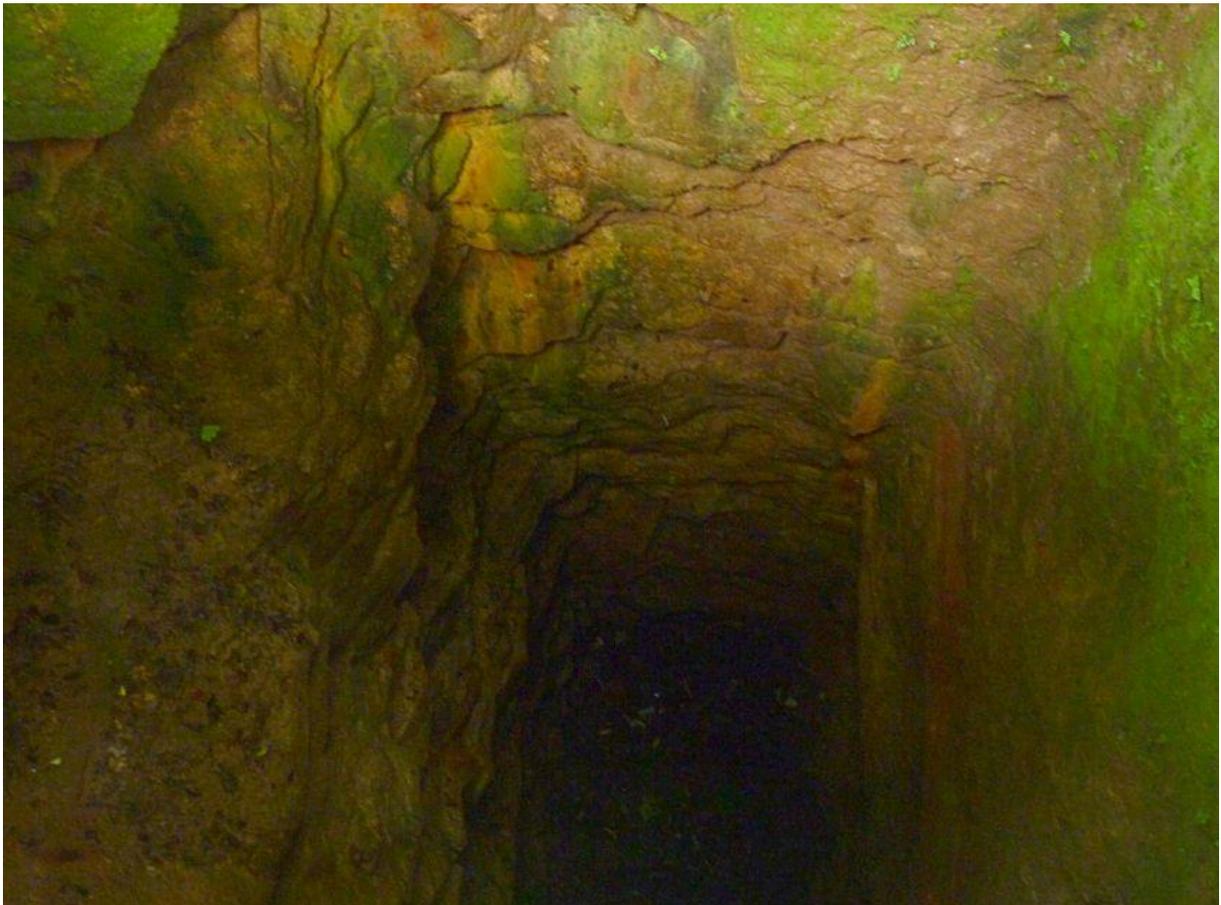
*Another view down the Engine Shaft.*

*The shaft from Cornish Mining records was stated to be down to 57 fathoms (342 feet)*

Further inspections by Stuart Dann have indicated that this large main shaft is choked with rubbish about 30 feet (5 fathoms) down, and that it was most likely used for hoisting out waste material and spoil, and perhaps later on, ore. Due to its size, such a big shaft may well have incorporated a double skip-way, and also perhaps ladders for the miners' access. The whim for the skip-ways would have been located in the adjacent smaller hollow as previously suggested. The Engine Shaft became, perhaps when completed around 1853, the new primary access shaft to the mine, with its larger skip-ways and ladder-ways, and again perhaps, taking over from the smaller access-only "second" Ladderway Shaft (see below).

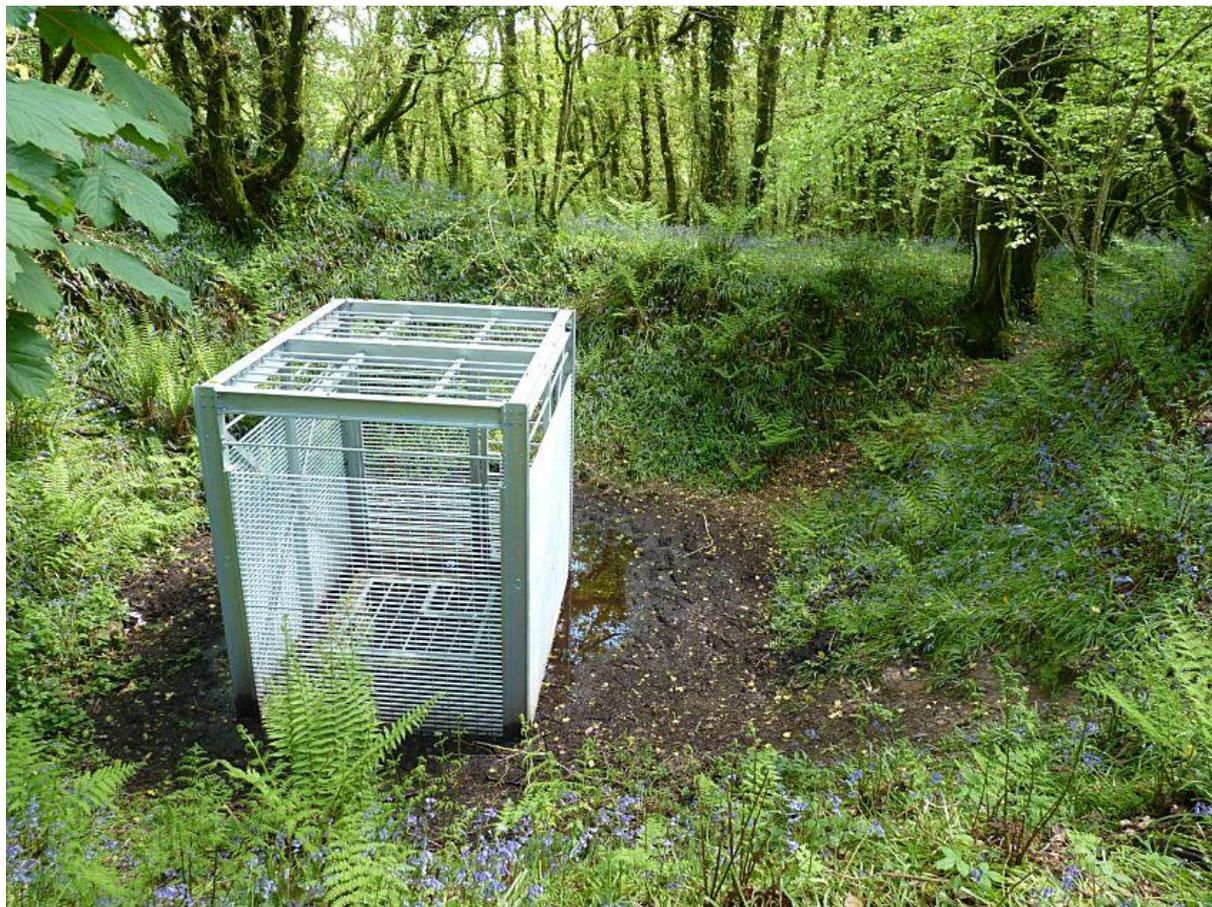
***The Engine Shaft has now been caged (2016) to prevent access and to provide further protection for the resident bats***
