# The History and Remains of the Wheal Victoria Copper Mine at Golitha Falls

By Clive ffitch, Redgate Smithy, Redgate, Cornwall

Dated 5 May 2020; for online photographs and content of this research, please refer to:  
<http://www.photofilecornwall.co.uk/cornwall-mineheritage/wheal-victoria-copper-mine.htm>

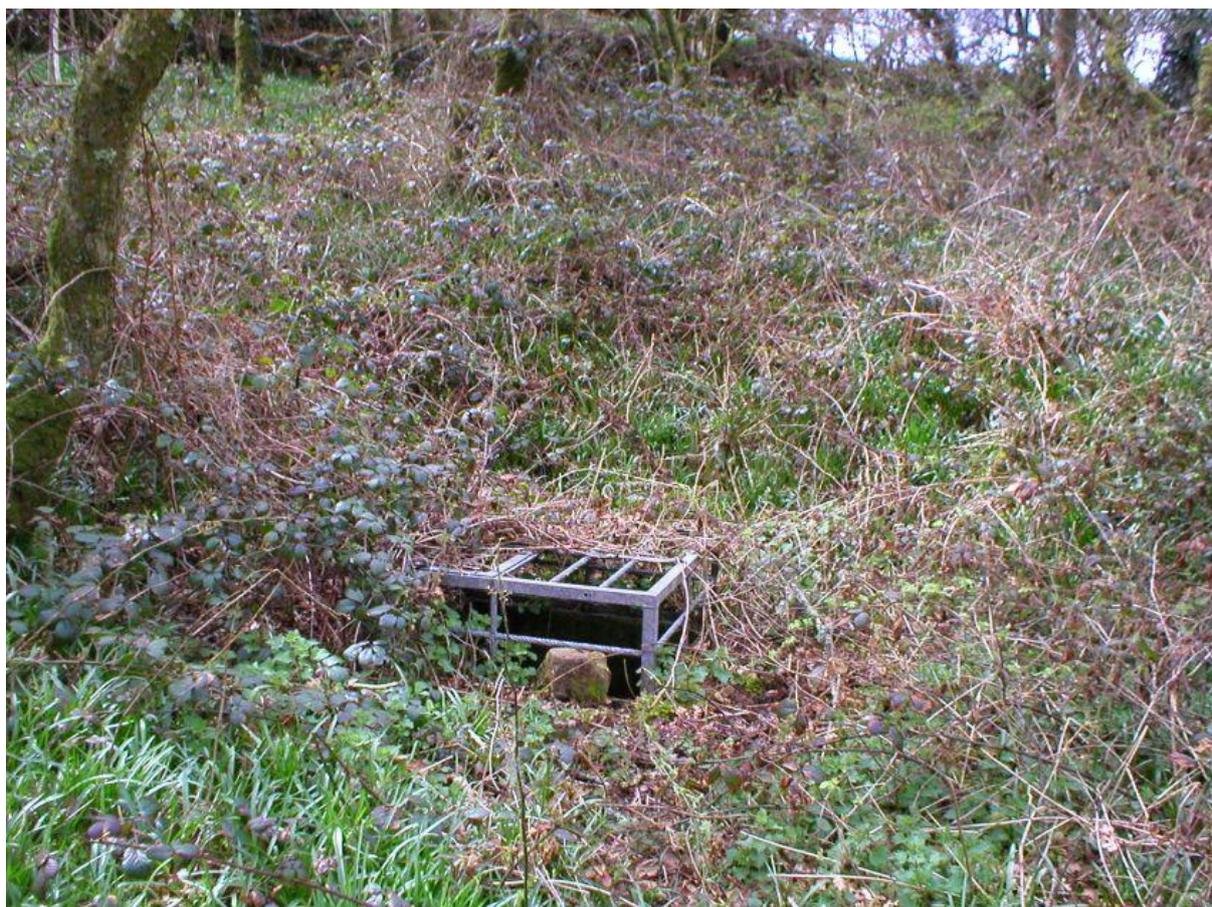
***The Second Shaft in 2006 - the Ladderway Shaft - with its caged top nearly overgrown***

Looking down the shaft itself, the narrow opening lower down implies the shaft was only ever used for limited access by miners themselves - there would have been only just enough room to climb down, if the hole was no bigger originally than it is now - or it was used solely for ventilation. It may have been an early exploratory shaft to determine the extent of the ore-bearing lodes, or to allow access to the First Adit workings that were driven during the early 1844 to 1846 excavations. Either way, it appears a lesser shaft than the Engine Shaft.

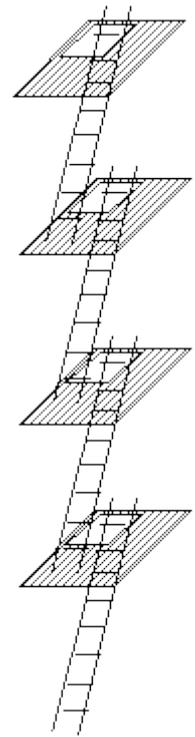
*Representation of a Ladder-way*

Correspondence with Mine Explorer Stuart Dann has suggested that the Second shaft is in fact a very nice condition "footway" (or Ladder-way shaft), with its wooden "sollars" (or wooden platforms supporting the staged ladders) in place. The ladders would have gone down the shaft in the manner illustrated on the right, with each successive platform being placed around 20ft apart. Stuart fully expects all the ladders to be still in place.

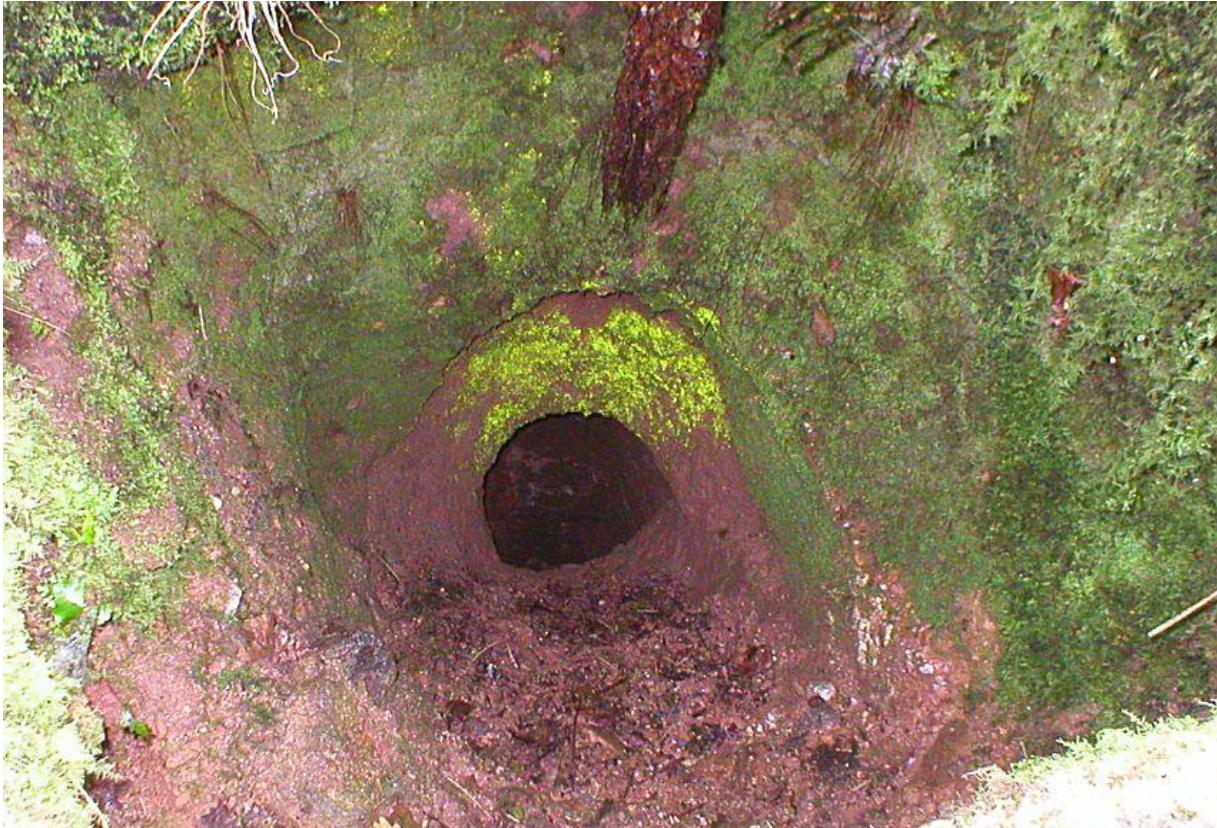
***Looking down the Ladderway Shaft showing the hole in the possible first sollar, overtopped with earth back-fill, due likely at least in part, to the action of badgers previously burrowing nearby, and part choking it***

On closer inspection of the photograph below, which was taken looking directly down the Second Shaft, on first sight it just seems to be a tight hole, but it is in fact very likely to be what remains of the ladder-way hole in the first sollar, which has been considerably run in with loose material. This has been increased in the past by a number of animal diggings near the shaft, likely the activity of badgers. A much clearer view of this ladder-way access would then be possible (theoretically) if all the earth was removed from the top sollar, thus revealing the extent to which the old miners' footway is still in place, and how much of the old nineteenth century timbers and woodworking may have survived.

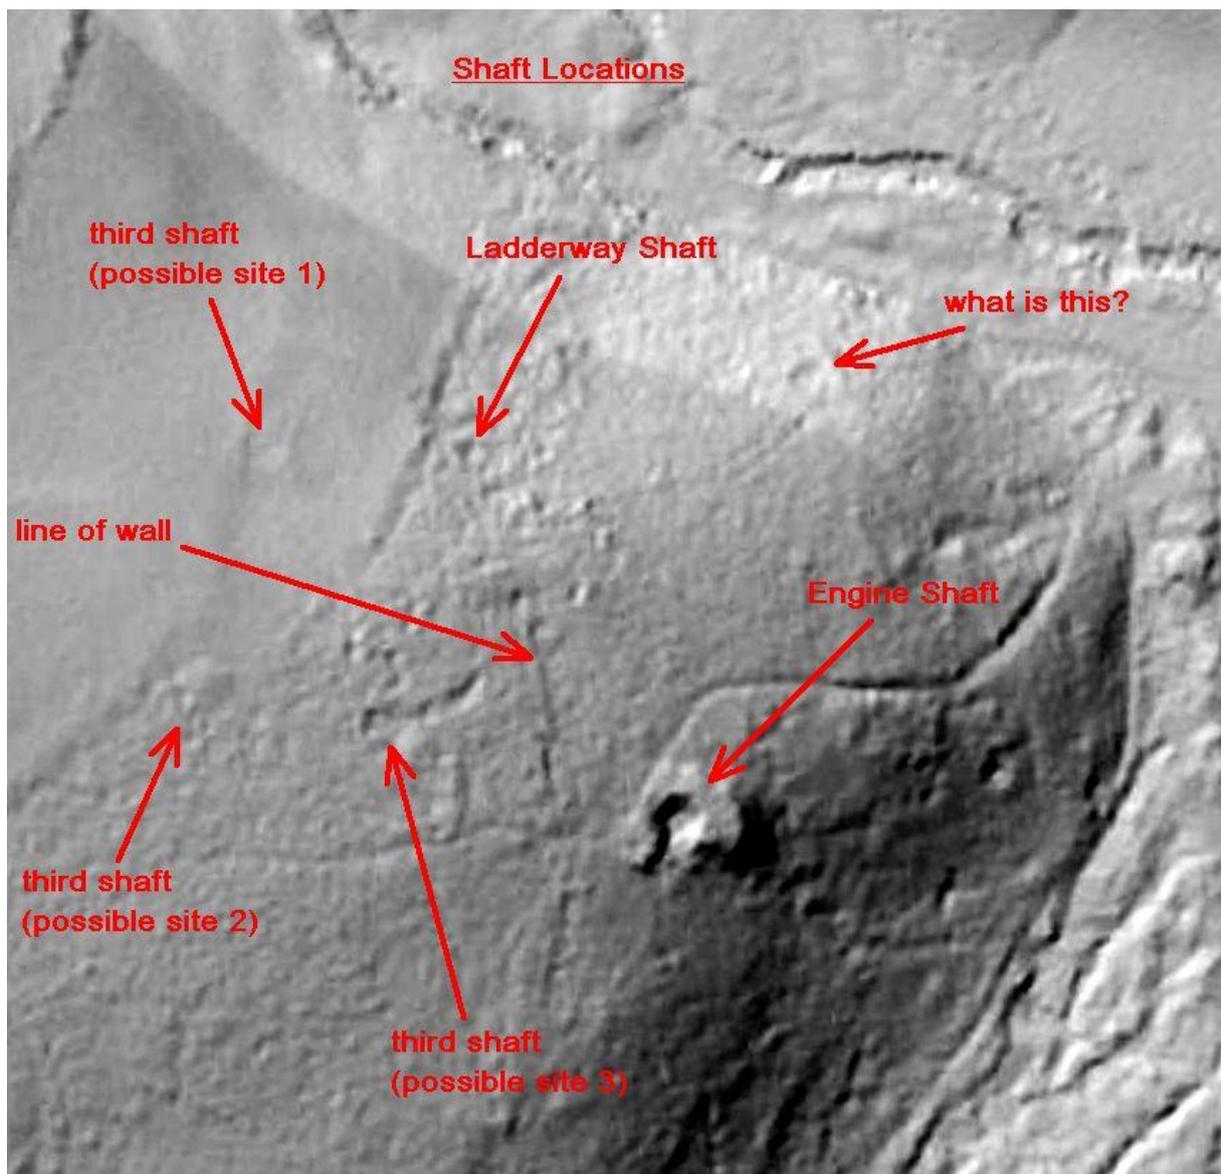
*Alternative possible locations of any Third Shaft fro LIDAR - Site 1 is most likely.*

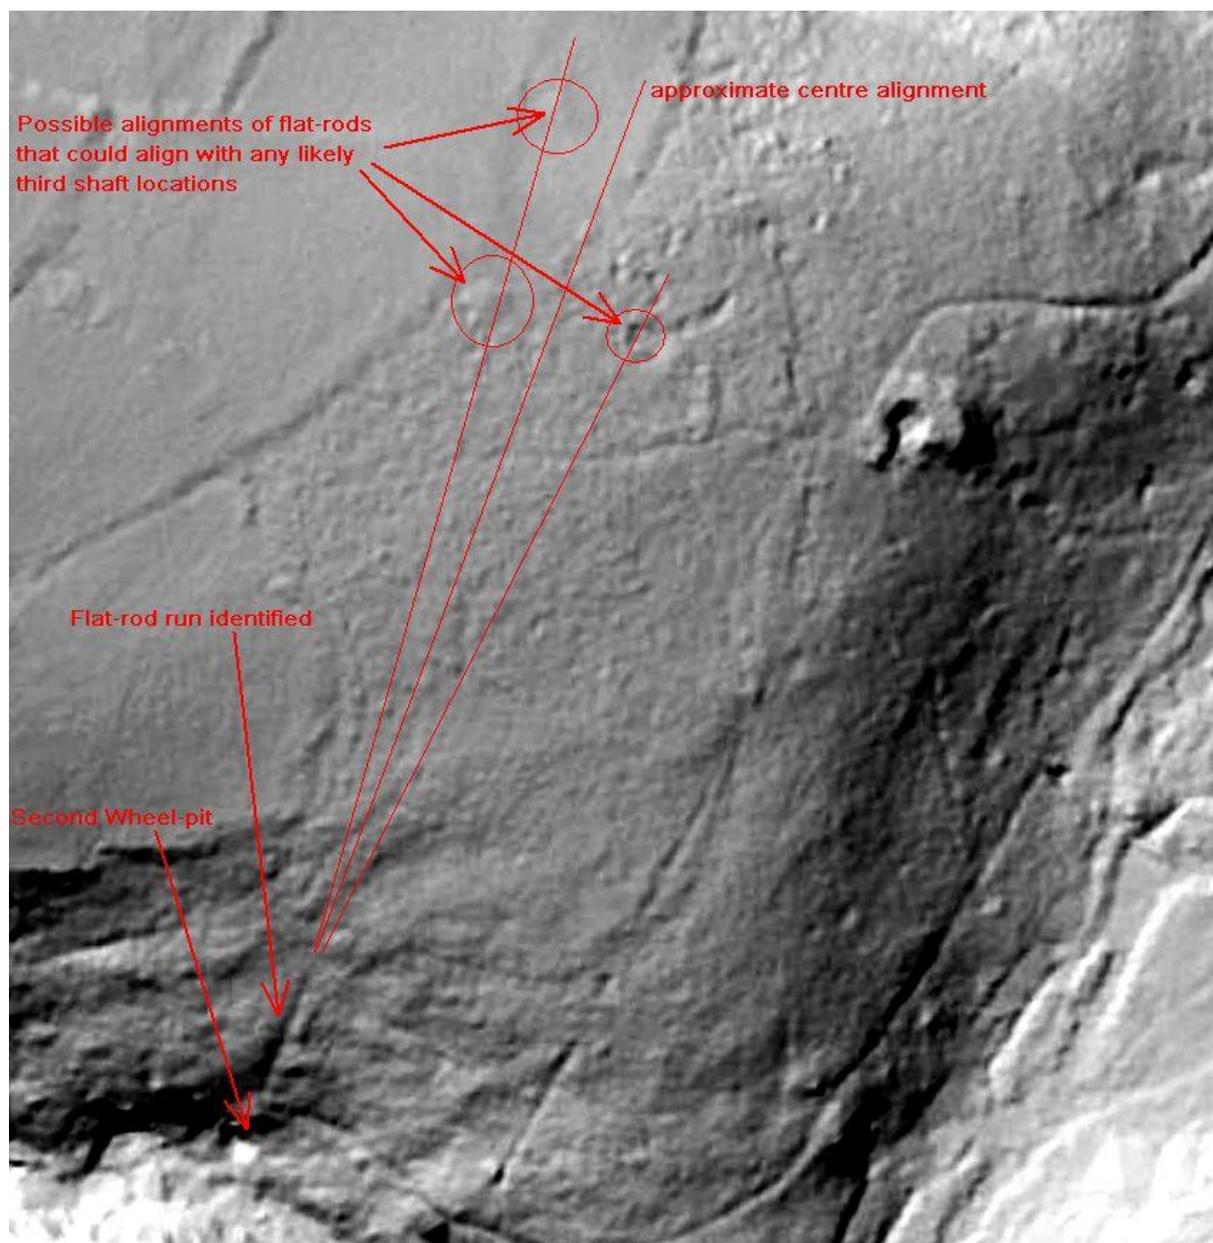
***The Second Wheel-pit Flat-Rod alignments with any possible Third Shaft location.  
This would certainly explain the purpose of the Second Wheel-pit.***

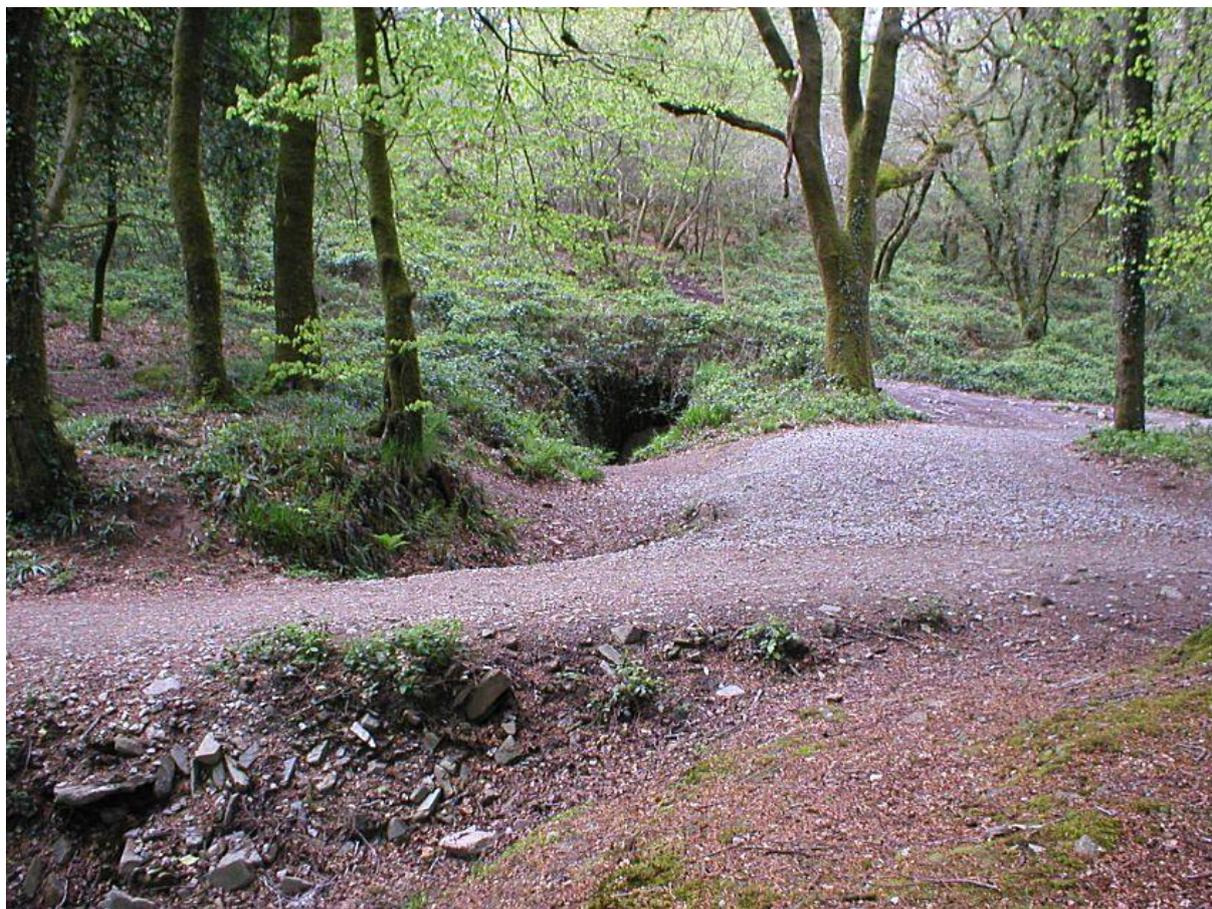
***The First Adit is tucked away by the meeting of paths, with the old Miners' Track over it***

Thought previously to be the second adit, this has now been identified as the First Adit, driven during the first Wheal Victoria mine excavation between 1844 and 1846. The entrance to this adit can be found not far into the lower woods of the Golitha Falls National Nature Reserve, along the lower paths and tracks, following what has been identified as the lower "Miners' Track". The adit also seems to be very small, and the access cutting is now be blocked by the courses of old leats (water channels) and new paths, and the gated adit itself is now home only to bats. The adit is likely to be well run-in and possibly severely choked further in, but this is difficult to determine as the adit is now well flooded. It appears that it curves slightly to the right and downwards, and likely in the direction of where the two shafts up on the hill were later sited. This adit may well be the full extent of the first excavations, as no shaft is identified as being sunk during these excavations. It is therefore likely that the height of the adit before run-in was at least of man height.

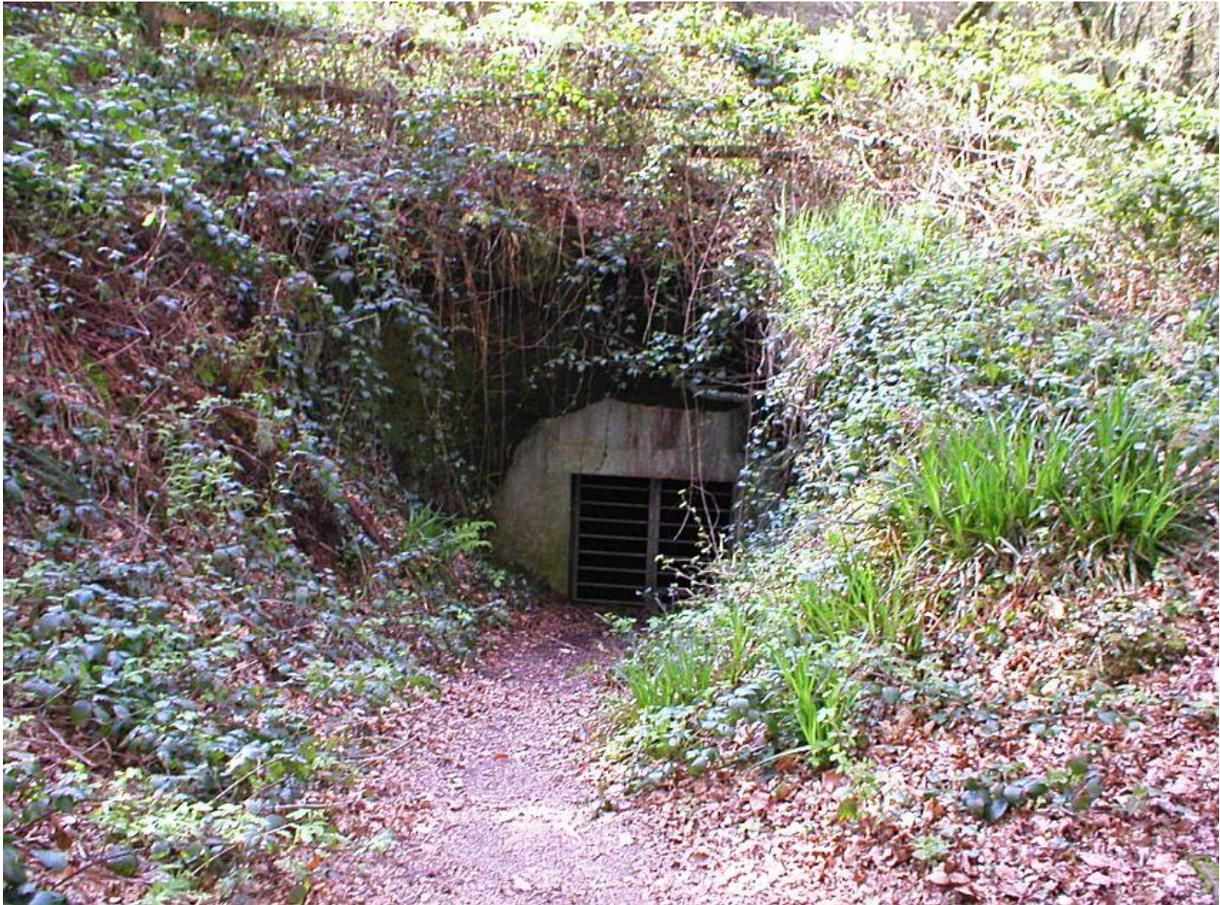
***The First Adit entrance, now well run-in***

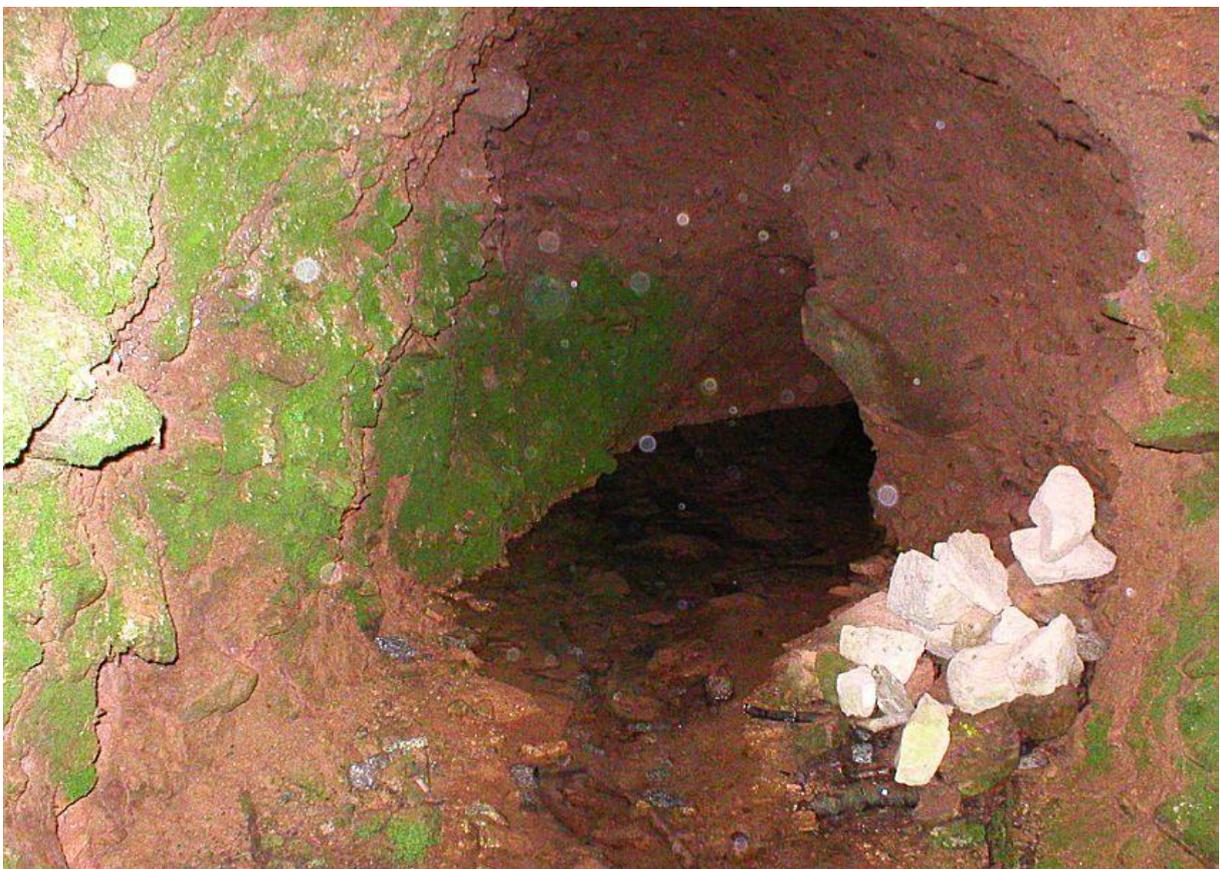
***Inside the First Adit, clearly well choked with debris  
(the unidentified white rocks have been partly exaggerated by flash)***

Looking inside the First Adit, flooding is immediately apparent. The adit appears to curve to the right and down, and seems small for regular human access, but this is likely deceiving as, if this was the only access to the early excavations, man-height would have been a requirement. From Mining Journal records, this adit was cleared during the second later excavation of 1851 to 1855 to 70 fathoms (420ft). Was this adit once used to remove ore, as well as likely mine spoil and waste?

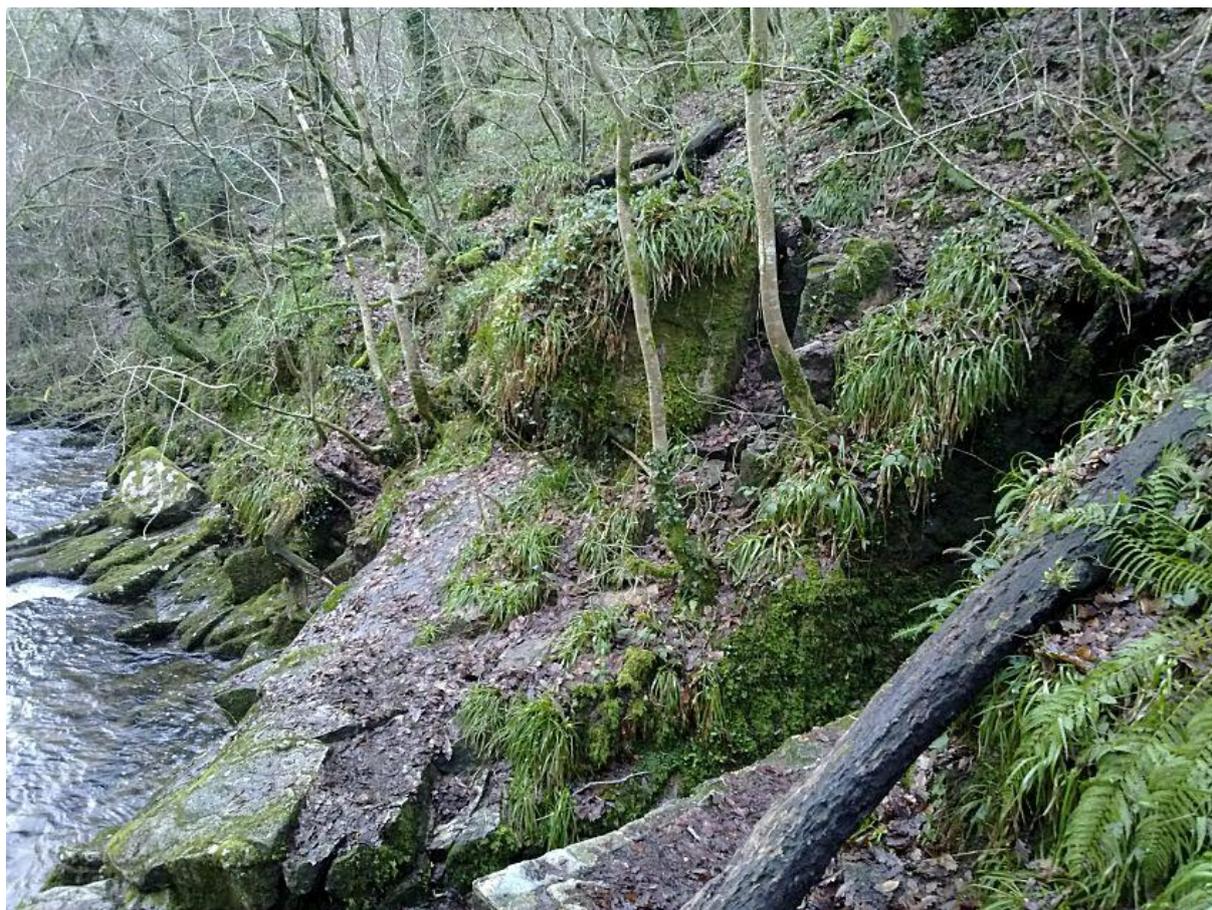
***The cleft in the rock by the side of the river hiding the main Wheal Victoria Second Adit. Precariously placed, but there was possibly a timber structure added for safer access***

As far as access to the adit is concerned, this may well have been via some form of wooden structure providing safer access from the waterside closer to the second wheel-pit. The adit was certainly a significant access portal to the mine, given its walk-in dimensions. It is certainly the best preserved adit, albeit in a precarious location right by the river, but due likely also to its apparently well concealed location.

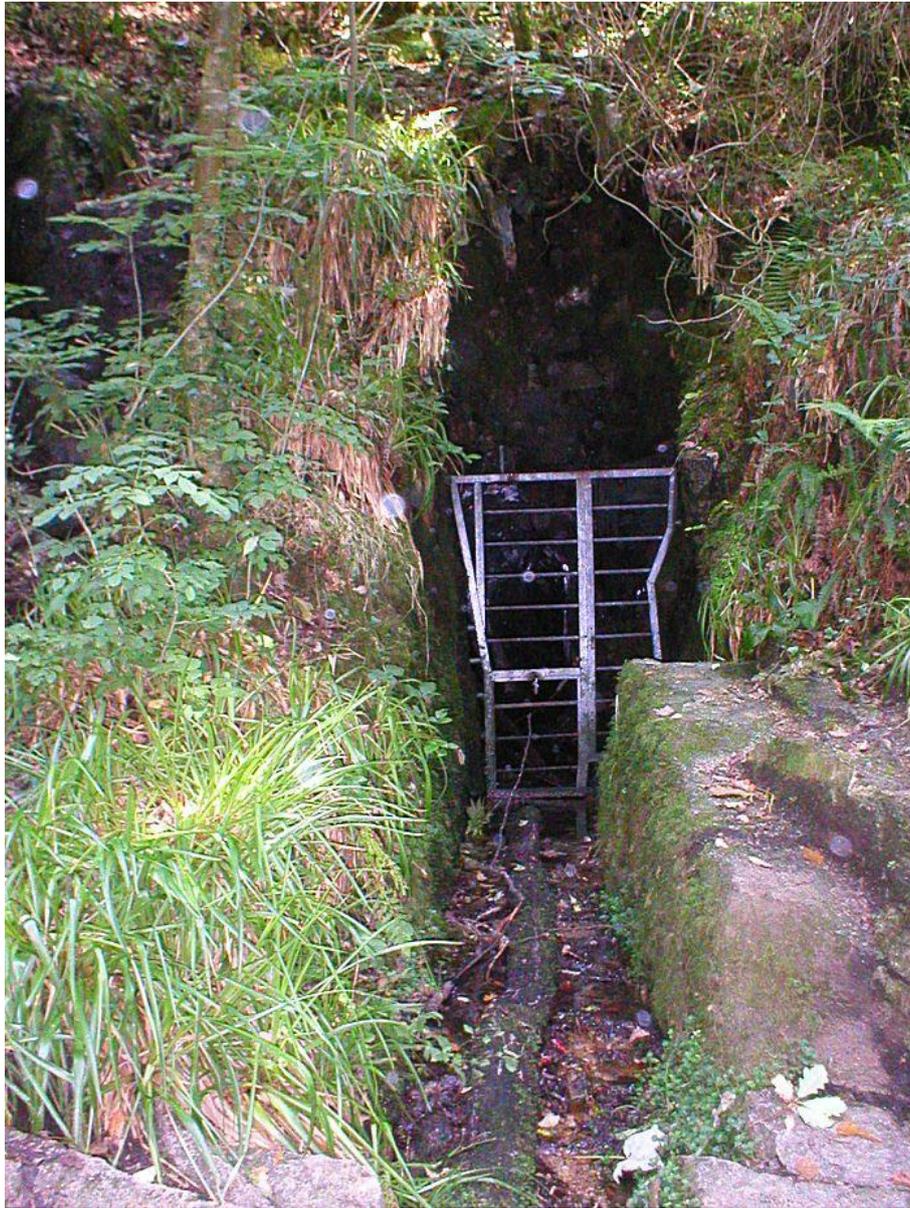
***Looking into the cleft and the entrance to the Second Adit hewn into the granite***

As with the identity of the other adit, this "Second Adit" was previously thought to be the first adit, but has now been identified as the second adit, driven during the second and final Wheal Victoria mine excavation between 1851 and 1855. This adit is not easily found, being sited in what appears to be a quite inaccessible position by the waterside, in a cleft right down by the edge of the lower falls. It is not in fact very far from the Second Wheel-pit, and can be located right by the water's edge, hidden from immediate view behind the rocks. Again it is well protected, and home now only to the bats. It is very unlikely that any ore was removed by way of this lower adit - there is certainly no evidence of any tramway into it - and the idea of bringing out any ore from way down in the woods by the wheel-pits from here defies both logic and practicality. This adit provided access, but was primarily for drainage of water from the mine pump, in association with the wheel-pits, and flat-rod run to the Engine Shaft, pumping water from the mine sump. This is further evidenced by the rusting pipework still visible within the adit entrance.

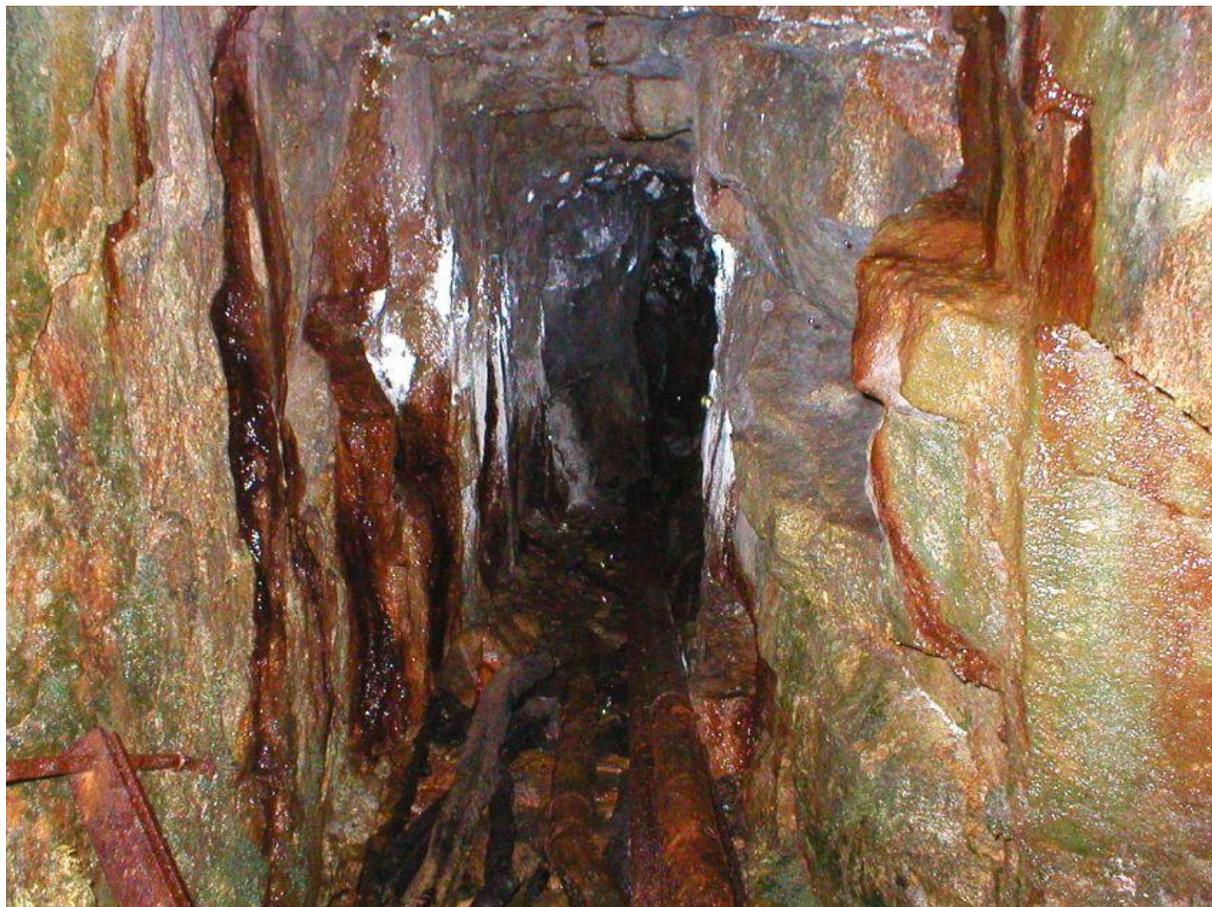
***Looking into the Second Adit and the ghosts of the past.***

The height of the Second Adit is clearly made for miners' access, and the old pipes are likely part of the old pipework for expelling the pumped out water from the mine, out of the adit and into the river.

It is possible to see inside the entrance of this second adit, and into the dark hard-won world of the Wheal Victoria miners of 150 years ago. The access into the adit is man-height, and it is possible to make out where the granite has been drilled and hewn away by hand, and there are old ironwork remains just inside. The amount of work required to open up a simple adit such as this one on the Wheal Victoria mine, where hand chisels, hammers and drill bits were the only tools available, is hard now to appreciate in today's modern age. The remains of old piping and iron work that can still be seen on the floor of the adit, may well have been a part of the equipment used for pumping out the mine workings and mine shafts further in.

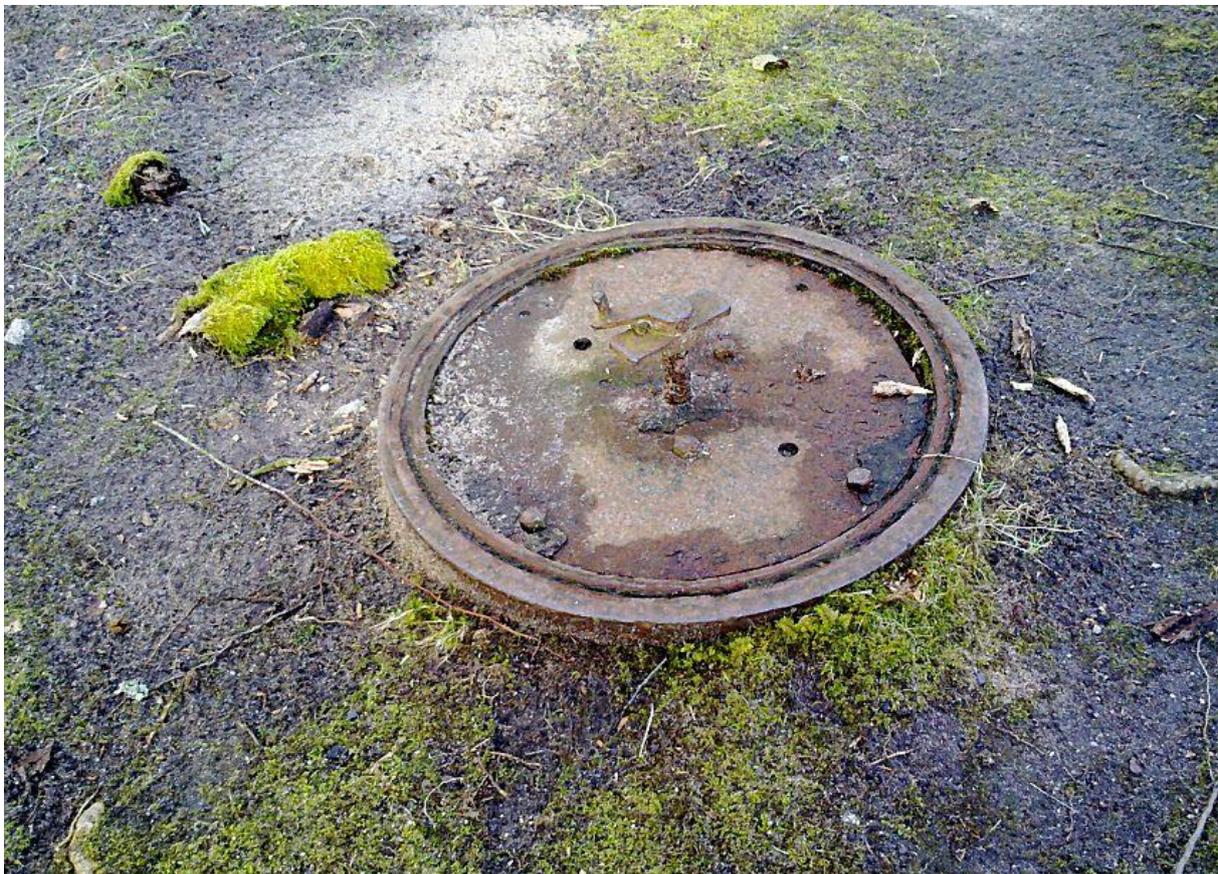
***This mysterious circular plate can be found on the ground adjacent to Draynes Bridge. What is it, what was it for, and what, if anything, lies under it???***

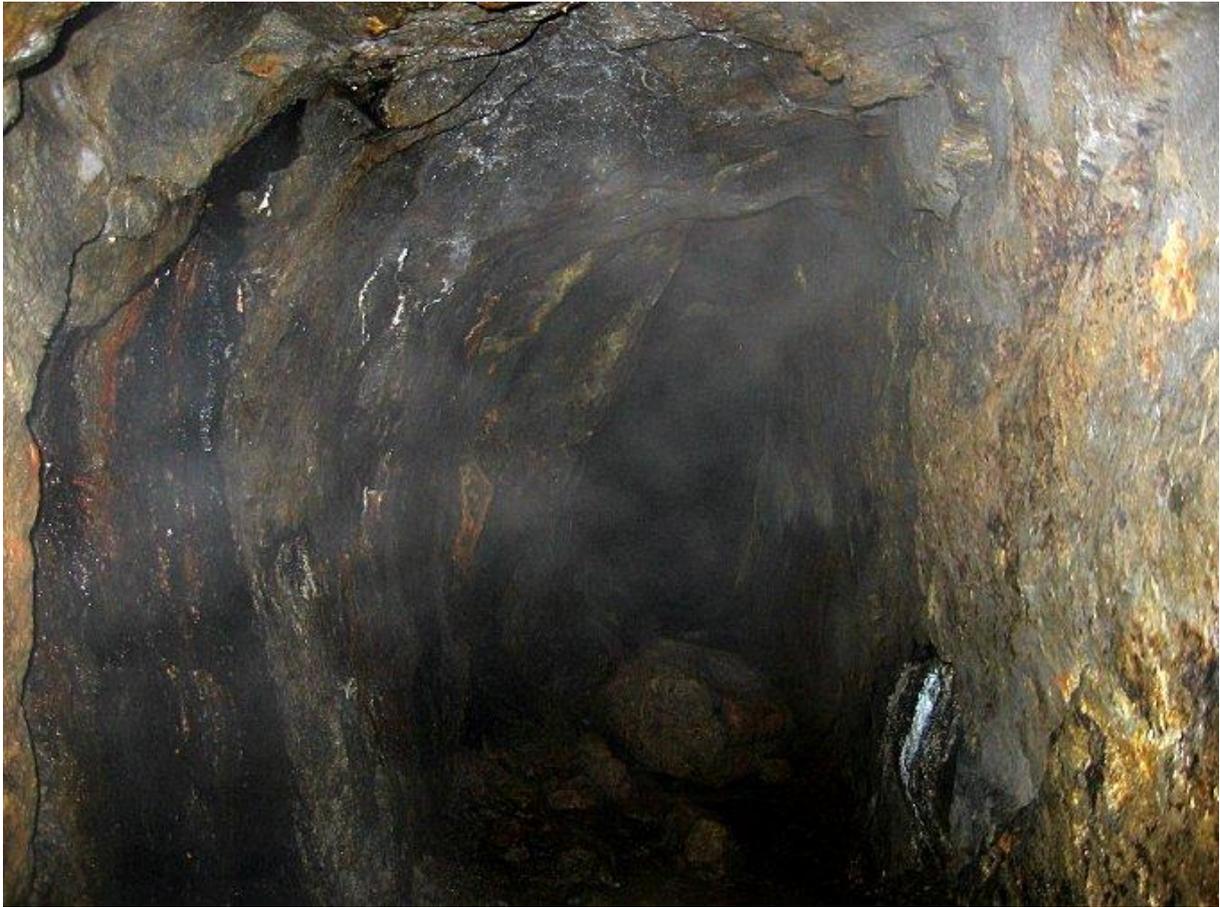
*View inwards, taken from further inside the main Second Adit, at an adit junction, and beyond the winze found in the adit floor (photo S.Dann)*

Not far inside, there is a pool in the floor of this Second Adit, which is called a Winze, which is an internal shaft sunk along a lode to see if it proved in depth. The depth of this winze, and whether or not it "goes", could be tested by bailing a few buckets of water out of it, but this was not able to be done. If the water level in such a shaft doesn't change, then the drowned workings are extensive.

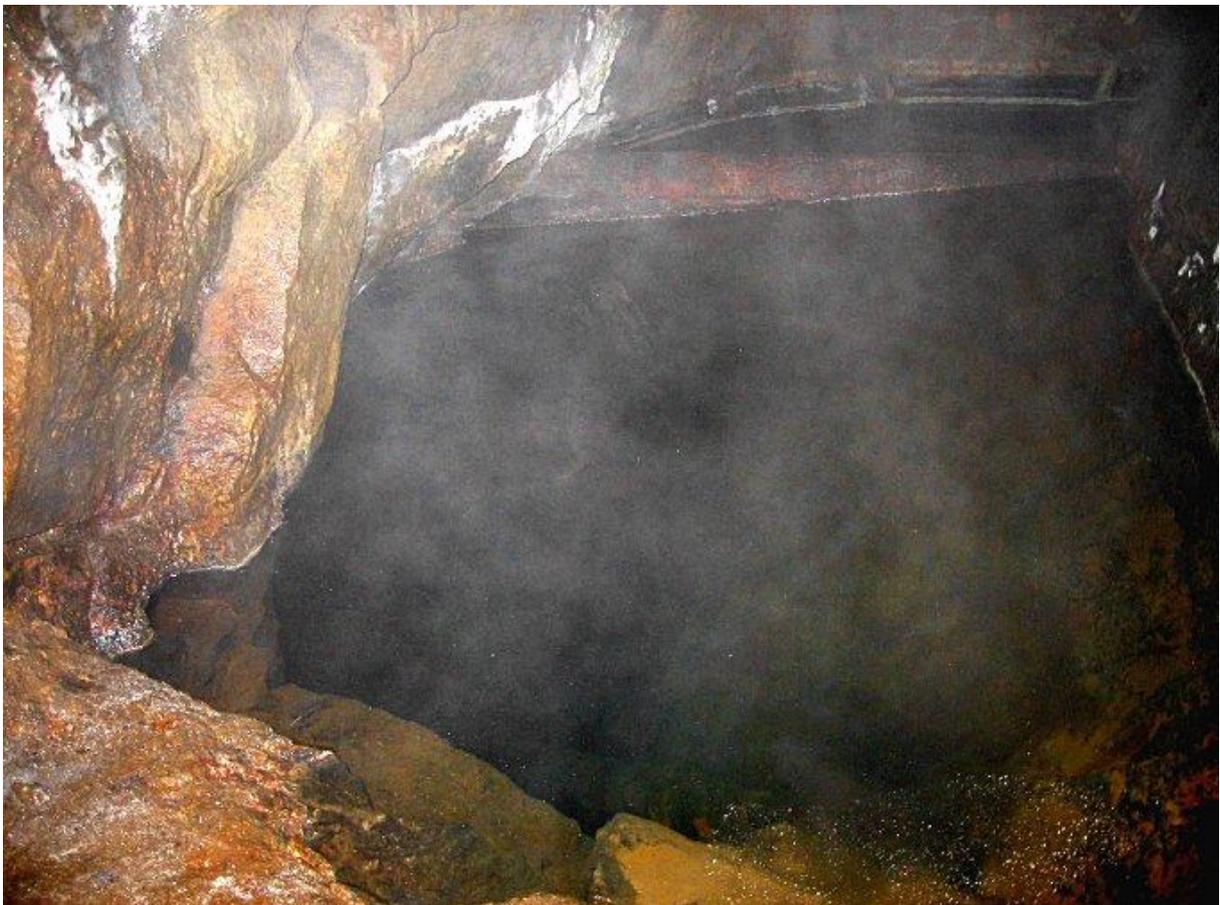
*Looking down at the flooded winze in the floor of the Second Adit (photo S.Dann)*

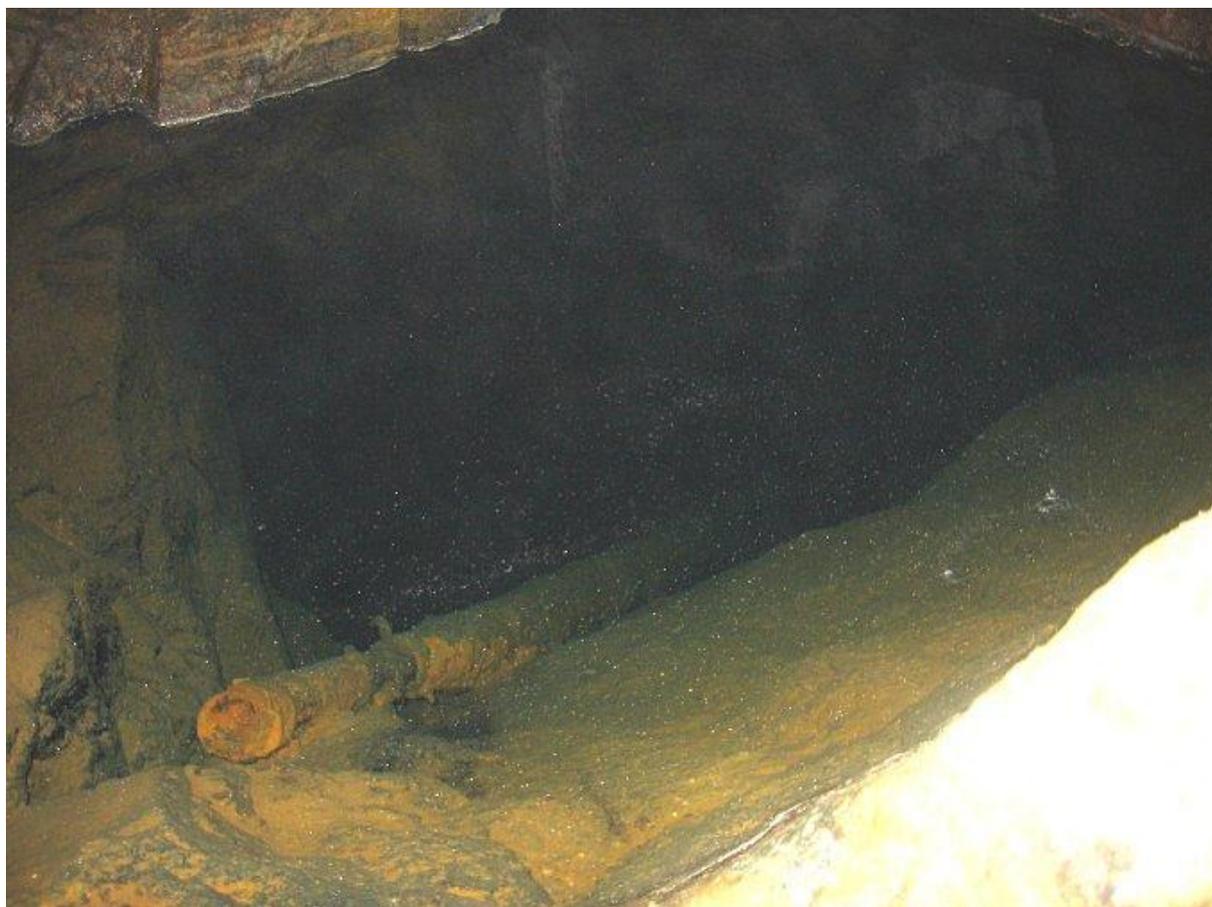
*Looking closer at the pipes remaining in the winze (photo S.Dann)*

The pipes that are visible in the water suggest by their presence that the winze was originally (and still is presumably) quite a deep hole, but that it can't have been very wet, due to the size of the bores. It is very likely that, as this adit was used for expelling pumped out water from the mine, and there is evidence of pipework descending into this winze, that the winze gives access to other levels that connect with the main Engine Shaft where the pump rods descend to the mine sump, recorded as being at a shaft depth of 57 fathoms (342 feet) from grass (shaft surface).

It is possible that this winze was pumped by "flat rods" but this was thought probably unlikely, and not practically feasible given the respective positions of the adit and the wheel-pits. It is however much more likely that this winze was effectively pumped out via the main shaft - the "Engine Shaft" - and the water present here is simply due to the complete mine having since been flooded. See the chapter on the [Engine Shaft and Flat-rod Run](#) (page 18) for more details about the shaft being the source of pumping, given that the shaft and this adit meet at some deeper level. Another possible explanation comes from surface evidence outside on the hillside, where there are a number of possible locations that have been identified for any still undiscovered but postulated [Third Shaft](#) (page 29).

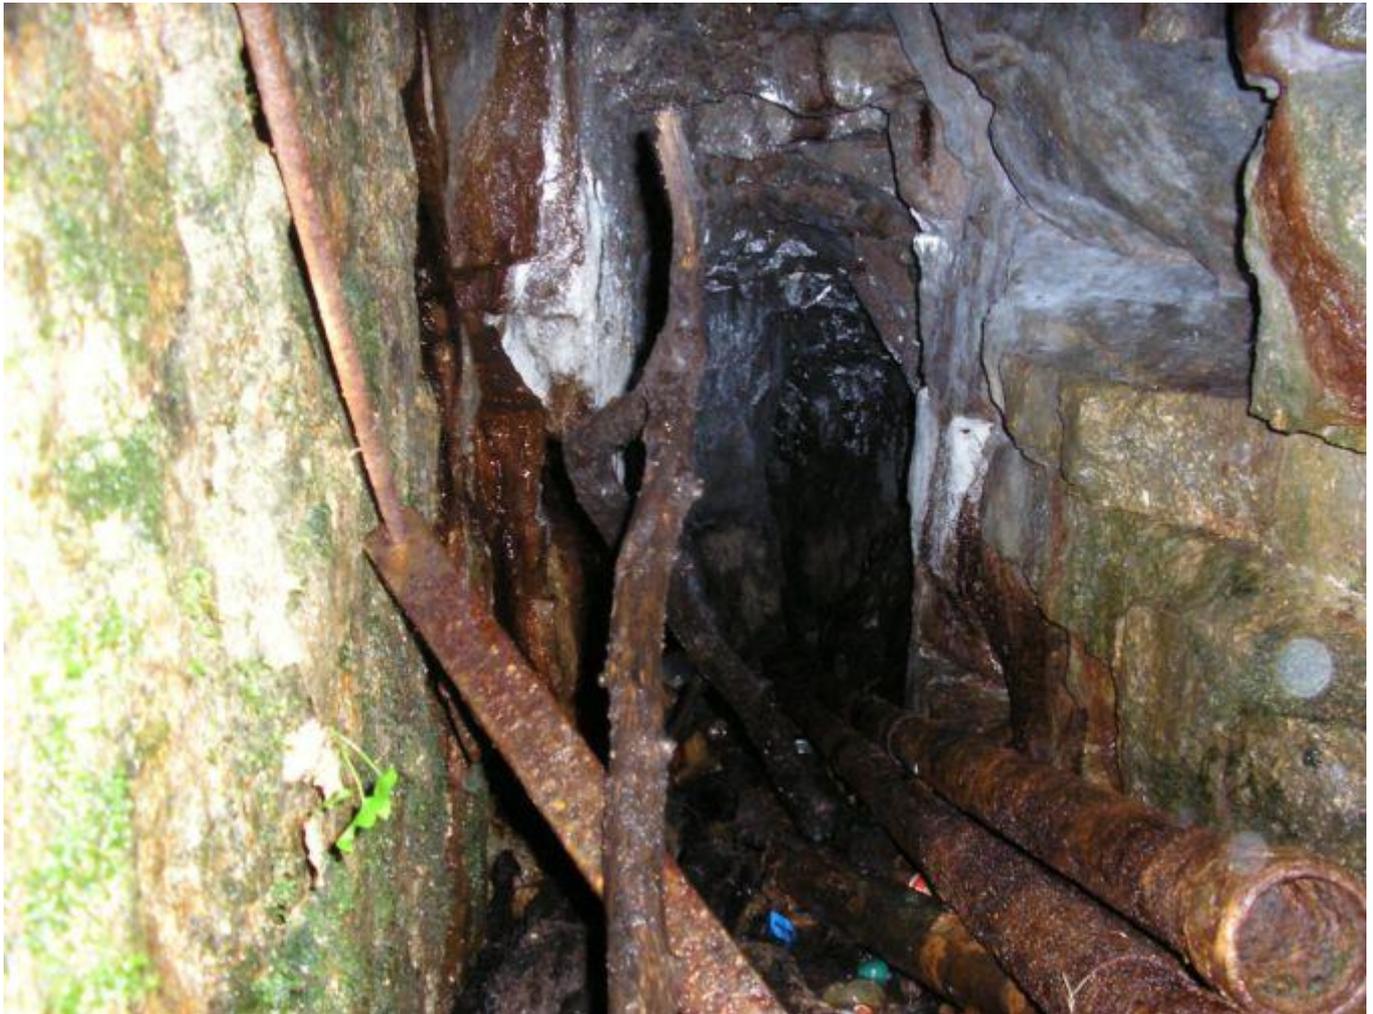
*The view into the adit entrance.*

From the view into the adit, there has clearly been some disturbance of pipes since my own photo here was taken back in 2004 [“Ghosts of the Past”](#) (page 37).

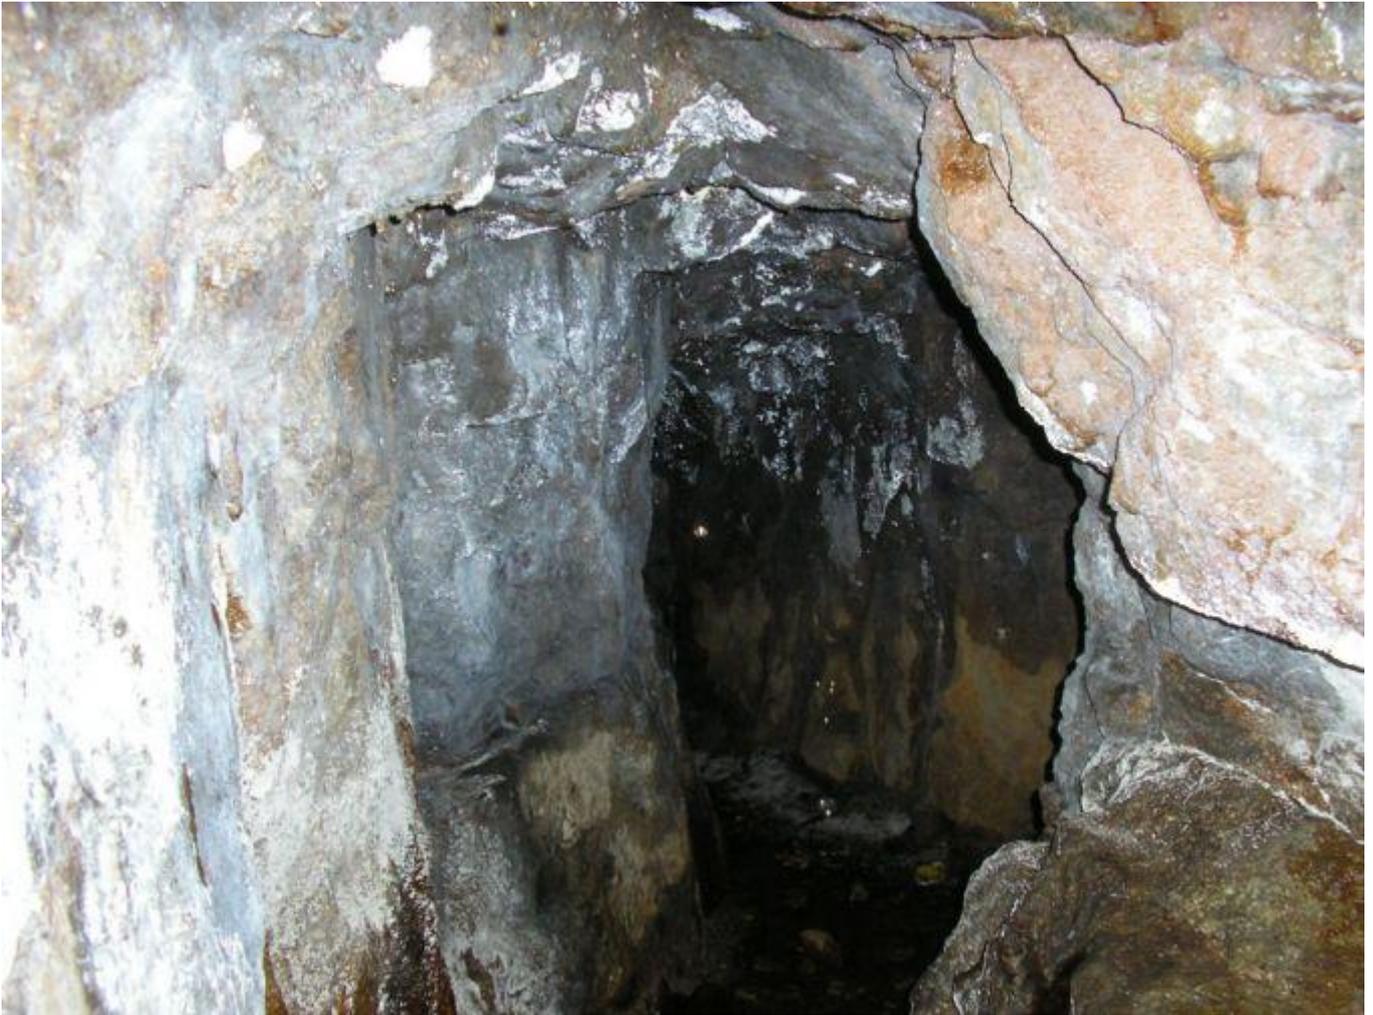
*Just inside the gate in the lower adit, with a small void just to the right.  
No pipework on the floor.*
