# The History and Remains of the Wheal Victoria Copper Mine at Golitha Falls

By Clive ffitch, Redgate Smithy, Redgate, Cornwall

Dated 5 May 2020; for online photographs and content of this research, please refer to:  
<http://www.photofilecornwall.co.uk/cornwall-mineheritage/wheal-victoria-copper-mine.htm>

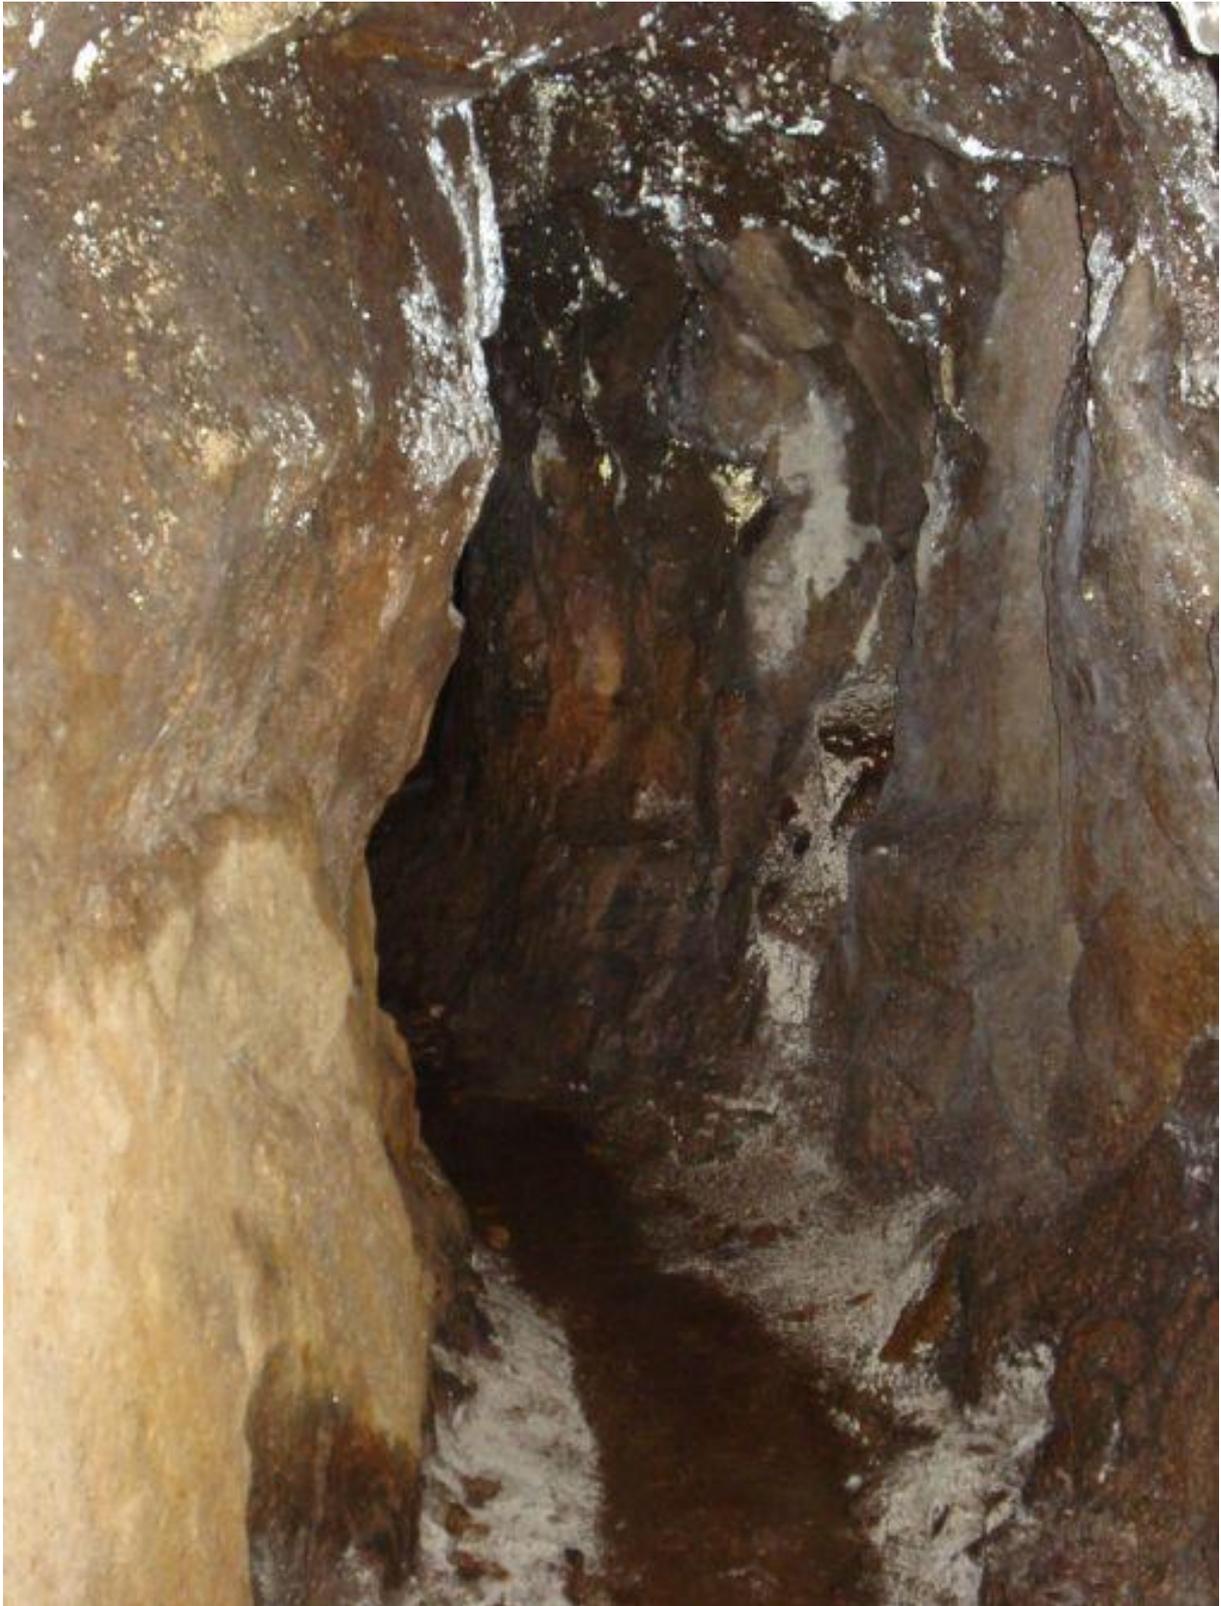
*Further into the adit now, small amount of water running out. Good condition.*

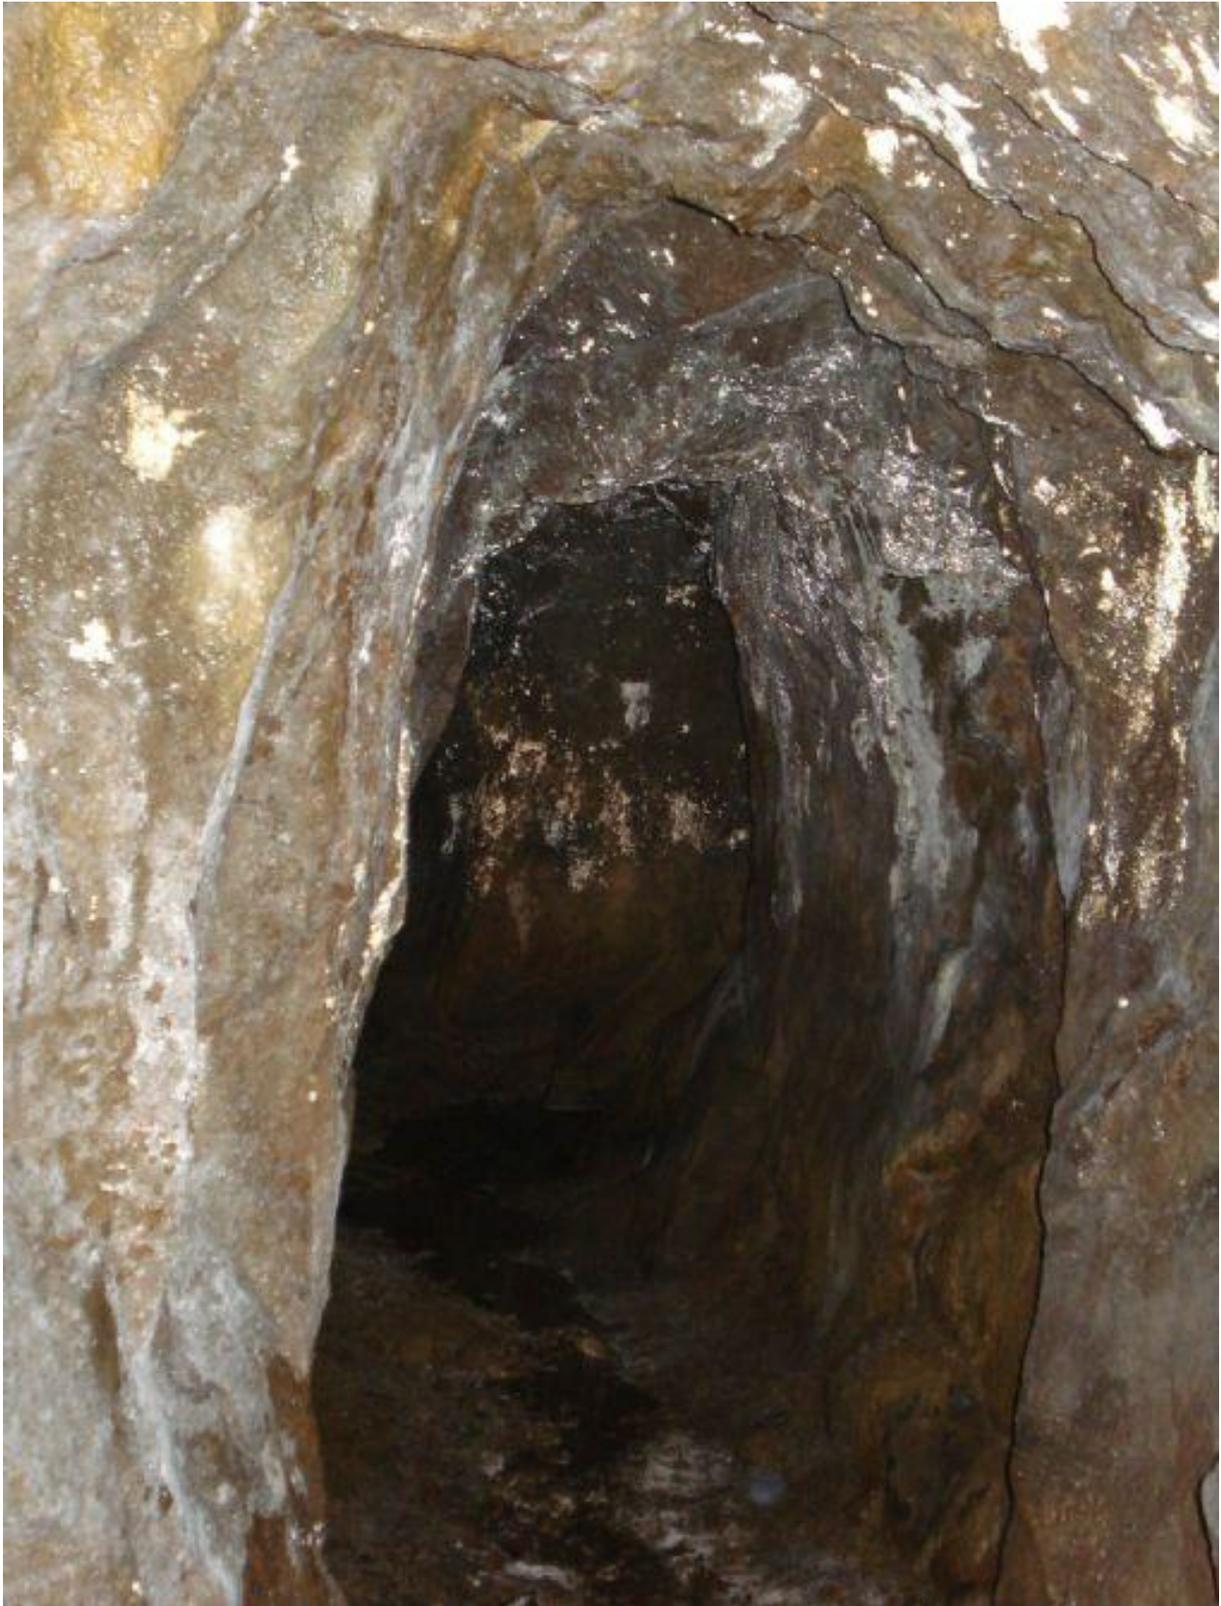
*In the adit, ahead a shaft can be seen flooded.*

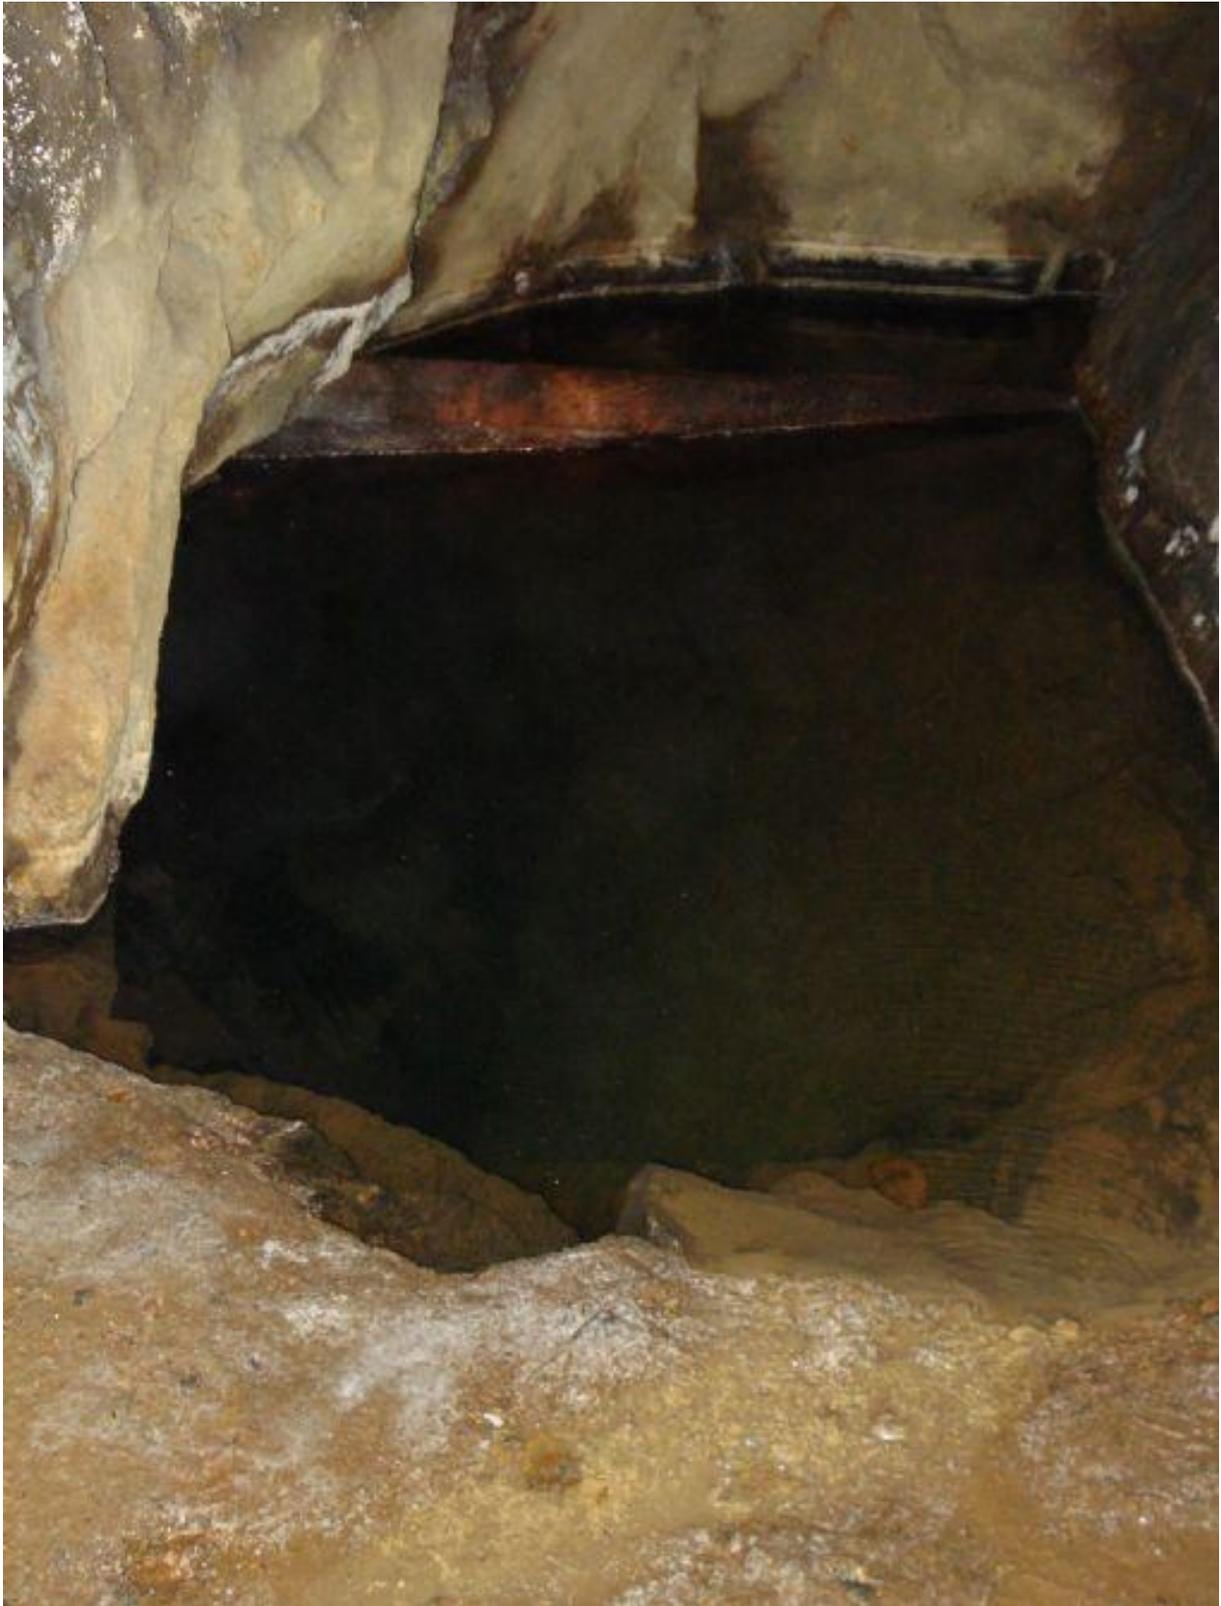
*The flooded shaft.*

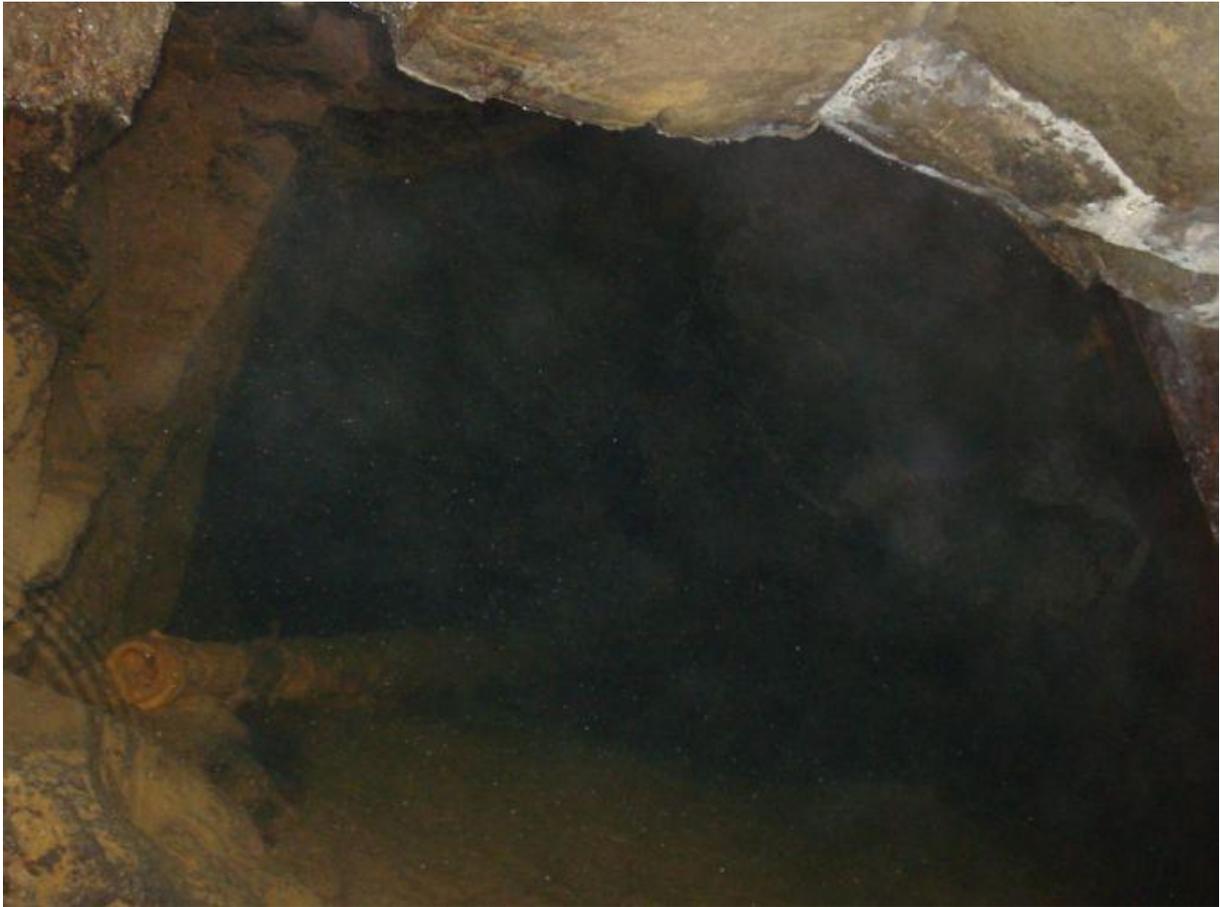
*Looking down the flooded shaft, the pipework is still in place disappearing down the shaft. The adit continues further on past - (photo courtesy of Orphan on [AditNow](#))*

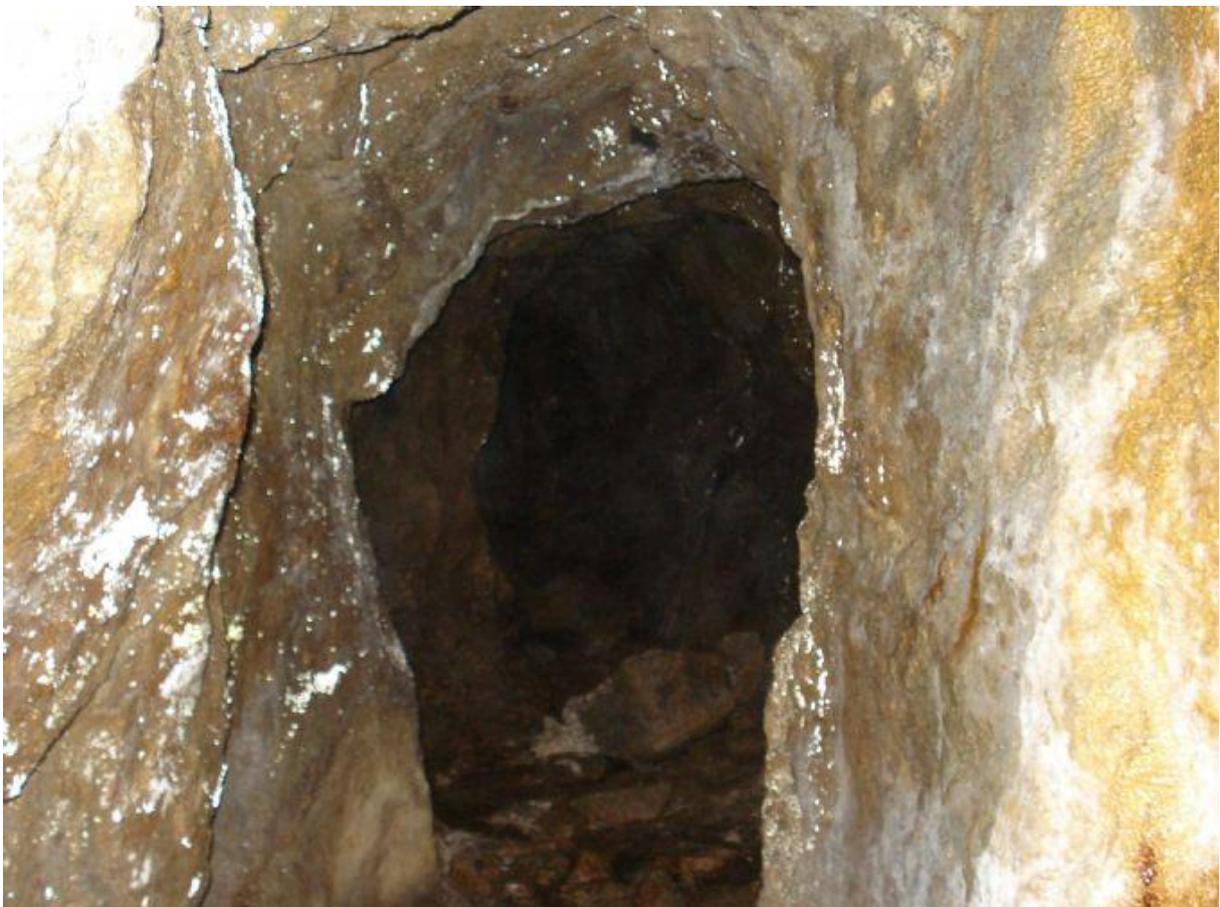
*Looking onwards past the flooded shaft - (photo courtesy of Orphan on [AditNow](#))*

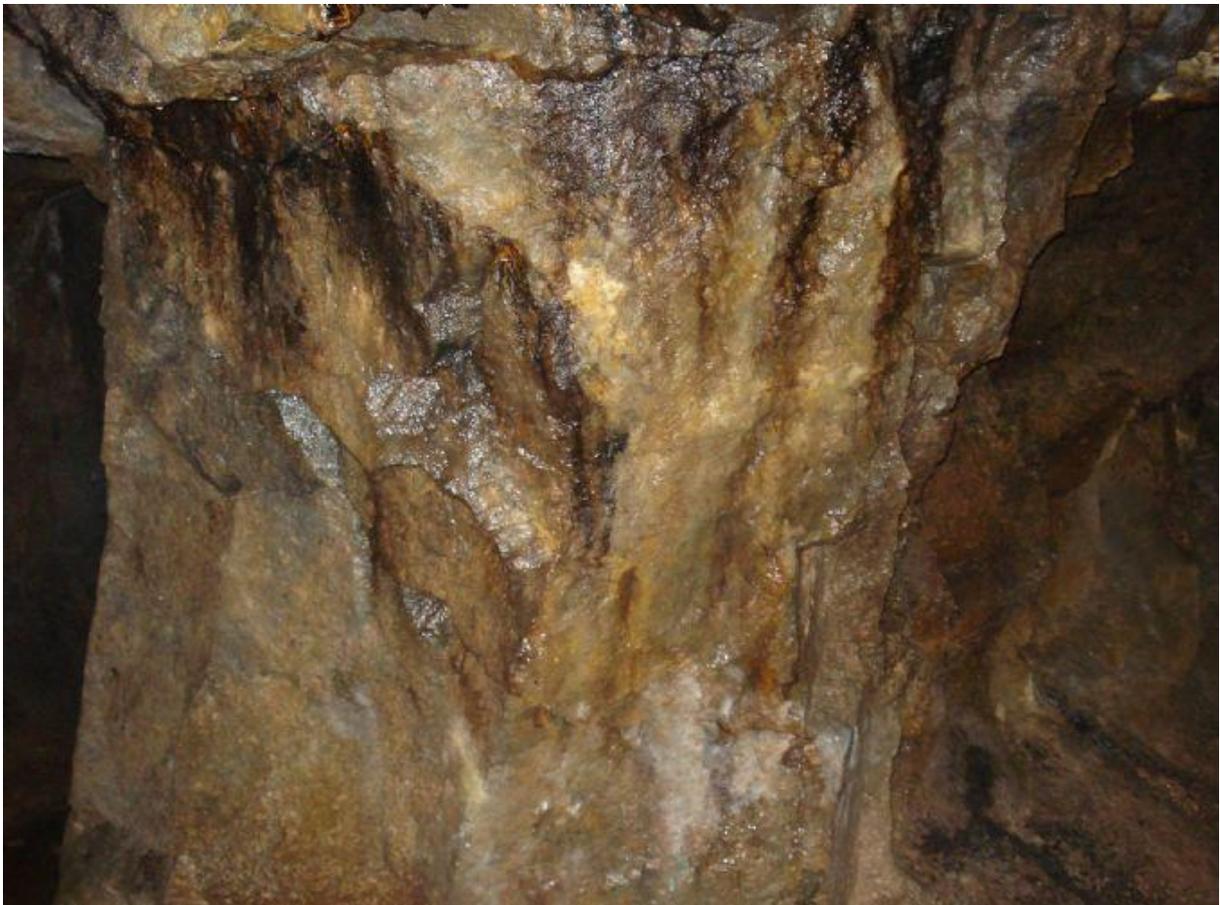
*The split - here the adit splits off into two branches.  
(photo courtesy of Orphan on [AditNow](#))*

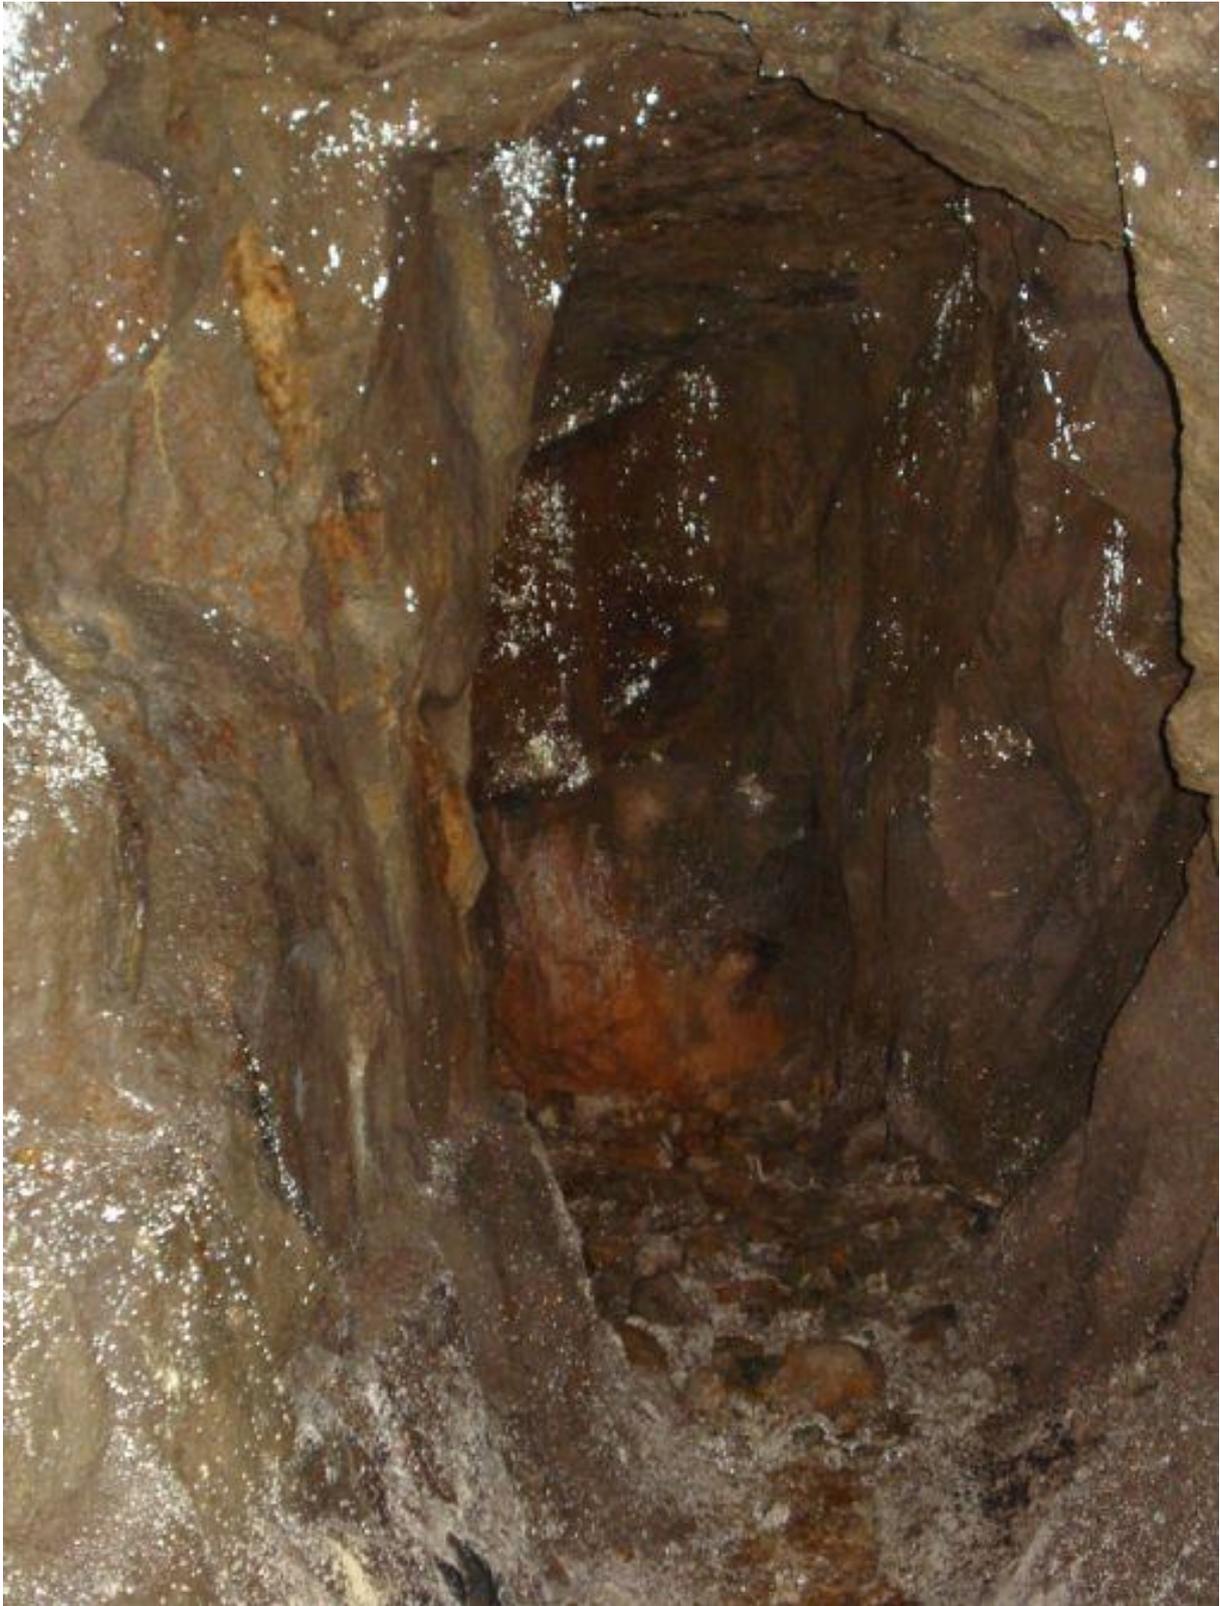
*Looking right from where the two branches split to where the passage ends.*

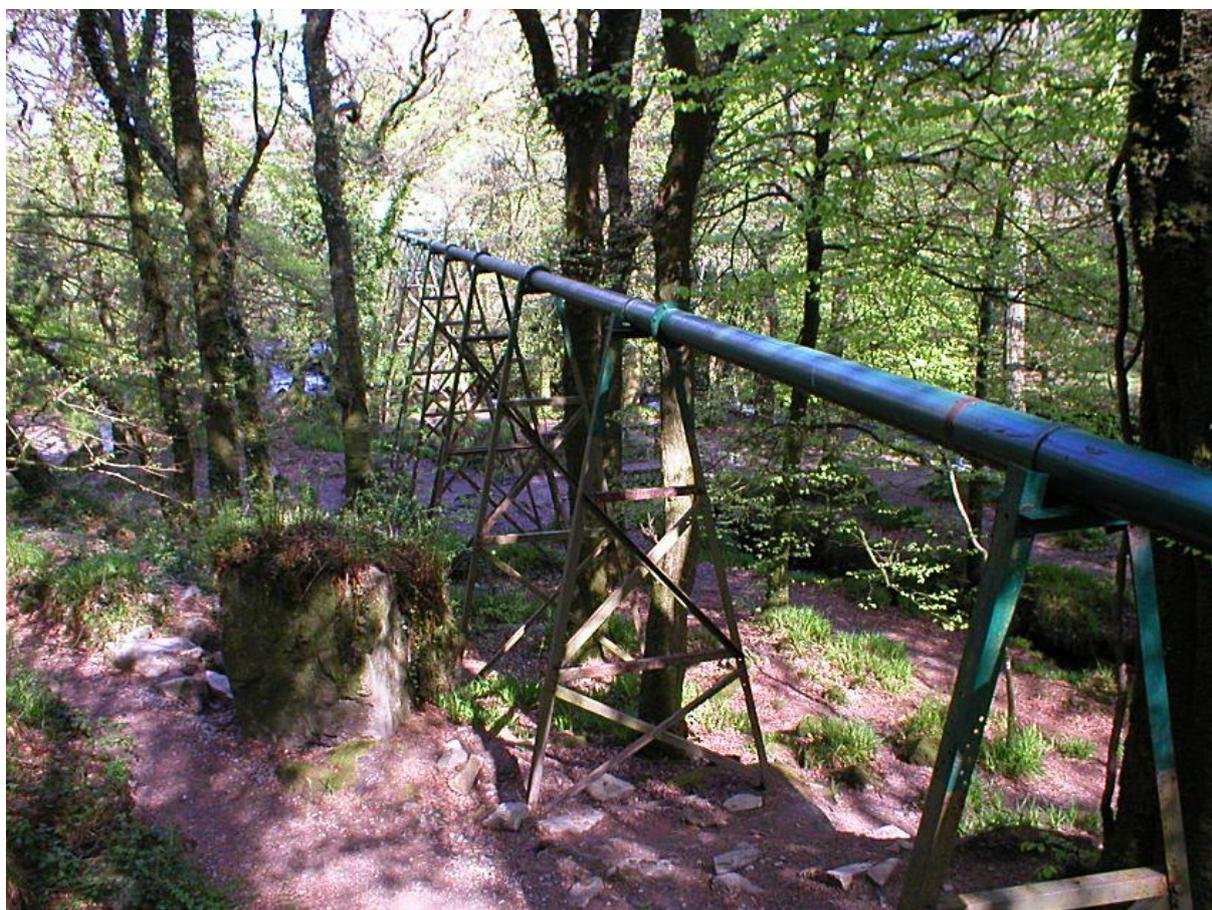
***The China Clay Pipeline at Golitha Falls***

When you start to explore [Golitha Falls National Nature Reserve](#), you will very soon realise that there is a rather strange large green pipe flying right through the middle of it. You might not notice it straightaway, as it is high up, and curiously manages to blend in somewhat with its surroundings. The pipe is a part of a long pipeline, about a foot in diameter, and contrary to a lot of peoples' belief, it does not carry water.

The pipeline is in fact a China Clay Pipeline, that was built to transport china clay from a China Clay Pit up on Bodmin Moor, down to the China Clay Dries at Moorswater for processing. The pipeline ran initially from Northwood China Clay Pit, and then after a short while was also used by the nearby Parsons Park (sometimes known as Park, or Lords Park) China Clay Pit, and it passes through Draynes, underneath Redgate, and then along a slightly tortuous route, on down to Moorswater near Liskeard. It was used to pump liquid kaolin (or china clay "slurry") from the pit for drying, and after the slurry was processed in the dries, the china clay in powder form was subsequently transported by train to the ports of Fowey and Par. The pipeline was constructed in 1908, and has no connection whatsoever with the Wheal Victoria Copper Mine, the remains of which can also be found down at Golitha Falls.

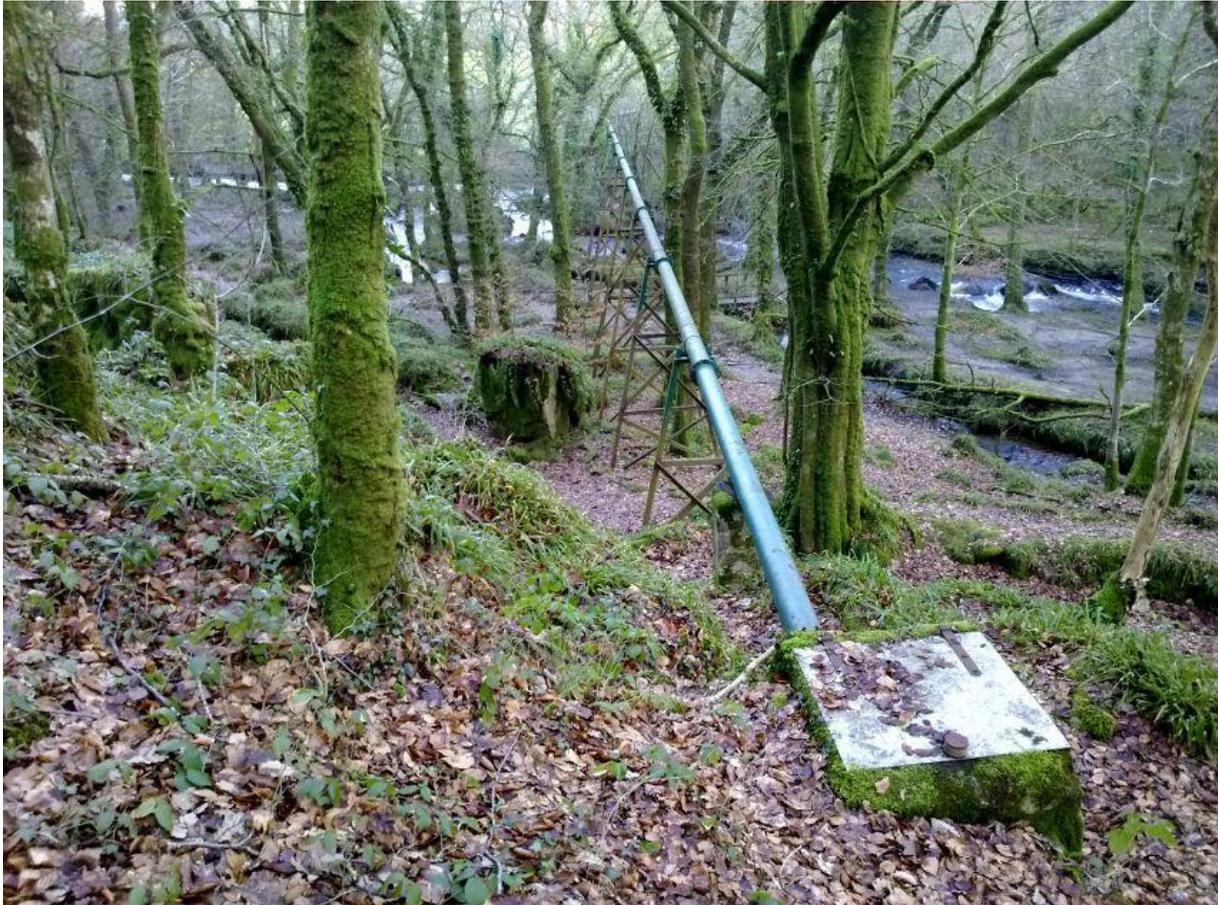
**Looking directly along the now disused China Clay Pipe during the winter**

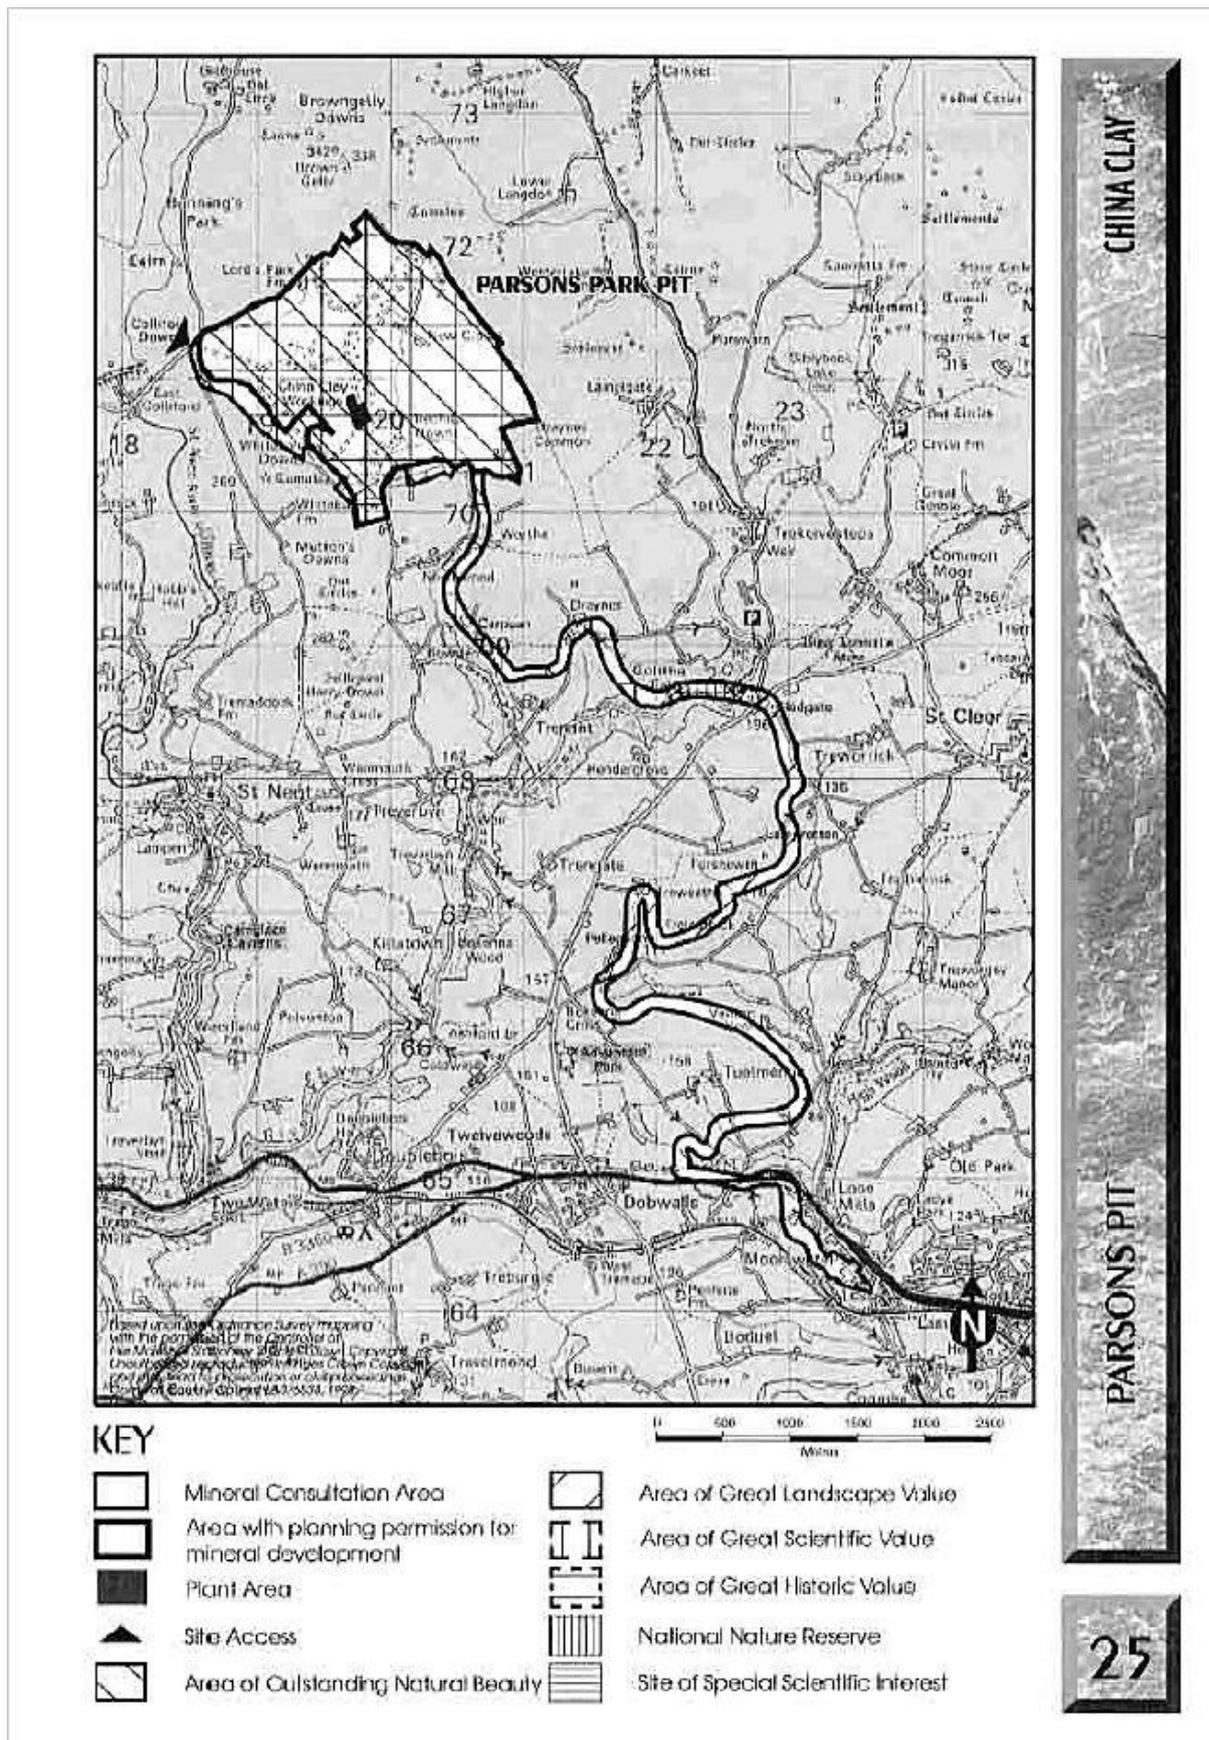
**The China Clay Pipeline from the 1998 Cornwall County Council's Minerals Local Plan, approximately 8.5 miles in length - Courtesy of Cornwall Council Archives**

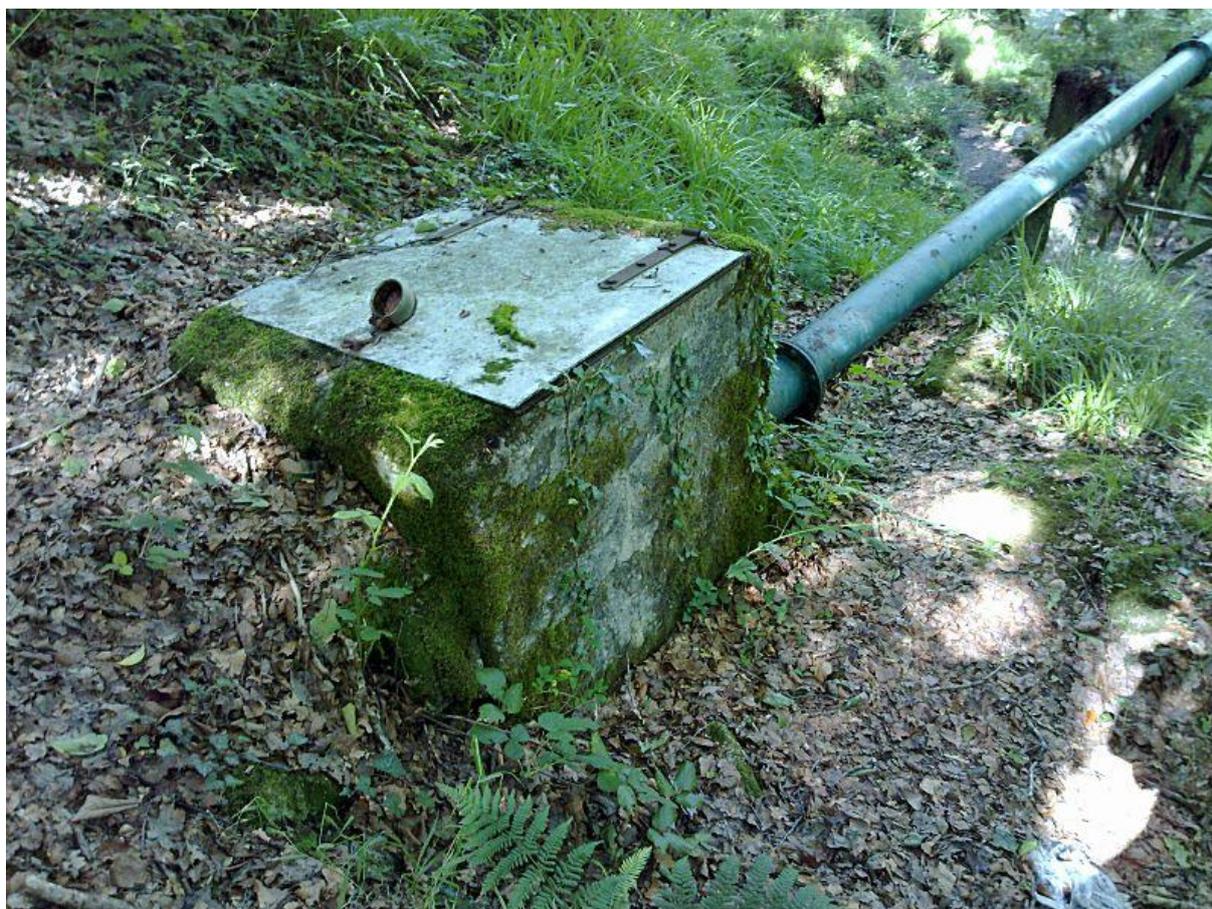
***The pipe disappears into the ground on the St Neot side via an inspection hatch***

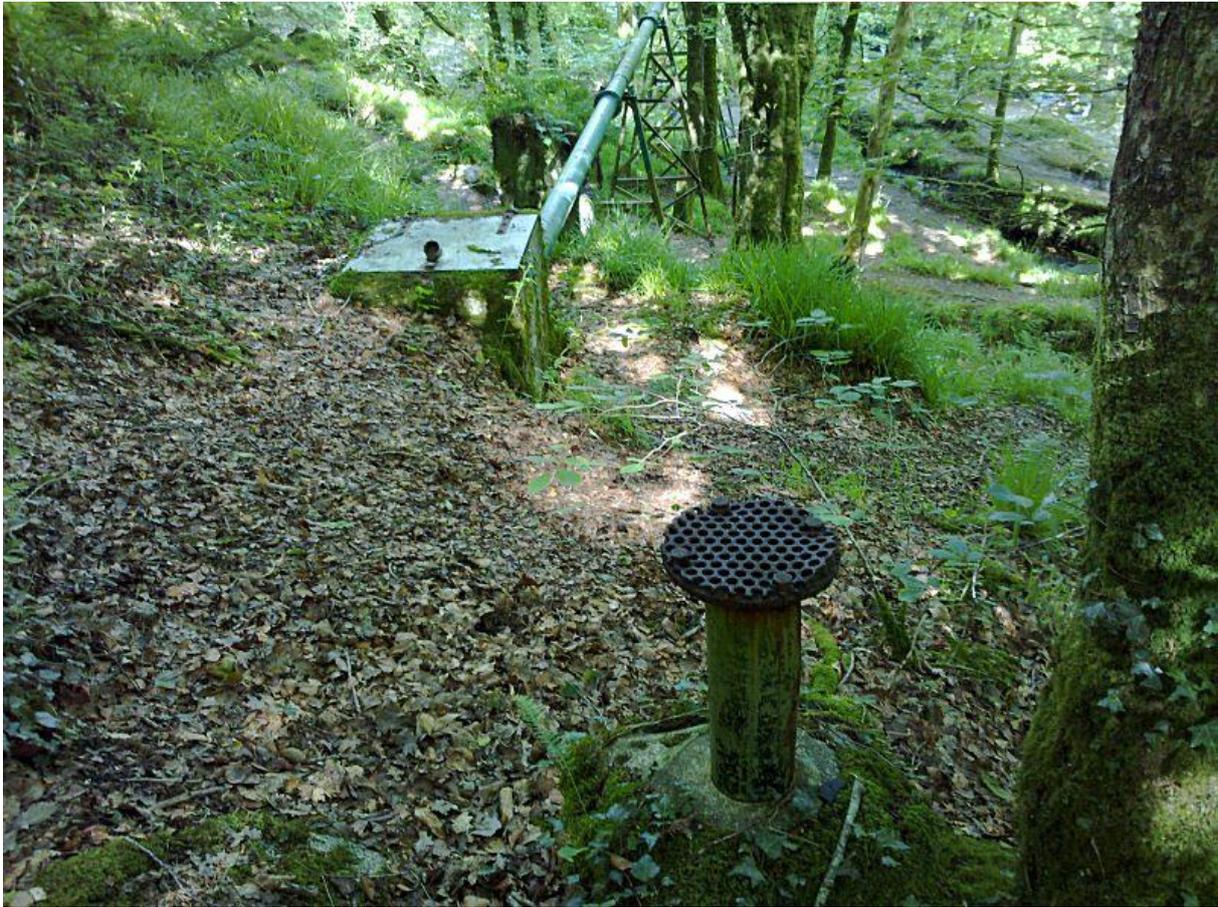
*The First Vent / Survey access pipe close to the inspection hatch*

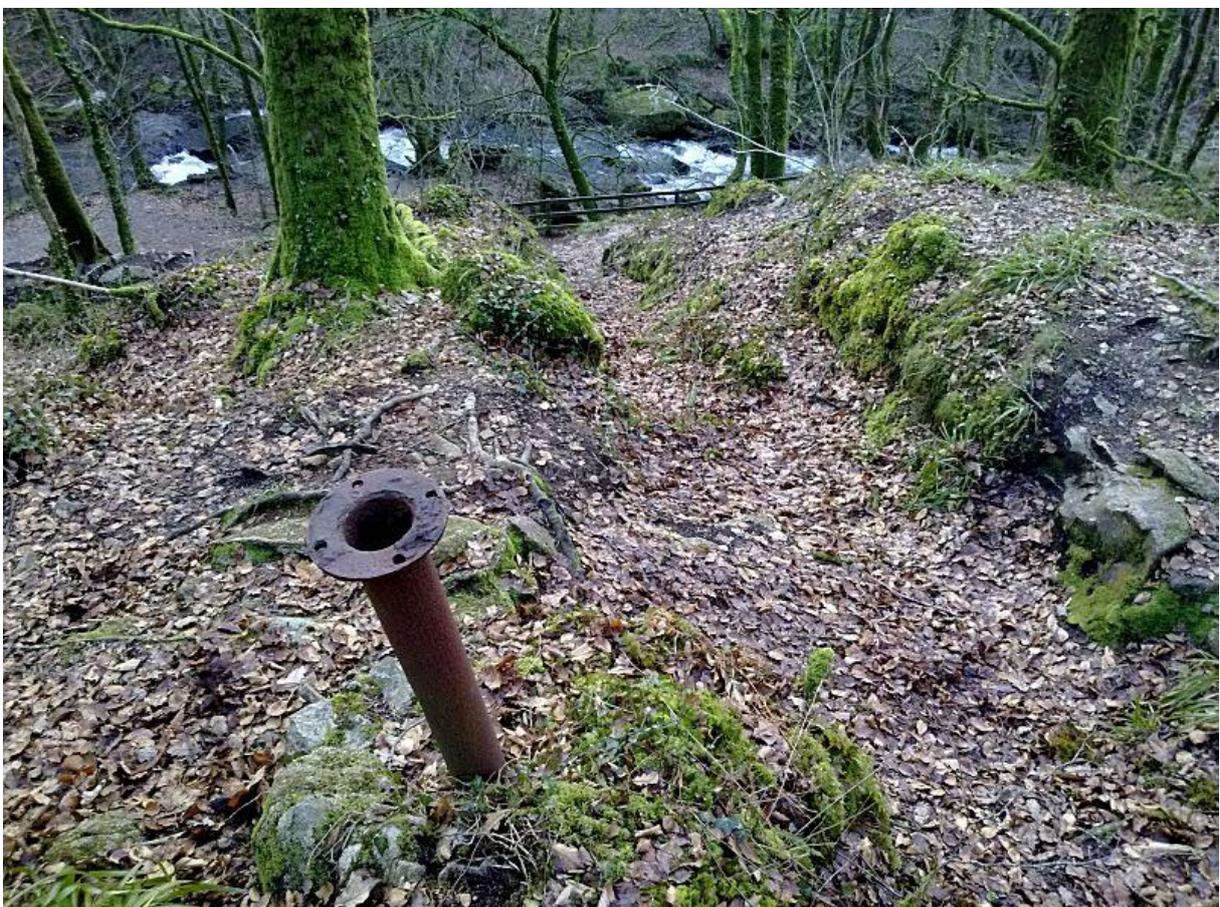
***The Second Vent / Survey access pipe encountered, coincident with the first flat-rod run.***

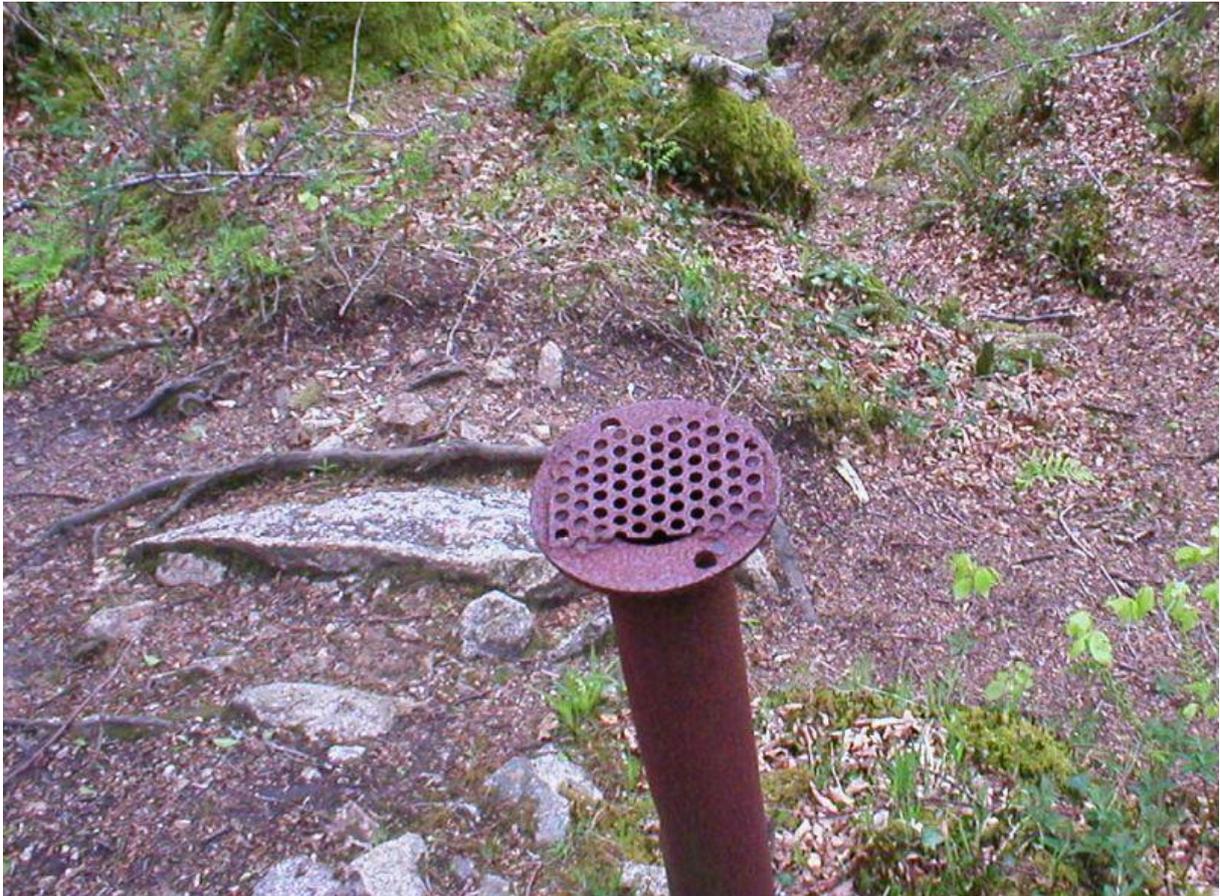
*The Second Vent pipe as seen in c.2005, still complete with mesh. As with the other clay pipe features, this has nothing to do with the mine, which closed over 50 years earlier*

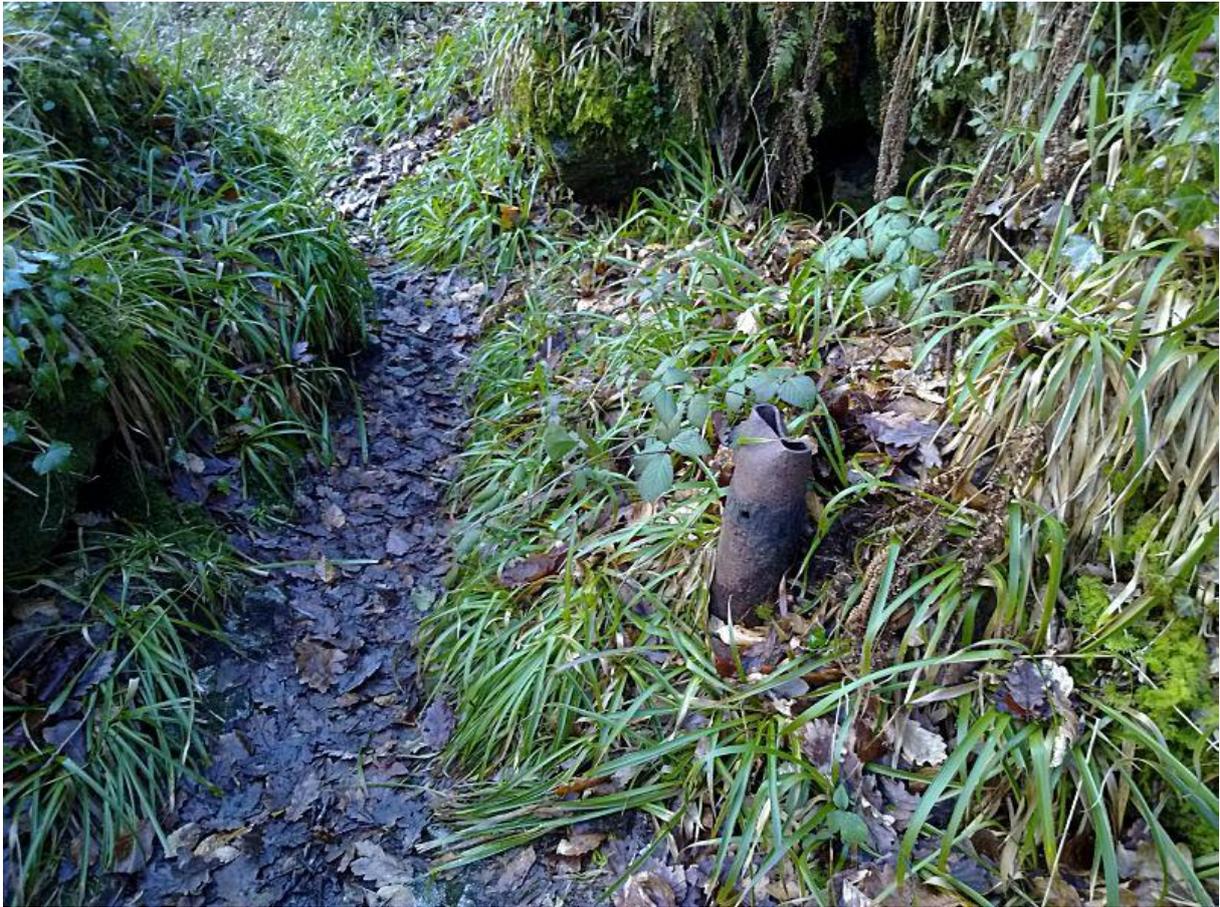
***Crossing the flat-rod run coming up from the second wheel-pit, there is what looks like another "cut-off" Third Vent / Survey access pipe right alongside the pipeline track***
