# The History and Remains of the Wheal Victoria Copper Mine at Golitha Falls

By Clive ffitch, Redgate Smithy, Redgate, Cornwall

Dated 5 May 2020; for online photographs and content of this research, please refer to:  
<http://www.photofilecornwall.co.uk/cornwall-mineheritage/wheal-victoria-copper-mine.htm>

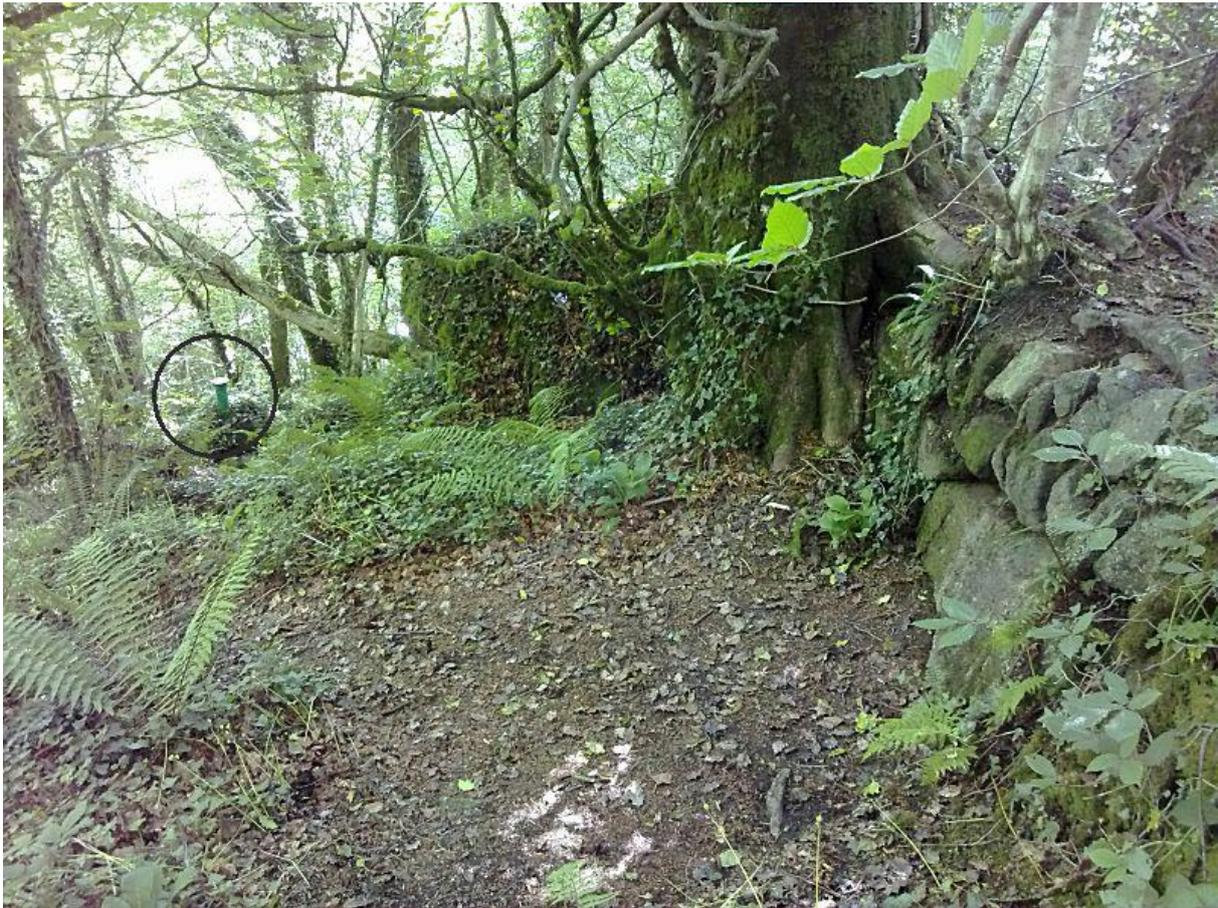
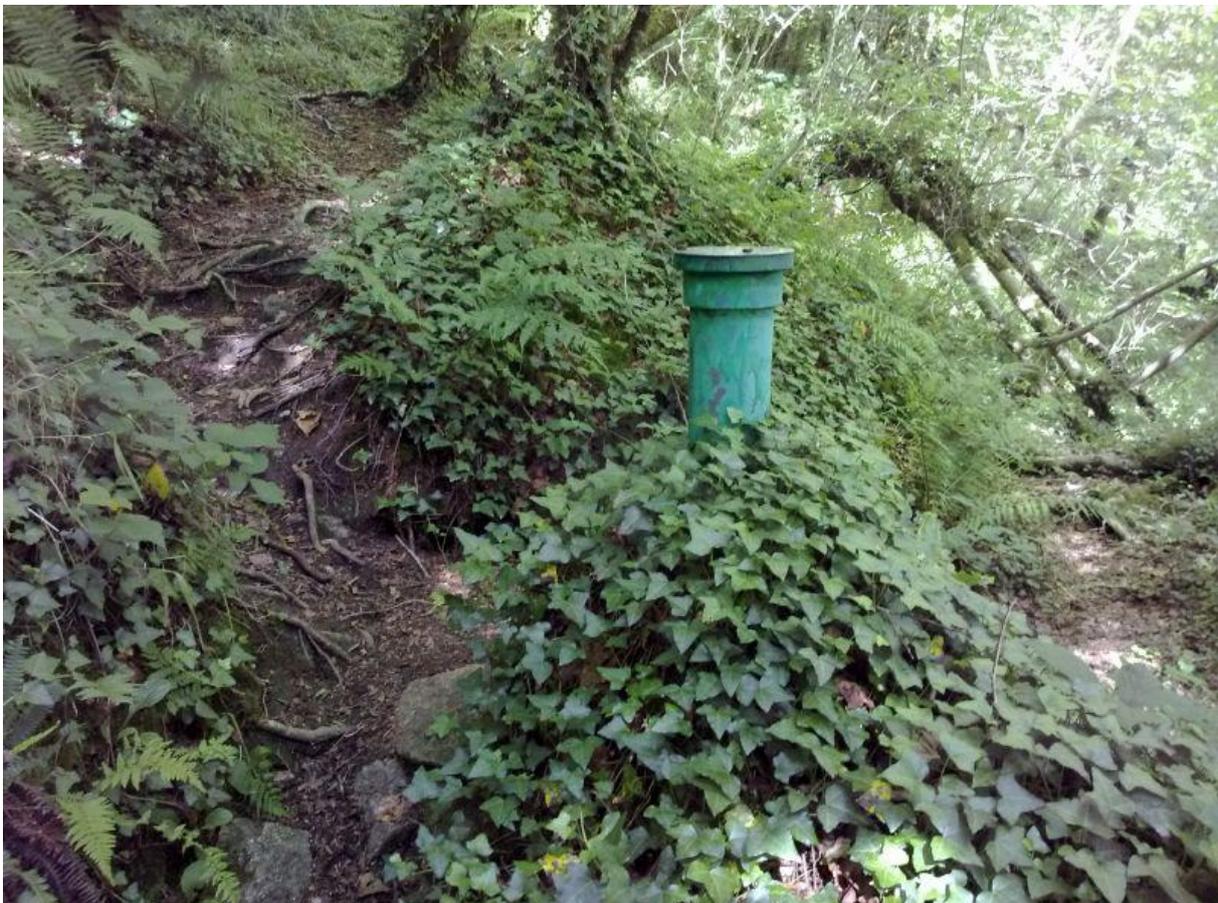
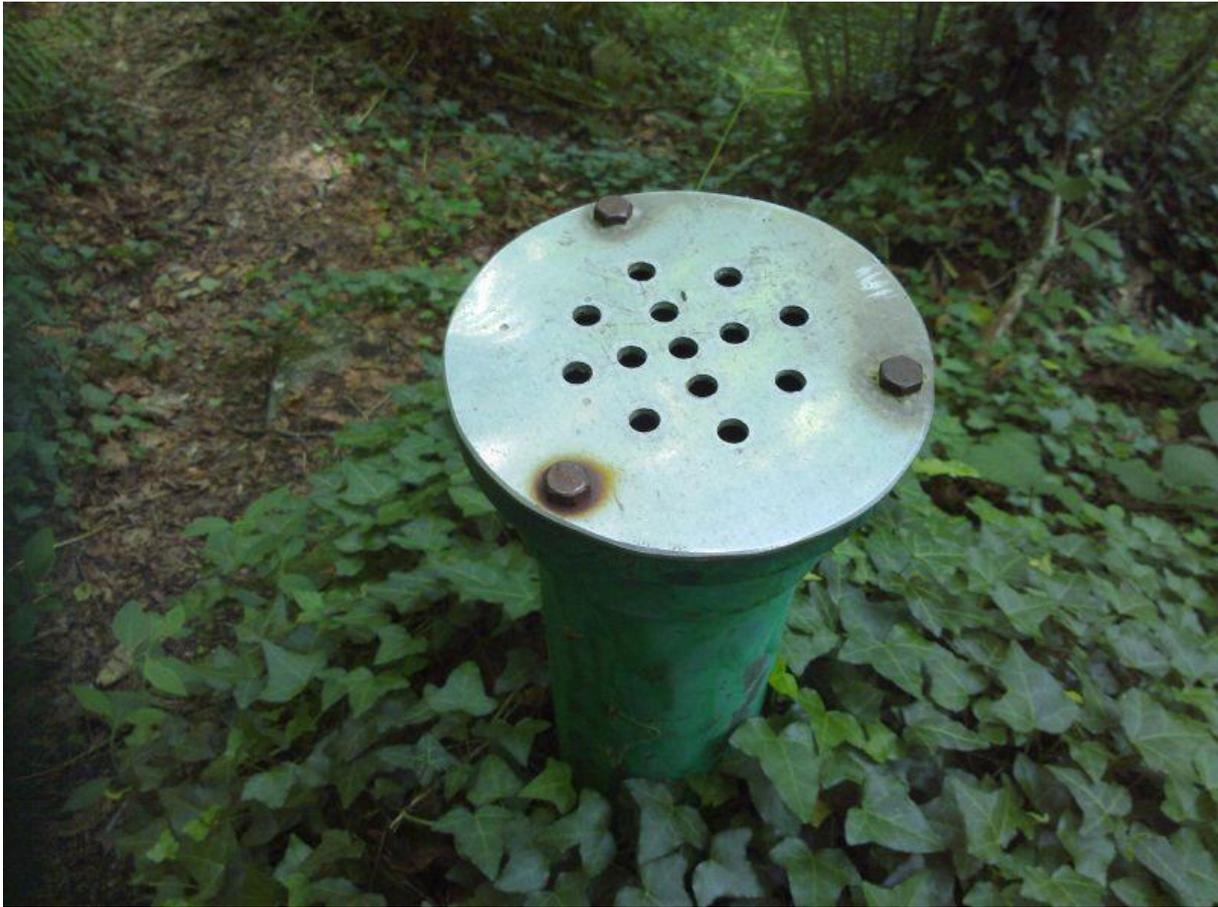
***Looking down to the Fourth Vent / Survey access pipe in the old wall***

***The Fourth Vent / Survey access pipe***

*Again, the Fourth Vent / Survey access pipe - a more recent part-plastic replacement?*

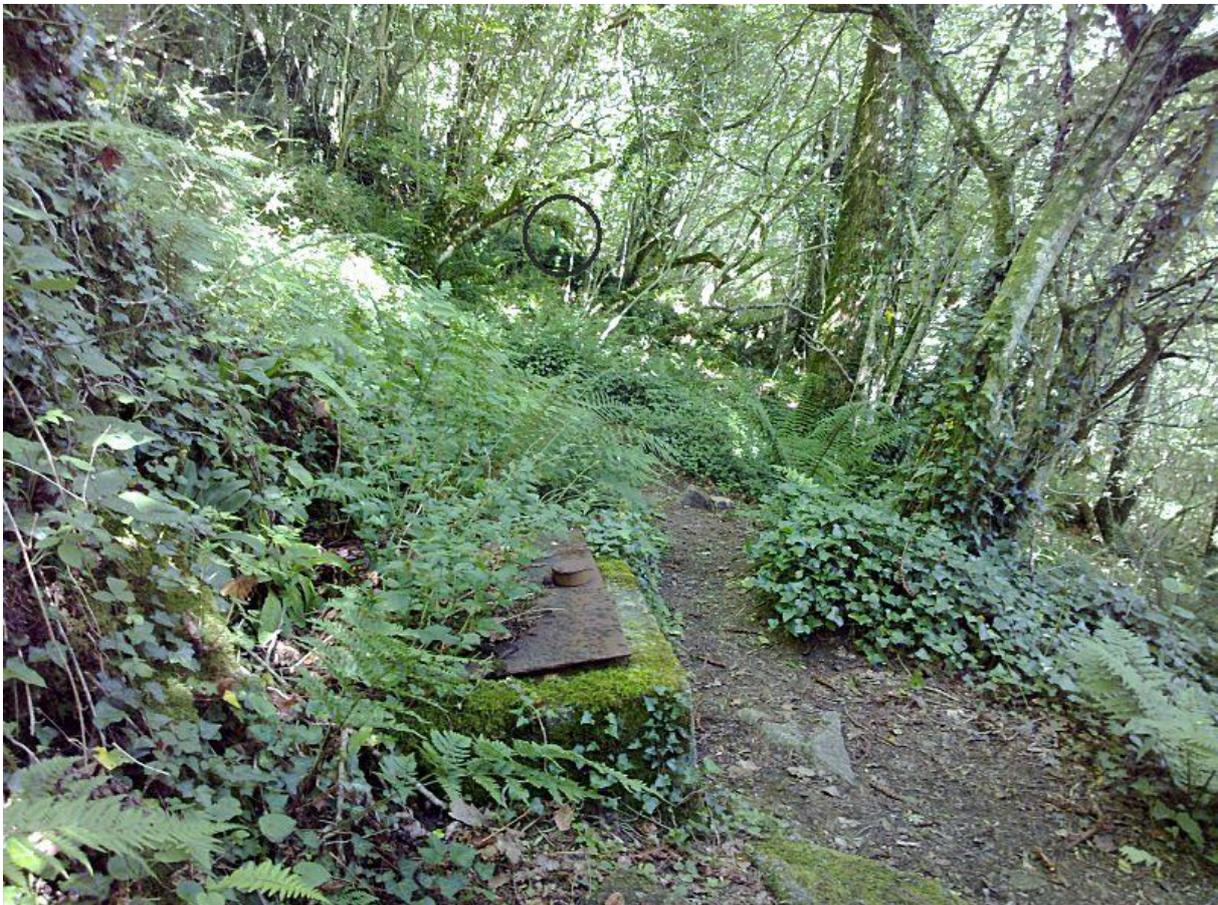
*A second inspection hatch discovered, now half hidden at the base of a tree, and looking back to the Fourth Vent / Survey access pipe (ringed)*

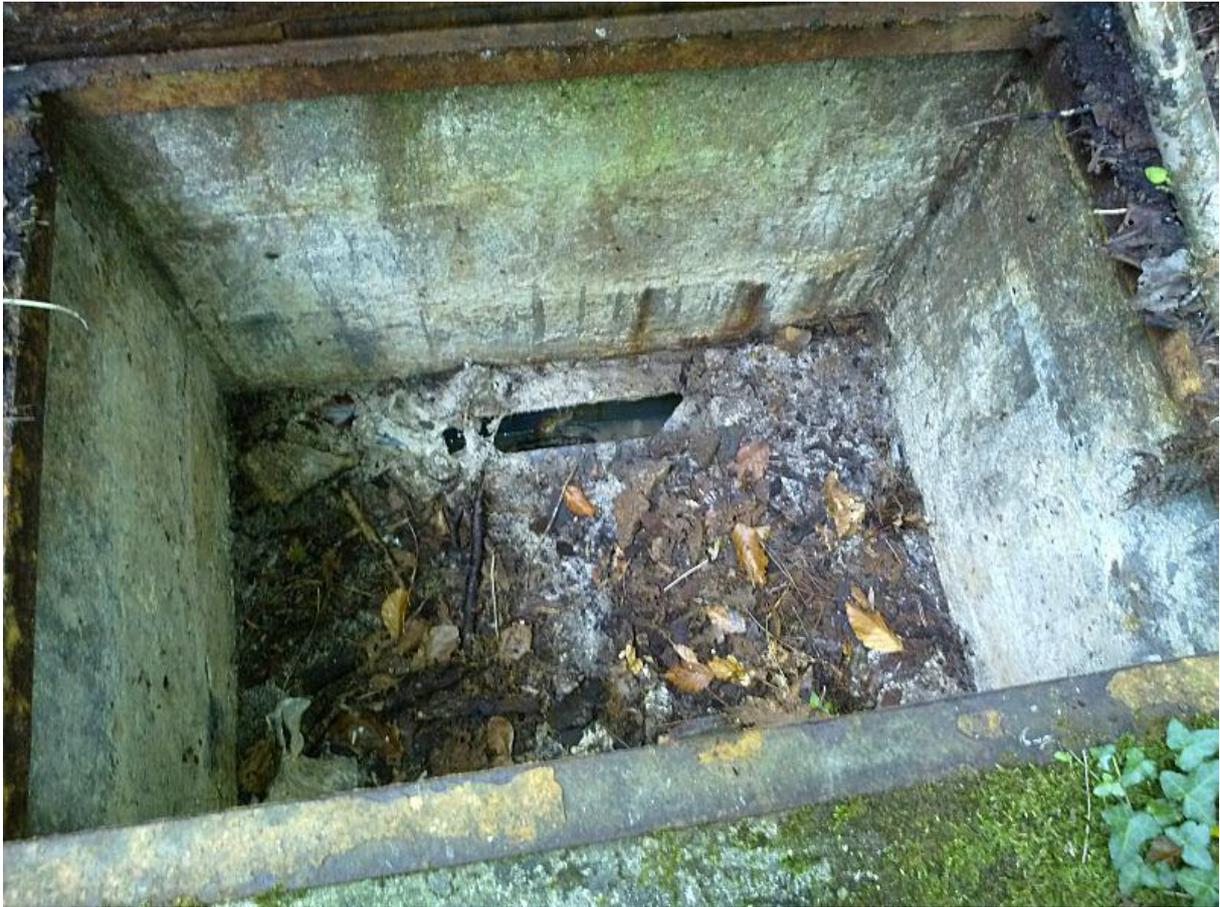
***Looking inside the inspection hatch, and the China Clay Pipe can be clearly identified (though now appears to have an apparently sawn hole in it)***

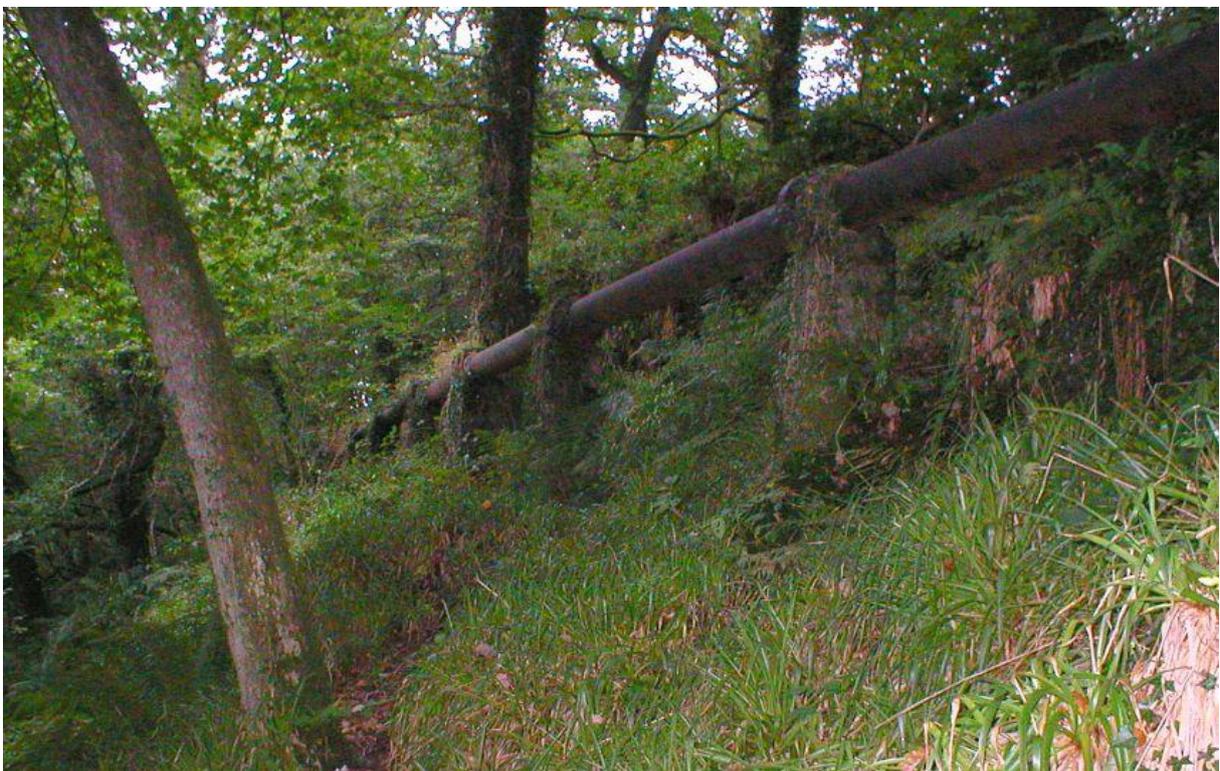
***The China Clay Pipeline emerges temporarily from the hillside from the direction of Parsons Park Pit, before once again disappearing underground (see [Map](#)).***
